SUBJECT: Service Update for Inventory Vehicles Only
Transmission Snap Ring Misalignment
Expires September 30, 2014

MODELS: 2013 Buick Regal, LaCrosse
2013 Chevrolet Malibu
Equipped with 6T40 Automatic Transmission (MHH)

Subject: 13282A – Service Update Bulletin
Transmission Snap Ring Misalignment
Revised Warranty Transaction Information

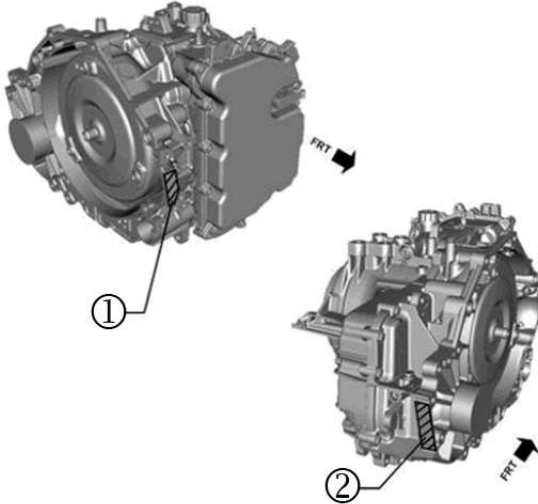
3613040

Note: A VIN derivative is required to be permanently engraved on the new transmission prior to installation. Refer to the illustration above for VIN engraving location points. Select one of the locations to engrave the required characters. VIN derivatives must be formatted as indicated below (# = last eight characters of the VIN).
