**SUBJECT: Service Update for Inventory Vehicles Only
Rear Glass Water Leak
Expires September 30, 2014**

MODELS: 2014 Chevrolet Cruze

Subject: 13272 – Service Update Bulletin
Rear Glass Water Leak

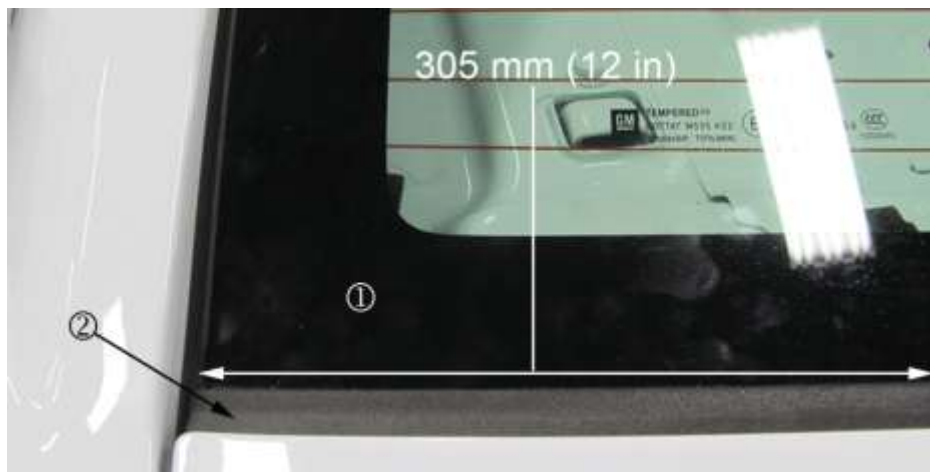
3613309

Note: Some vehicles may have a urethane sealing issue in the area shown in the photograph. The area of concern is a 305 mm (12 in) section of the rear window glass that begins at the left (driver side) lower corner and ends near the CHMSL. The urethane sealing issue, if present, may allow water to enter the trunk. Look for evidence of a water leak in the trunk.

1. Locate the rear left (driver side) window glass (1) and rear window water deflector (2).

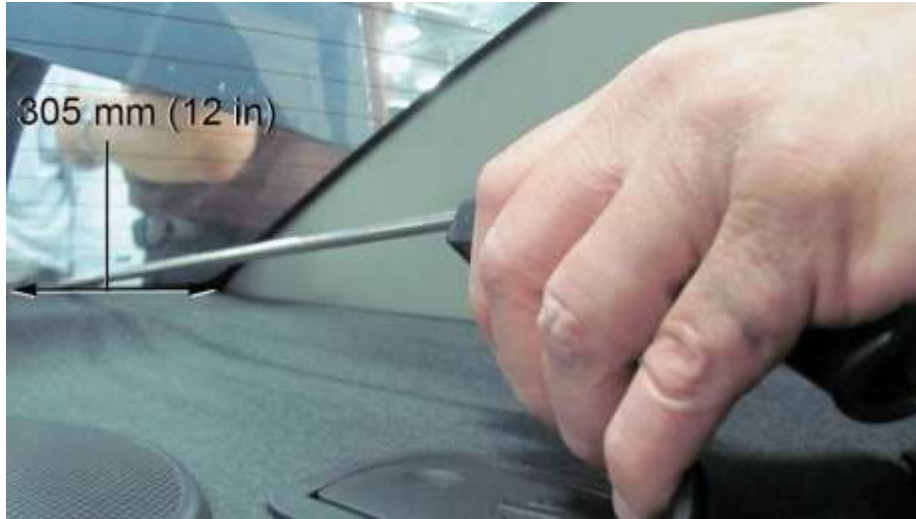
3613312

Note: Have a second technician sit in the rear seat of the vehicle to apply air pressure to the rear glass during and after step 2. Use a small air nozzle to apply compressed air to the inspection area. Refer to photograph.

3. Apply compressed air to the bottom edge of the rear glass in the inspection area indicated in the photograph.
4. Determine if a water leak is present. Examine the soap and water solution to determine if a water leak is present.
 - If a water leak is NOT present, no further action is required.
 - If a water leak is present, remove and replace the rear window glass. Refer to *Rear Window Replacement* in SI.
