# Service Bulletin

**SUBJECT:** Service Update for Inventory Vehicles Only  
Bent Piston Oil Squirters  
Expires September 30, 2014

**MODELS:** 2014 Chevrolet Silverado  
2014 GMC Sierra  
Equipped with 5.3L V8 Engine (RPO L83) or 4.3L V6 Engine (RPO LV3)

Subject: 13290 – Service Update Bulletin  
Bent Piston Oil Squirters

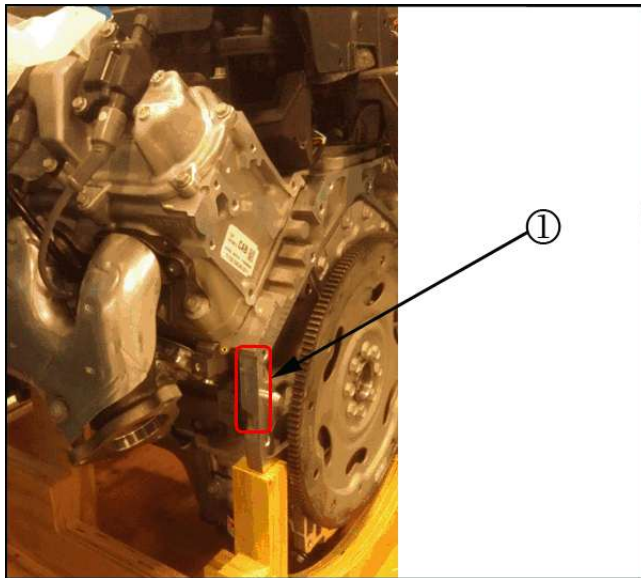
3613345

**Note:** A VIN derivative is required to be permanently engraved on the new engine prior to installation. Refer to the illustration above for VIN engraving location point. VIN derivatives must be formatted as indicated below (# = last eight characters of the VIN).
