# Service Bulletin

**SUBJECT:** Service Update for Inventory Vehicles Only  
Bent Piston Oil Squirters  
Expires September 30, 2014

**MODELS:** 2014 Chevrolet Silverado  
2014 GMC Sierra  
Equipped with 5.3L V8 Engine (RPO L83) or 4.3L V6 Engine (RPO LV3)

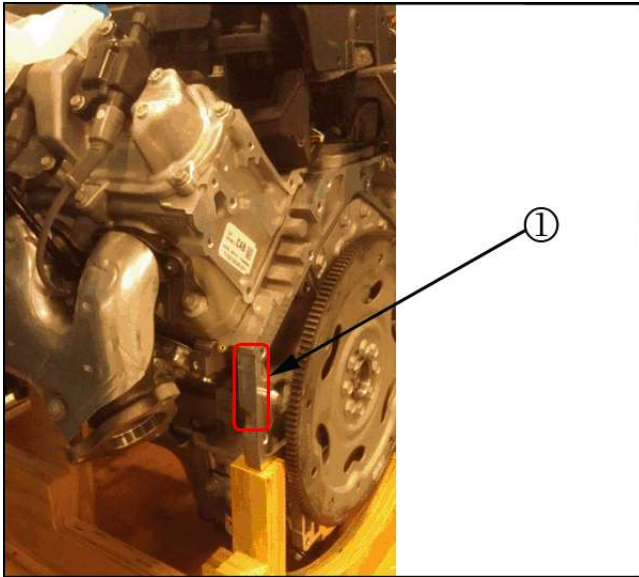
3613345

**Note:** A VIN derivative is required to be permanently engraved on the new engine prior to installation. Refer to the illustration above for VIN engraving location point. VIN derivatives must be formatted as indicated below (# = last eight characters of the VIN).
