Service Bulletin

SUBJECT: Service Update for Inventory Vehicles Only
Seatback Movement

MODELS: 2014 Chevrolet Silverado
2014 GMC Sierra
1500 Series Equipped with Manual Reclining Seatback

Subject: 13310 – Service Update Bulletin
Seatback Rattle

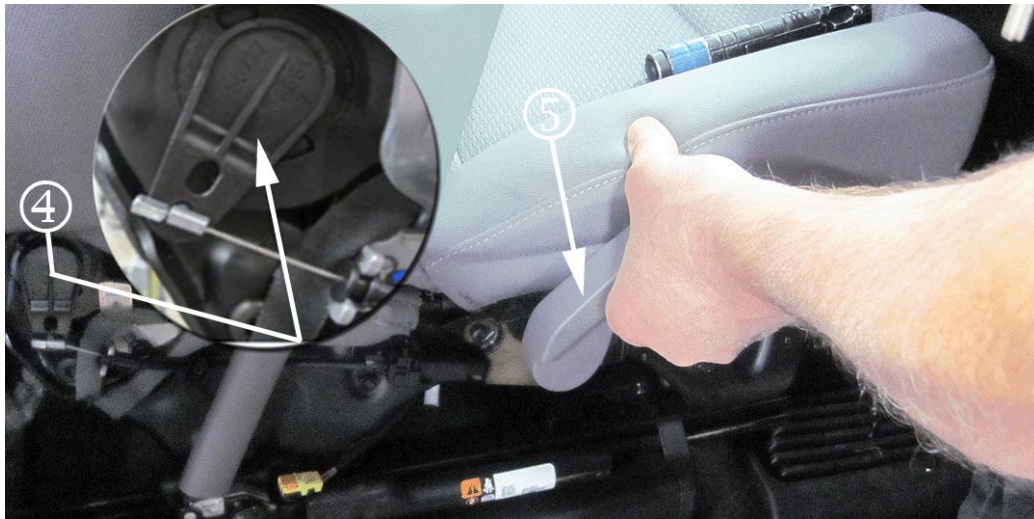
3627548

(4) Recliner Lever (5) Recliner Handle

1. Determine if the front driver and passenger seats are 8-way power seats or 2-way manual seats. Reset the recliner cable adjustment on seats equipped with the 2-way manual recliner option by proceeding to step 2.
2. It is important to ensure that the recliners are fully locked when adjusting the cable. To ensure the recliners are fully locked follow steps 2.1-2.5.
 - 2.1 Lift the recliner handle and allow the seatback to come to the full forward position (Caution: seatback may come forward forcefully.)
 - 2.2 Release the recliner handle
 - 2.3 Gently push the seatback rearward until it locks in its first position.
 - 2.4 Shake the seatback forward and rearward at least 3 times to verify it is fully locked.
 - 2.5 Make sure the recliner lever is not moved/bumped/nudged out of position during the adjustment process.

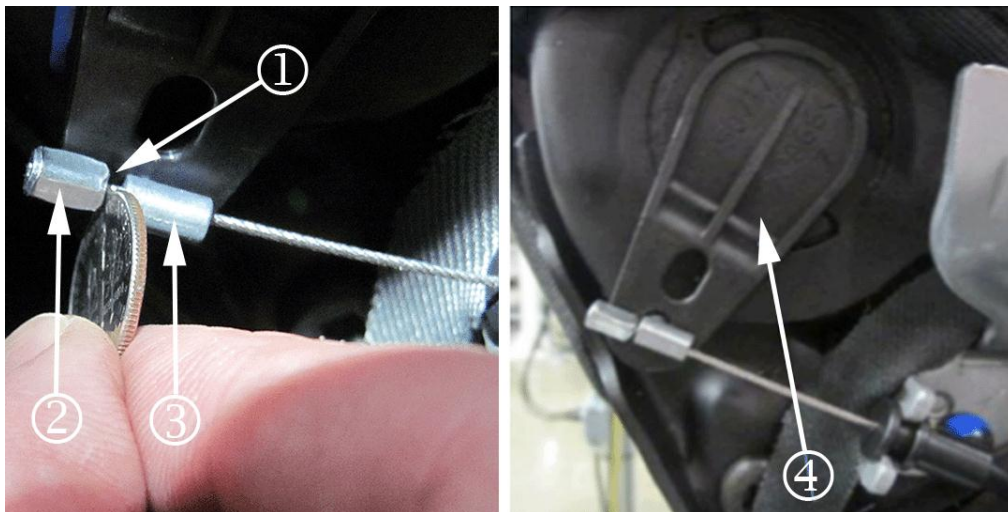
3627546

(1) End Gap (2) Ferrule (3) Z-Fitting (4) Recliner Lever

6. Insert a dime into the cable end gap.
7. While holding the dime in place, adjust the play in the cable so the ferrule, the dime and the Z-fitting are gently touching. Make sure the recliner lever is not moved/bumped/nudged out of position during the adjustment process.

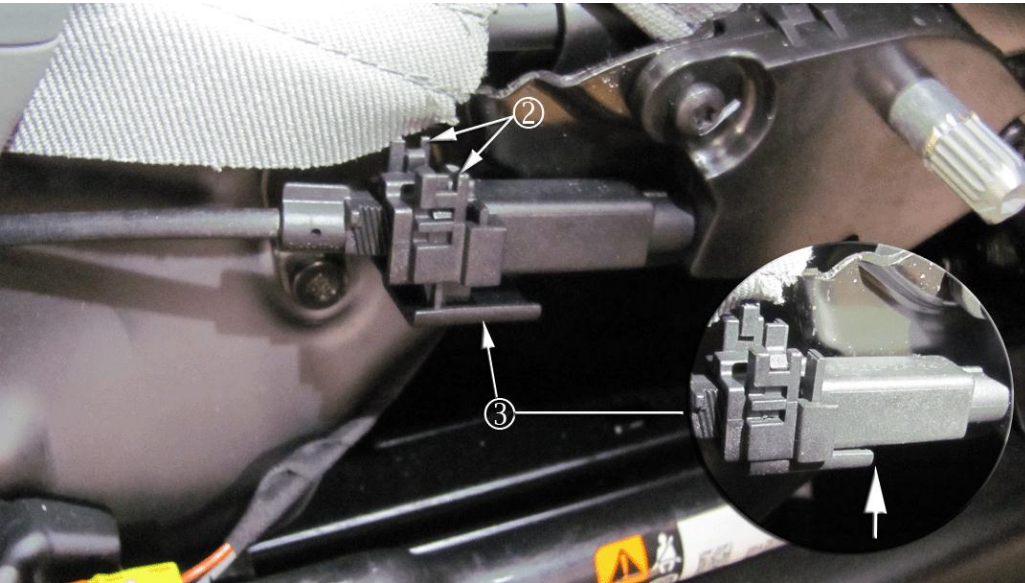
Note: The cable end gap may increase or decrease a small amount once the recliner cable adjuster is placed in the lock position.

8. Push the recliner cable adjuster pad (3) to lock the recliner cable adjuster. Remove the dime. The adjusting process is now complete.

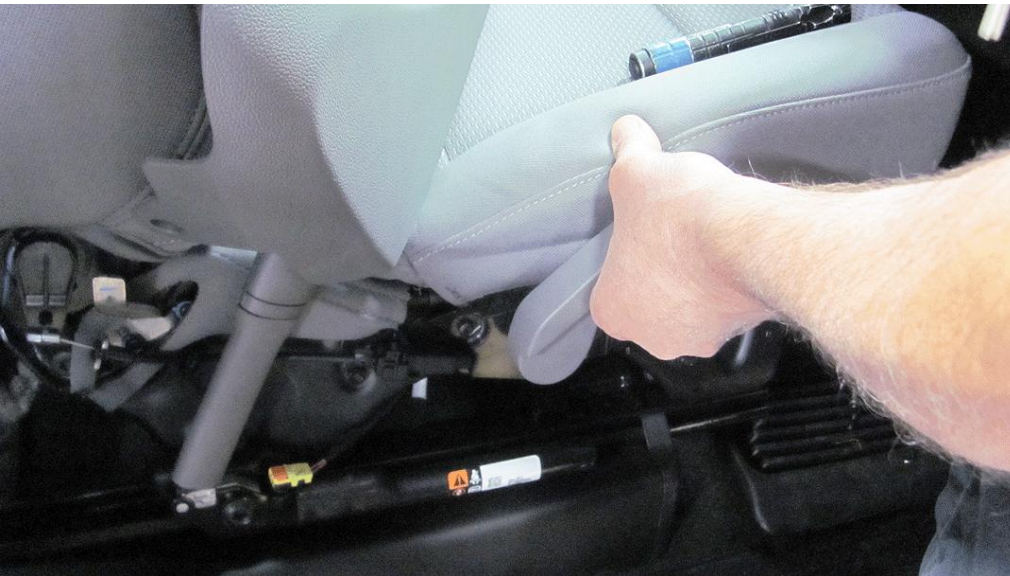
- 10.7 There should be no movement of the seatback beyond a small amount of lash, and no ratcheting sound during steps 10.3-10.6.
- 10.8 There must be clearance between the ferrule and Z-fitting. The cable must not have tension.

9. Verify the cable adjustment was successful: Temporarily place recliner handle onto the recline spline and perform steps 9.1-9.4.
