Service Bulletin

SUBJECT: Service Update for Inventory and Customer Vehicles
Software Enhancement Update
Expires with Base Warranty

MODELS: 2013 Chevrolet Sonic, Spark, Trax
Equipped with MyLink Radio (UF7)

Subject: 13128C – Service Update
Software Enhancement Update
Revised Service Procedure

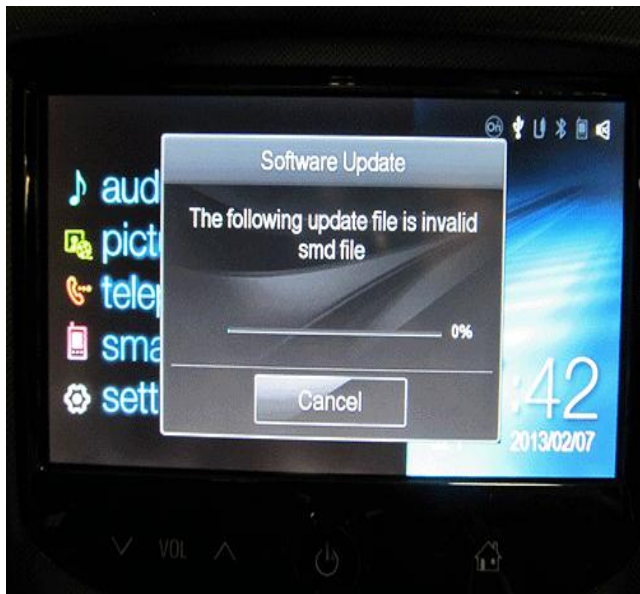
3286662

8. If you see the message as shown above "The following update file is Invalid SMD file," continue to the next step. Otherwise, skip to Step 14.
