Service Bulletin

SUBJECT: Service Update for Inventory Vehicles Only

Low Rear Differential Fluid Level

MODELS: 2014 Chevrolet Corvette

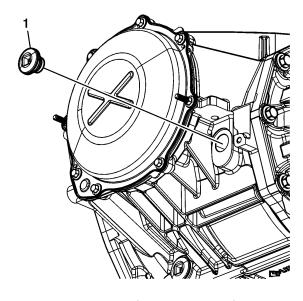
3404597

This bulletin provides a service procedure to check the rear differential fluid level on **certain** 2014 model year Chevrolet Corvette vehicles. The rear differential assembly for these vehicles may have been shipped from the supplier with insufficient fluid. If the fluid is low, dealers are to add fluid and test drive the vehicle. If a loud whine, gear, or bearing noise is observed during the test drive, dealers are to contact the GM Product Quality Center (PQC) for additional instructions.

- 2. Check the rear axle fluid level. Refer to Rear Axle Lubricant Level Inspection in SI.
 - If adding rear axle fluid is NOT required, no further action is required. Lower the vehicle. Refer to *Lifting and Jacking the Vehicle* in SI.
 - If adding rear axle fluid is required, add the recommended amount of fluid to the rear axle. Proceed to step 3.
- 3. Take the vehicle on a 10 minute road test to determine if there is a whine, gear or bearing noise.
 - If rear axle noise is NOT present, no further action is required.
 - If rear axle noise is present, contact the PQC for additional instructions.
