# Service Bulletin

**SUBJECT:** Service Update for Inventory and Customer Vehicles  
4-Wheel Drive Transfer Case Adapter Housing  
Expires with Base Warranty

**MODELS:** 2013 Chevrolet Silverado HD  
2013 GMC Sierra HD  
Equipped with 4WD and 6-Speed Automatic Transmission (MW7)

Subject: 13346 – Service Update Bulletin  
4-Wheel Drive Transfer Case Adapter Housing

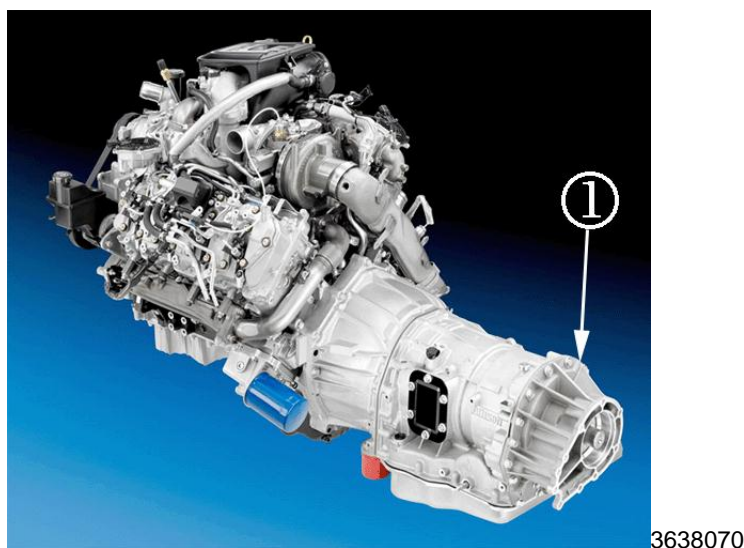
2. Locate the traceability number on the transmission low reverse clutch housing (1). The traceability number was written with a black paint marker.

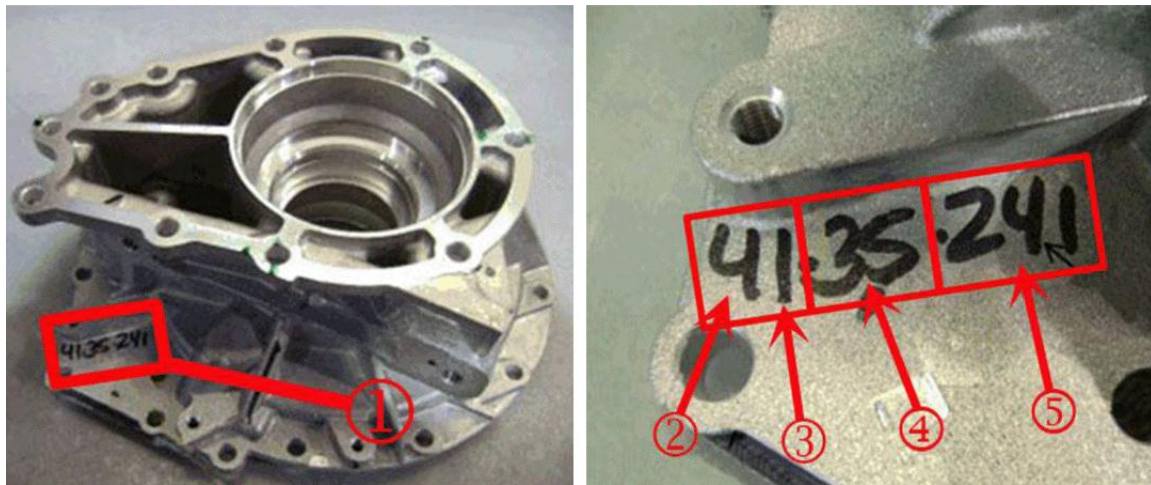
Numbers shown in the photograph above do NOT fall under the suspect parts. (1) Location of Traceability Numbers. (2) Machine Number (3) Fixture Number (4) Shift Sequence Number (5) Machine Julian Date.

3. Determine the traceability number written on the low reverse clutch housing. The number includes a machine number, fixture number, shift sequence number and machine Julian date. Refer to the photograph to review the breakdown of the traceability number.

- If the traceability number includes a machine and fixture number of black 31 or 32 and machine Julian date of 254, proceed to step 4.
    - If the traceability number includes machine and fixture numbers other than black 31 or 32 or a Julian date other than 254, no further action is required. Lower the vehicle. Refer to *Lifting and Jacking the Vehicle* in SI.

- If the test drive produces these symptoms, replace the 4WD extension housing. Proceed to step 5.
      - If the test drive does NOT produce these symptoms, no further action is required. Lower the vehicle. Refer to *Lifting and Jacking the Vehicle* in SI.

5. Remove low reverse clutch housing. Refer to *Low and Reverse Clutch Piston and Output Carrier Assembly Removal* in SI.
  6. Install new low reverse clutch housing. Refer to *Low and Reverse Clutch Piston Housing Installation* in SI.
