Date: 10/05/2013

Subject: PLEXIGLAS SUPPORT VIBRATION

Models: MULTISTRADA 1200 MODEL YEAR 2013 (all versions)

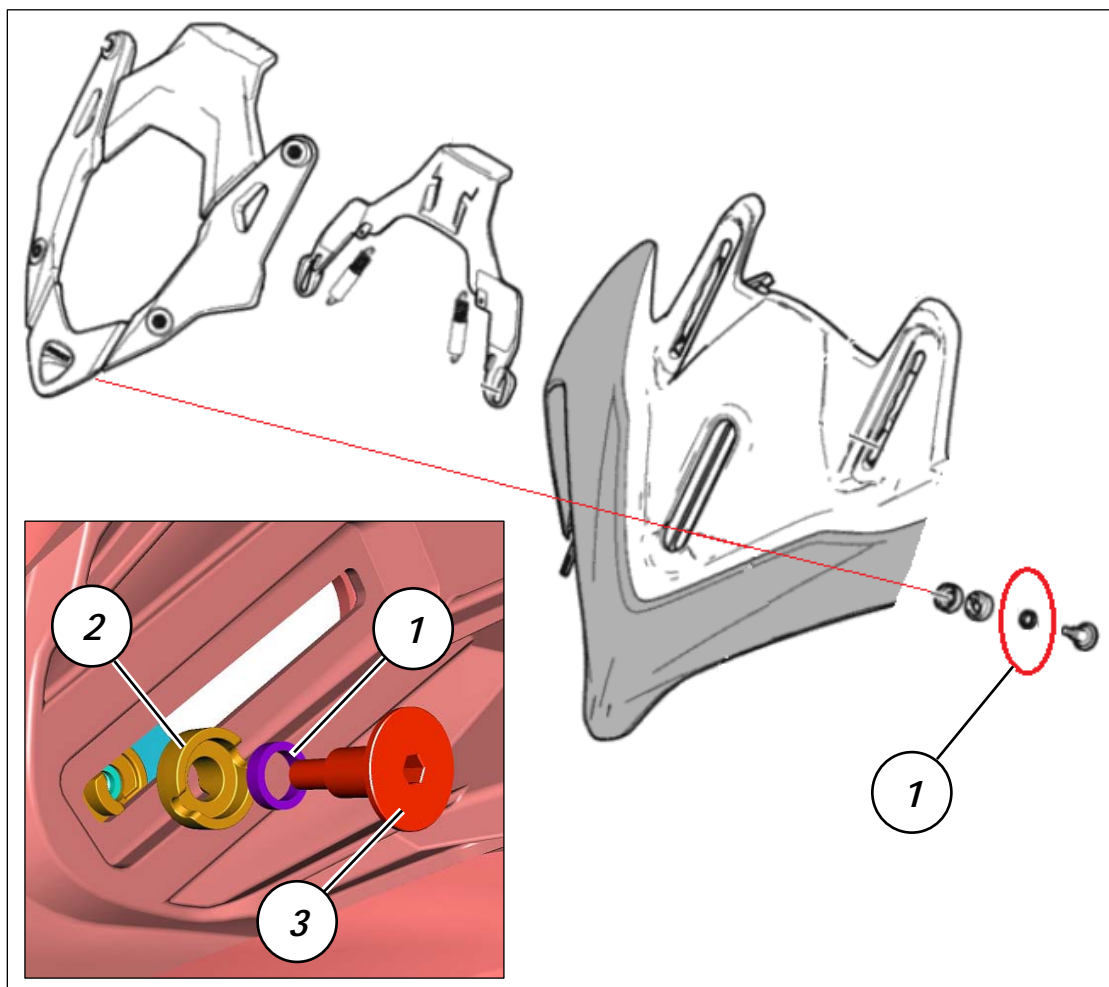
The Multistrada 1200 Model Year 2013 belonging to the first produced lot could feature a vibration in the Plexiglas support when riding the bike.

The play that could cause such vibration can be also checked with stopped motorcycle.

To prevent this, replace original equipment **rubber pad (1)** placed between **special screw (3)** and **bushing (2)** with a new rubber pad (part. no. 86611132A).

Remove the bike headlight fairing to reach the Special screw (3). Afterwards tighten such screw to a torque of 5 Nm ± 10%.

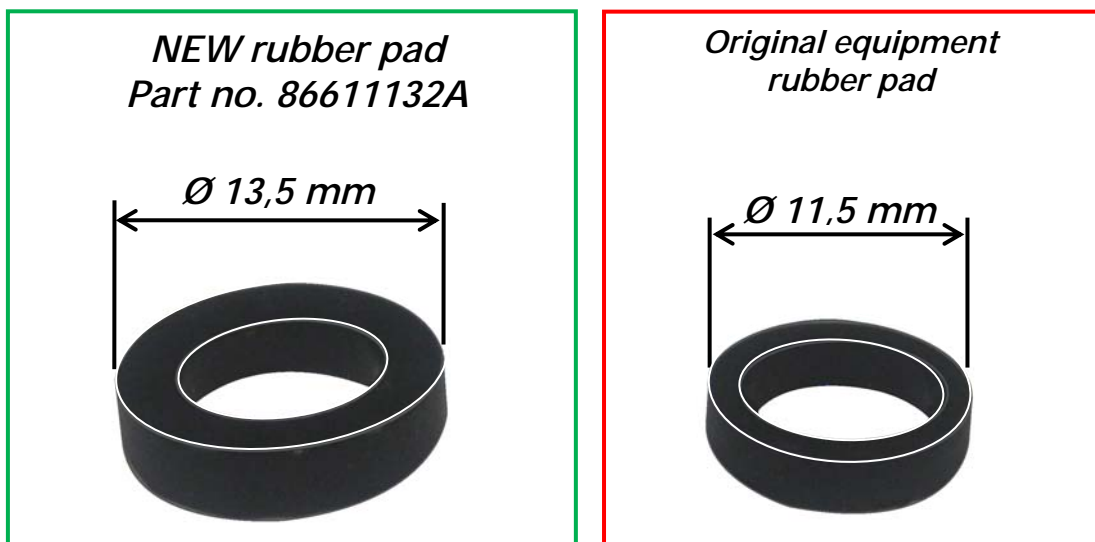
The new rubber pad (part. no. 86611132A) can be distinguished from the one supplied with the original equipment (external diameter 11.5 mm) as it features a larger external diameter (the external diameter being now 13.5 mm):
