VOLUNTARY CAMPAIGN BULLETIN

SUBJECT:	Diesel Particulate Regeneration (DPR) Igniter Plugs
DATE:	03/01/2013
BULLETIN NO:	RCB-001-13
CAMPAIGN NO:	A8560
AFFECTED MODELS:	Certain 2011 through 2013 model year NE8J, NJ8J, NV8J models equipped with a J08 engine.

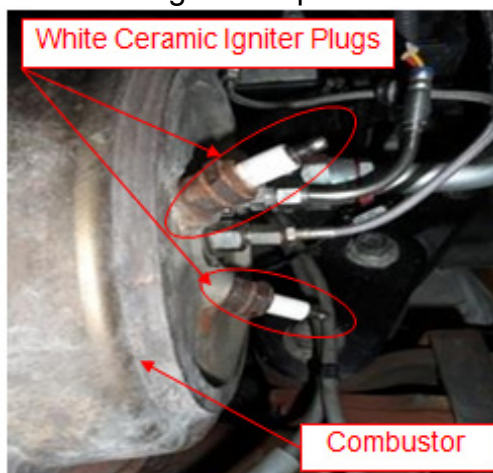
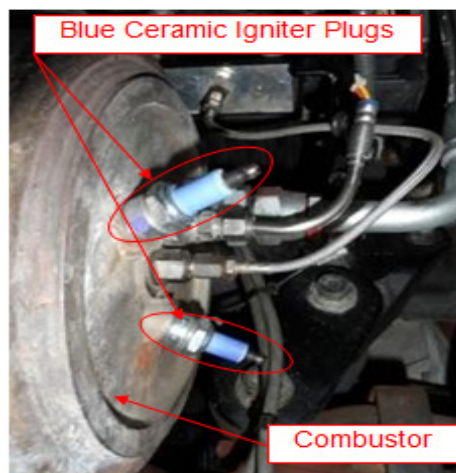
Verify the ceramic color of the igniter plugs:

- If White – go to Step 4.
- If Blue – go to Step 6.

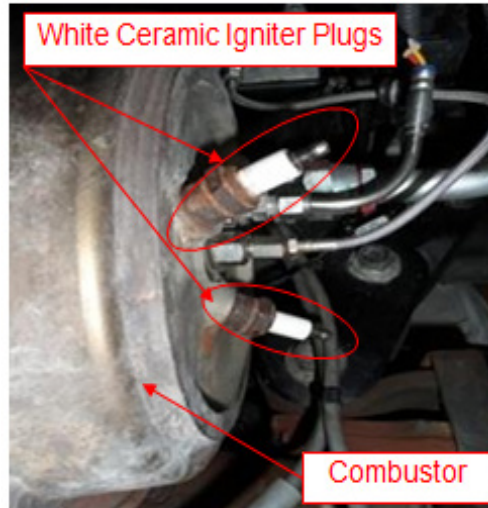
Never reuse any of the white ceramic igniter plugs removed as a result of this campaign. The specification of the white ceramic igniter plug is different from the specification of the blue ceramic igniter plug. Use of the white ceramic igniter plugs may potentially result in a burner system misfire.

4. Remove both white ceramic igniter plugs from the combustor

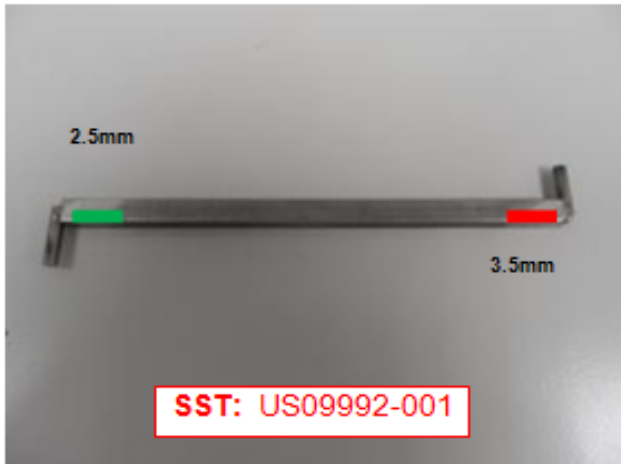
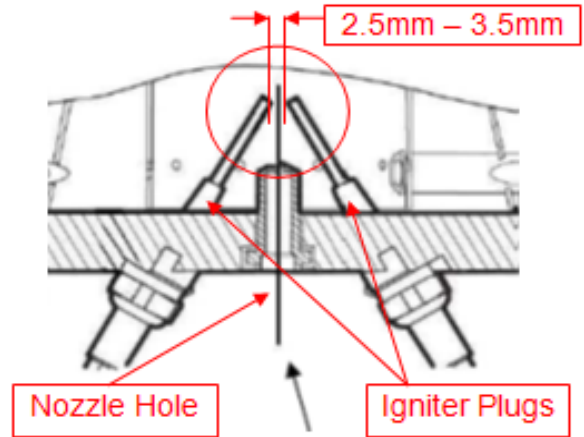
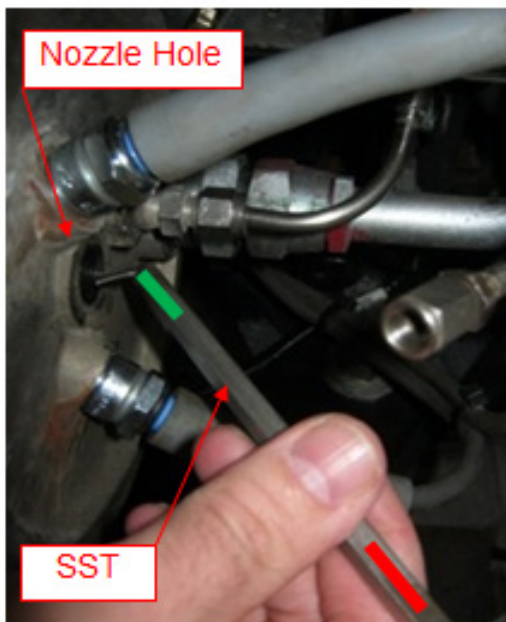
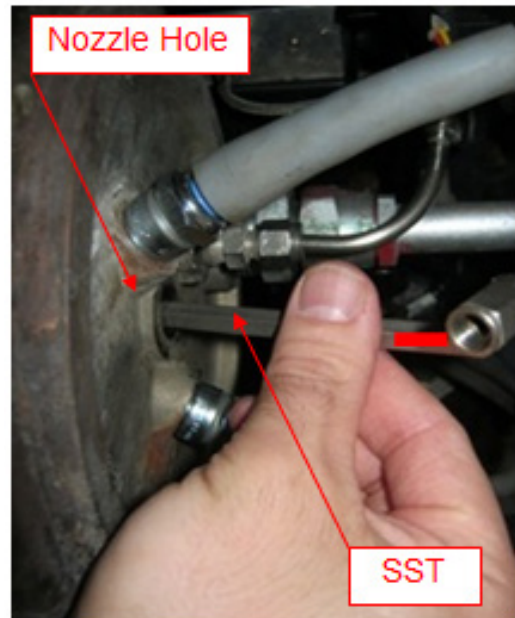
The SST is a “Go - No-Go” gauge to check the igniter gap at the tips. The tool has a 2.5mm gauge on one end and a 3.5mm gauge on the other end. The 2.5mm end should be able to pass between the igniter tips while the 3.5mm end should not.

Igniter Gap Specification: 2.5mm – 3.5mm

7. Using the SST to check igniter plug gap:

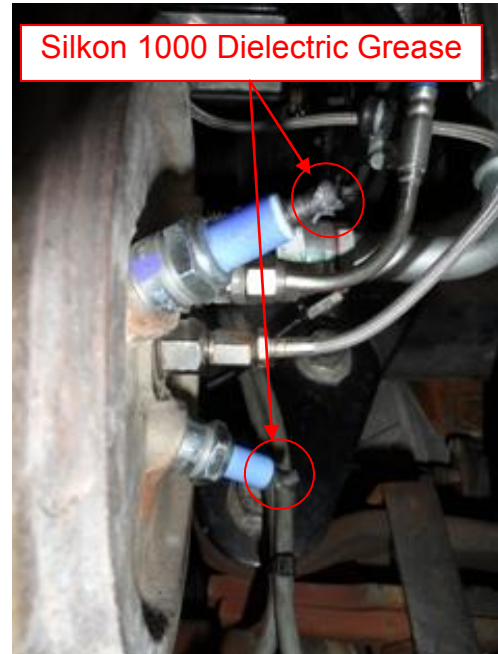
Do not forget to apply the Silkon 1000 dielectric grease to the igniter plug terminal. Failure to apply Silkon 1000 dielectric grease may cause electric corrosion on the igniter terminal during normal operation. Electrical corrosion on the igniter terminal may result in a burner system misfire.

12. Apply a small amount of Silkon 1000 dielectric grease on each blue ceramic igniter plug terminal.

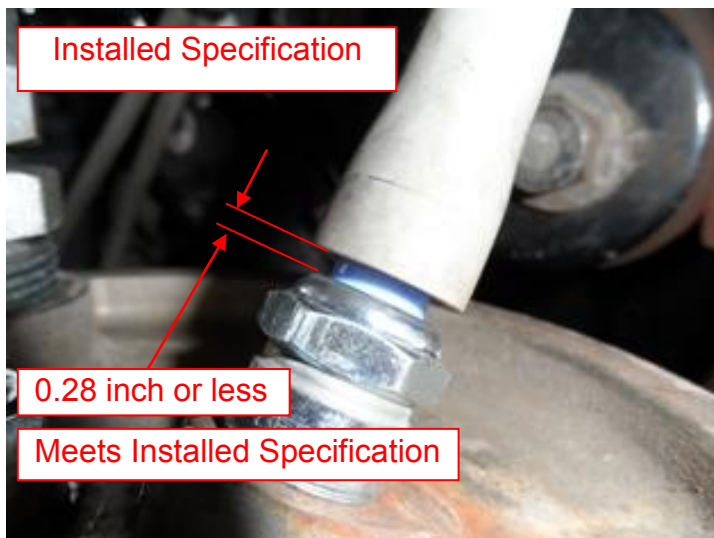
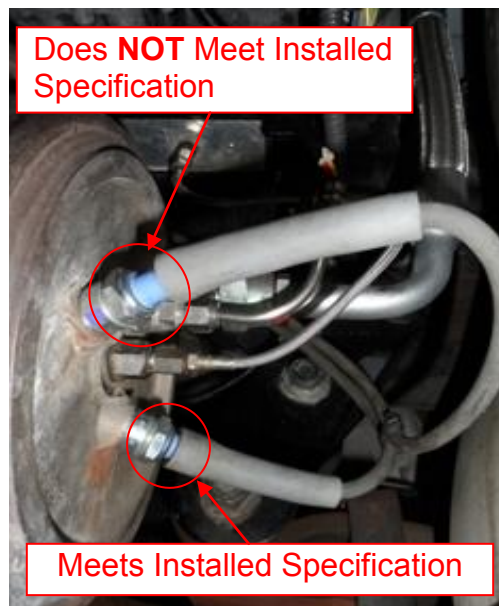
Installed Specification: 0.28 inch (7mm) or less

Failure to install the ignition wire boot to meet the installed specification may result in a burner system misfire.

14. Check the exposed ceramic surface of each igniter plug. If not within the installed specification, adjust the ignition wire boot to meet the installed specification.
