| REFERENCE: | Nova Bus Manuals |
| RS N°: | MQR 7621-371, NC 641 |

| SUBJECT: | Stanchion in the articulation area of the vehicle |

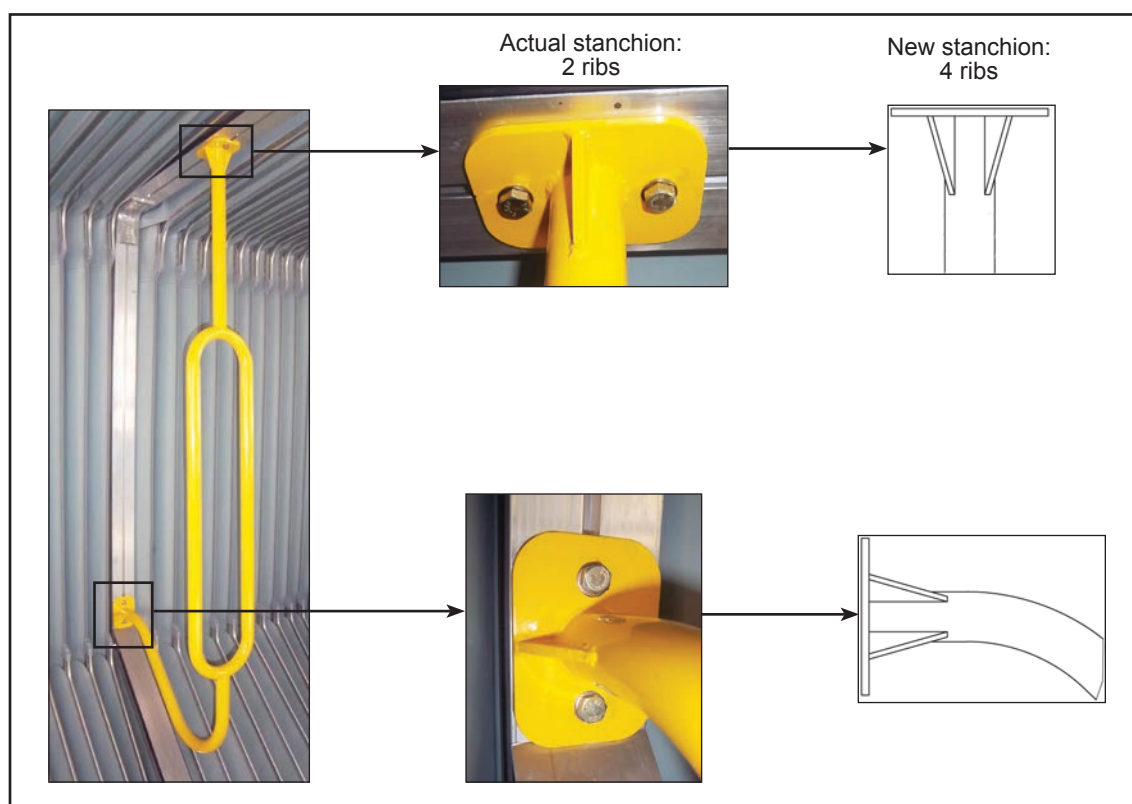
| JUSTIFICATION: | A break may occur between the mounting plate and the stanchion. |

*Figure 1 - Typical Stanchion in the Articulation Area*

- 1.1 Unbolt the two stanchions located in the articulation area. Retain the hardware. See Figure 1.
- 1.2 Install the new stanchions with the retained hardware. Use blue Loctite thread locker, or an equivalent. Tighten to safely secure the parts in place. ❖
