GROUP <b>Transmission</b>	MODEL <b>2011-2012MY Sportage (SL)</b>
NUMBER <b>048</b>	DATE <b>September 2013</b>

## TECHNICAL SERVICE BULLETIN

**SUBJECT: COMBINED TSB/SERVICE ACTION: SHIFT KNOB TRIM RING REPLACEMENT PROCEDURE (SA147)**

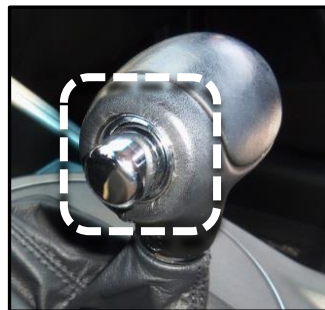
**Shift Knob Trim Ring Assembly**

This bulletin provides the procedure to replace the shift knob trim ring on some Sportage (SL) vehicles, produced from May 6, 2010 to June 8, 2011 (2011MY) and from May 17, 2011 to March 23, 2012 (2012MY), which may exhibit a difficult to depress A/T shift knob button. This condition may be caused by decreased clearance between the shift button and the trim ring. Replace the affected trim ring to resolve the concern by following the Service Procedure outlined in this bulletin. Before conducting the procedure, verify the vehicle is included in the list of affected VINs.
