GROUP BODY	MODEL 2012-2013MY Optima (QF)
NUMBER 103	DATE September 2013

TECHNICAL SERVICE BULLETIN

SUBJECT: PANORAMA SUNROOF & SUNSHADE MOTOR REPLACEMENT

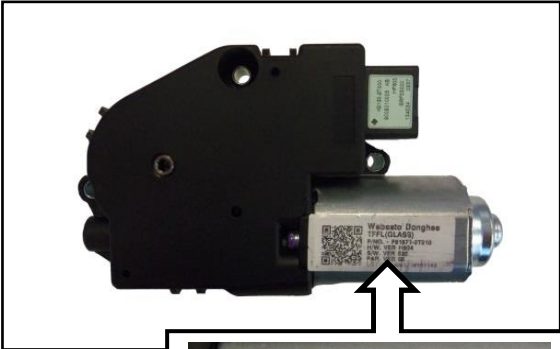
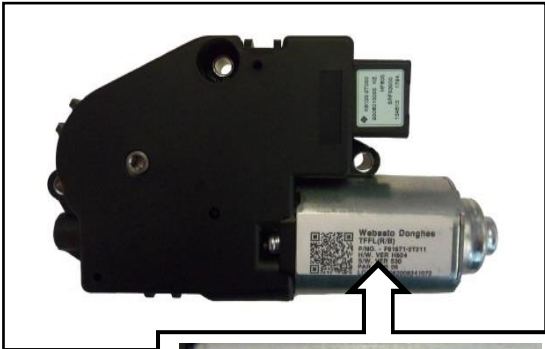
Sunroof Motor P/N 81671 2T210	Sunshade Motor P/N 81671 2T211

Refer to the table below to differentiate between the sunroof and sunshade motors.
