PRODUCT SUPPORT PROGRAM FOR INSPECTING THE 396-3793 ENGINE WIRING HARNESS AND POSSIBLY REPAIRING THE ENGINE WIRING HARNESS ON CERTAIN CT660 ON HIGHWAY TRUCKS

Media Number -TEBE0185-00

SERVICE LETTER

PS43996

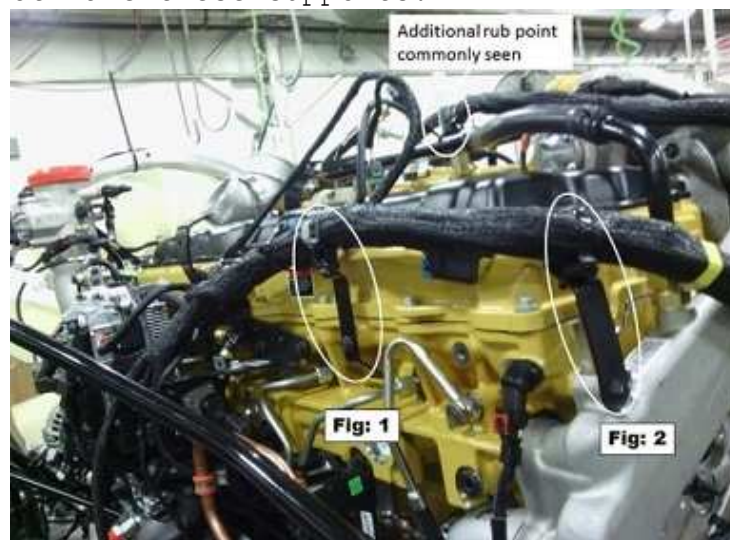
Image1.1.1

Confirm the harness support hardware from Fig:1 and Fig:2 in Image 1.1.1 is installed on the engine. If the engine is not equipped with the harness support hardware, refer to the Parts Needed for the parts. Install as necessary. View common rub points especially on early built trucks that do not have these supports.

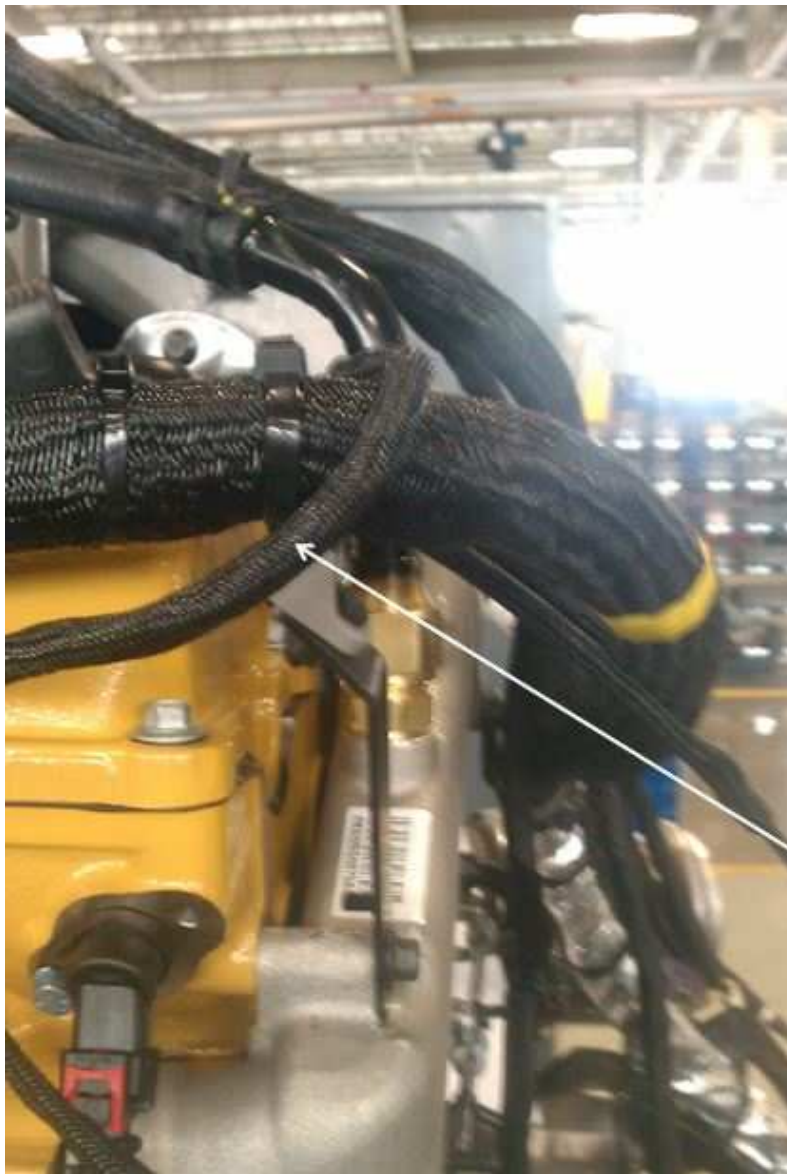
Image1.2.1

Also seen is this style of tie down. In Image 1.2.1 the wire is not laying in the saddle/clip correctly and will rub.

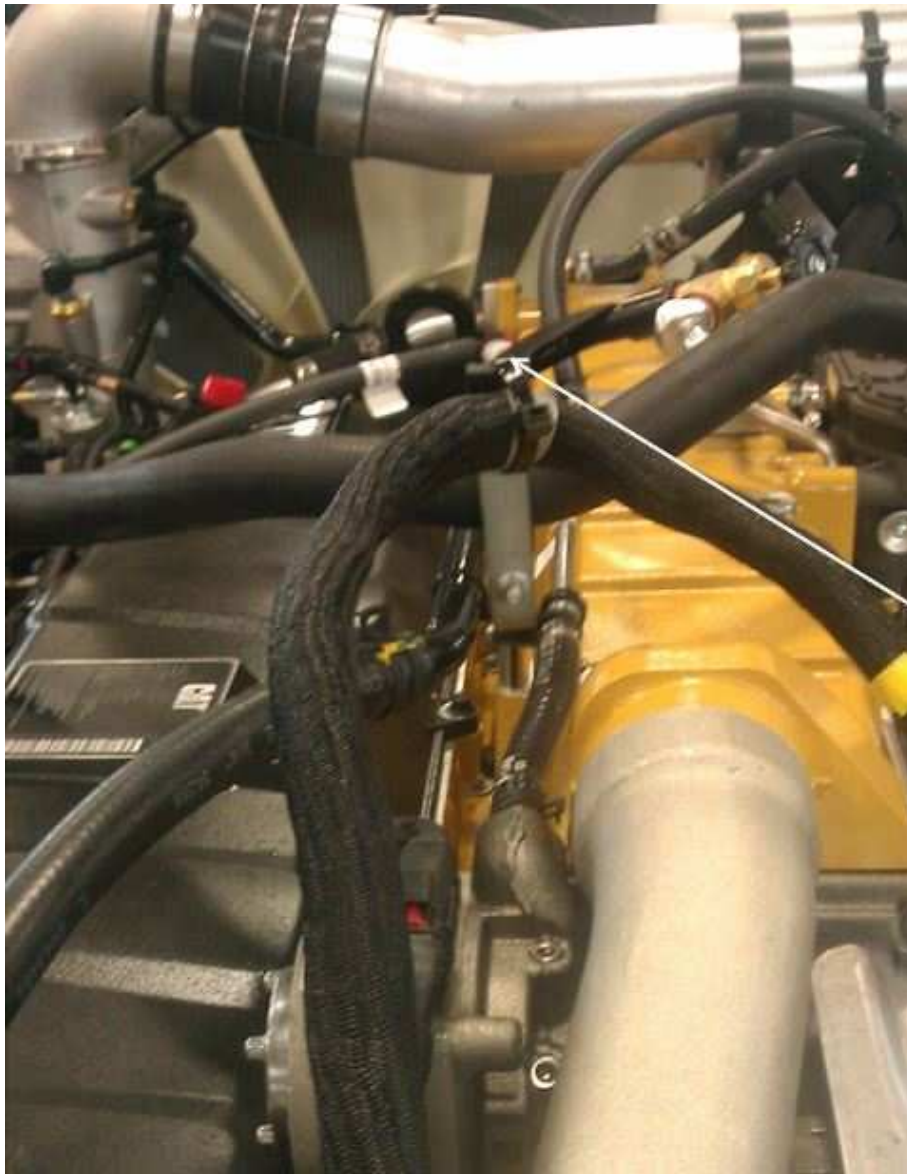
Image1.3.1

Common rub location. In Image 1.3.1 the wire is not laying in the saddle/clip correctly and will rub.

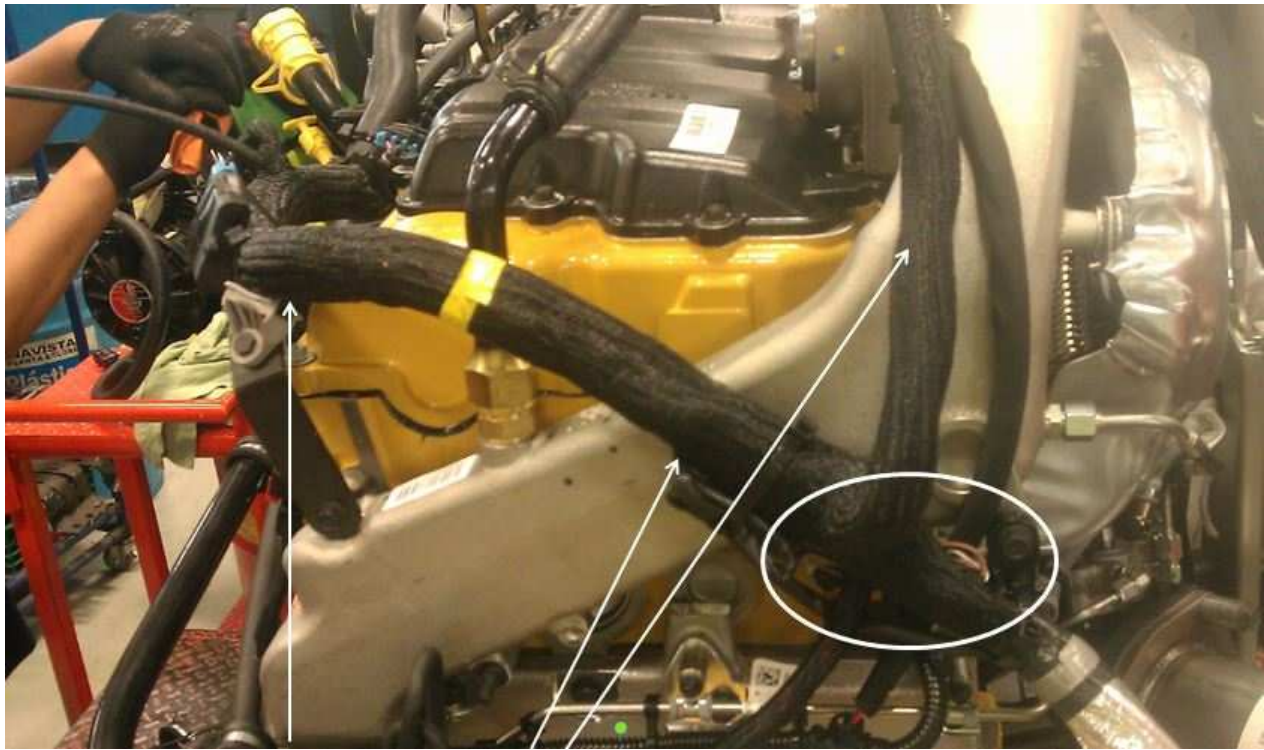
Image1.4.1

Refer to Image 1.4.1. Common rub locations at the back of the engine. Make sure the oxygen sensor wiring is not rubbing the coolant crossover pipe as seen here (white circle). Make sure the wiring was not smashed during cab install and is not rubbing on the floor boards/access panel.

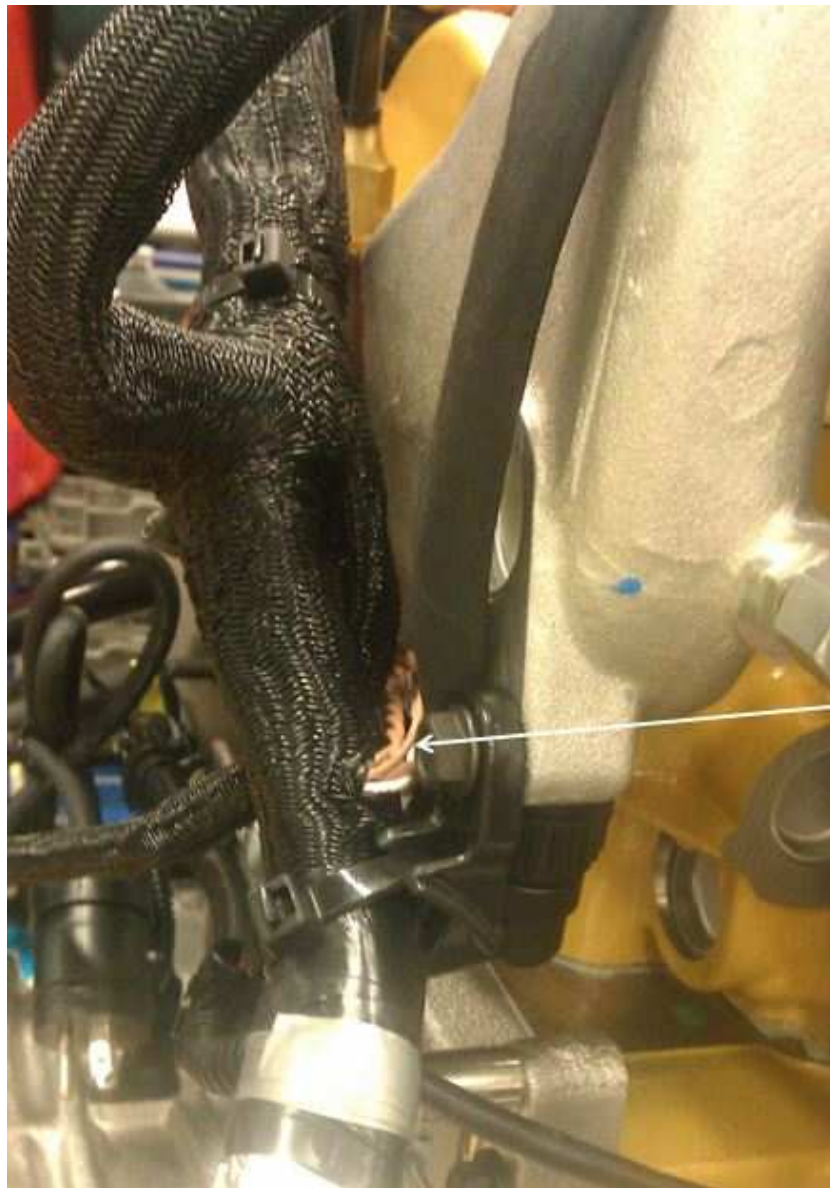
Image1.5.1

Refer to Image 1.5.1. Close up of oxygen sensor wiring. Make sure the oxygen sensor wiring is not rubbing the coolant crossover pipe as seen here.

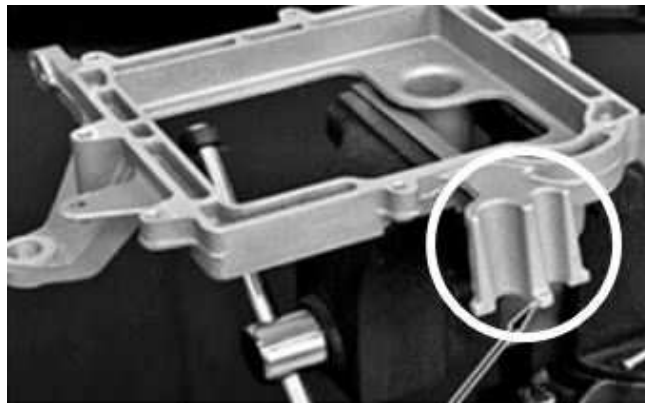
Image1.6.1

Refer to Image 1.6.1. If the rub point is identified at wiring mount (circled in white) of the ECM bracket and wiring harness please remove. This wire mount has been known to rub the harness. Inspect the harness in this area. Remove the mount by carefully cutting the mount off with a die grinder cutoff tool and deburr the area. The mount can be carefully removed while ECM and bracket are still bolted to engine.
