Group:	42 – Rear Axle
Warranty Code:	5221973
Bulletin No.:	SB -13 - 001
Issue Date:	4/04/2013

S E R V I C E B U L L E T I N

Incorrect Rear Axle Differential Fluid

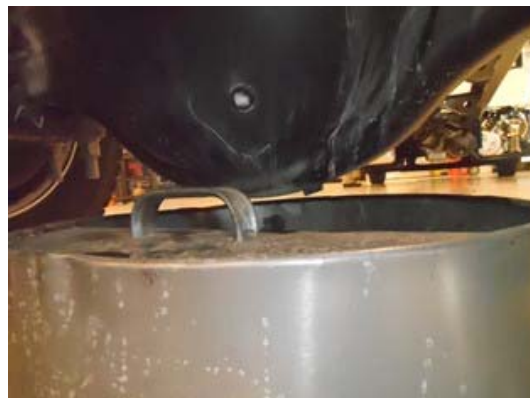
Certain rear drive axles were improperly filled with non-synthetic differential fluid during assembly at the WV assembly plant instead of the intended Full Synthetic differential fluid. The non-synthetic differential fluid must be drained and refilled with the recommended synthetic fluid or equivalent.

3. Position a drain pan under the drain plug. Remove the drain plug and drain the non-synthetic differential fluid from the rear axle assembly.
