Service Bulletin No:	13-006
Group:	27-Electrical & Meters
Issue Date:	07-05-2013

SUBJECT:
CORRECTION OF WORKSHOP MANUAL FOR 2011, 2012 and 2013 CONVENTIONAL MODELS
(CORRECTION OF DIAGNOSIS PROCEDURE OF CAN COMMUNICATION LINE)

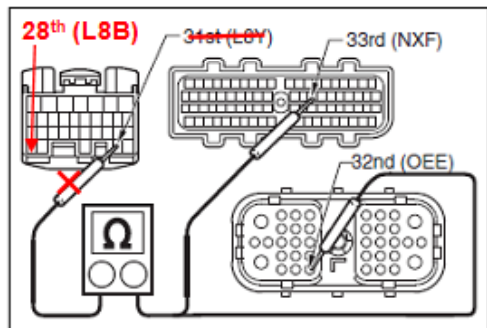
2. INSPECTION OF THE HARNESS BETWEEN AT-ECU/AMT-ECU AND VEHICLE CONTROL ECU (1)

- (1) Check continuity between 33rd (NXF) terminal of the AT-ECU connector (80P) or 32nd (OEE) terminal of AMT-ECU connector (38P) and 31st (L8Y) terminal of the vehicle control ECU connector (32P)

Wrong: 31st (L8Y)
Correct: 28th (L8B)

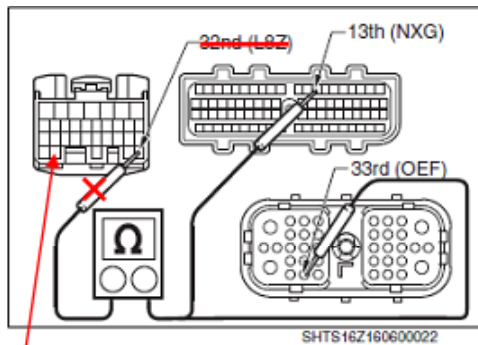
3. INSPECTION OF THE HARNESS BETWEEN AT-ECU/AMT-ECU AND VEHICLE CONTROL ECU (2)

- (1) Check continuity between the 13th (NXG) terminal of the AT-ECU connector (80P) or the 33rd (OEF) terminal of the AMT-ECU connector (38P) and the ~~32nd (L8Z)~~ terminal of the vehicle control ECU connector (32P)

Wrong: 32nd (L8Z)
Correct: 29th (L8C)

Replace the harness. (Malfunction part 4 in CAN communication line)
