Service Bulletin No:	13-014
Group:	61 – Cab & Body
Issue Date:	10-10-2013

Seat Squeak

Certain 2011MY through 2013MY NE8J, NJ8J and NV8J model Hino conventional trucks that were assembled at the Williamstown, WV assembly plant prior to 5/14/2013.

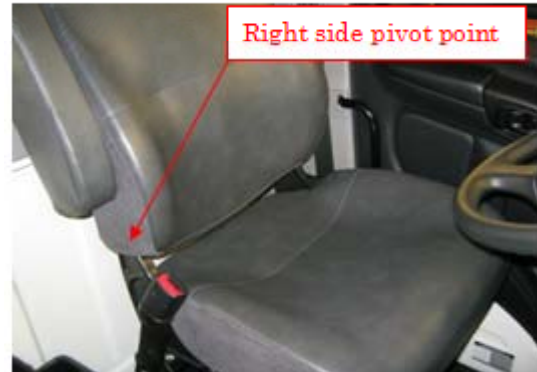
1. Inspect the seat to confirm if the noise is coming from the right side pivot point of the seat back frame and seat base assembly.

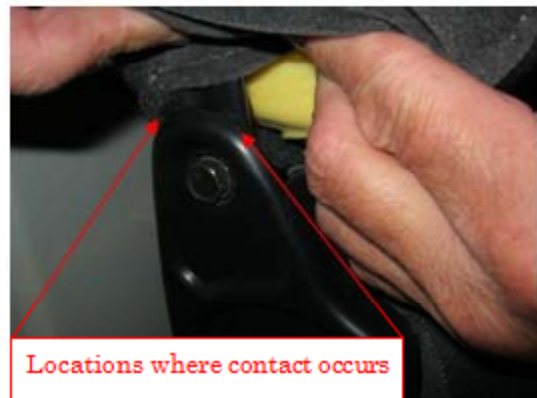
An audible seat squeak may occur from the driver seat and/or single occupant passenger seat while driving over rough roads. This audible squeak may be occurring because of contact between the seat back frame and the seat base assembly at the seat pivot area. This technical service bulletin discusses installing a washer between the seat back frame and seat base assembly to increase the gap of these components. This added gap will eliminate the contact point and audible squeak

2. Is there contact of the seat back frame and seat base assembly?

-**Yes**, Proceed to the repair procedure to install a washer to increase the gap between the seat back frame and seat base assembly.
