# Service Bulletin

**Subject:** Intermittent Service Power Steering Message on Vehicle Start Up

**Models:** 2013-2014 Cadillac ATS

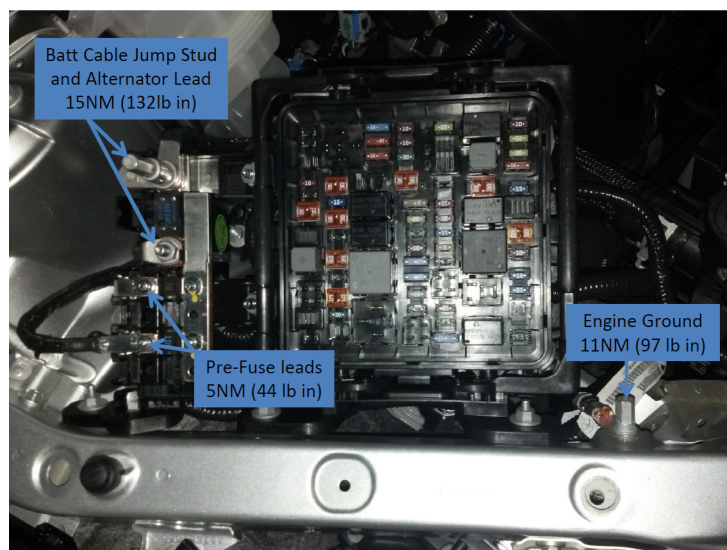
If no DTCs are present, the issue may be caused by a momentary loss of power or ground in the power steering gear circuits.

1. Inspect the underhood fuse block power and ground connections for proper torque as identified in the above photo.

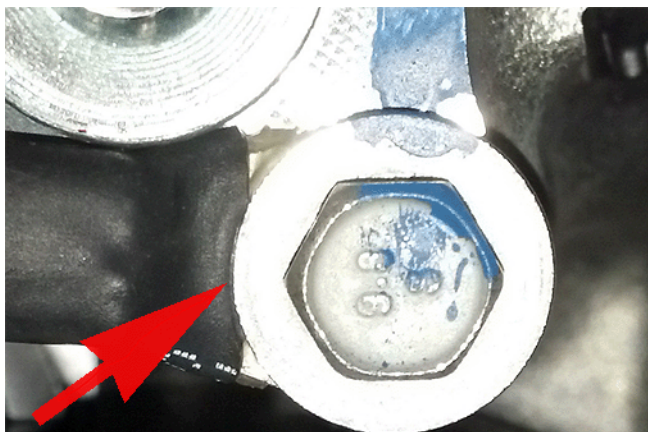
Look for either excess shrink wrap or glue under the eyelet. Inspect for adhesive that has seeped out onto the eyelet during the heating of the shrink tube, or the shrink tube itself extending into the eyelet area.

**Important:** It is not an adequate check to simply try to wiggle the ground wire to check for looseness. The ground must be removed and checked for these items, cleaned and reinstalled.

2. Inspect engine ground #G104, verify the torque and ensure the connection is clean and sound.

3. Carefully trim the heat shrink tube if needed, clean adhesive from the eyelet (sand off), reinstall and torque.
