Service Bulletin

PRELIMINARY INFORMATION

Subject: Information on Accessory Bed Liner Installation for Pre-Drilled Bed Liners and for Vehicles Equipped With Upper Tie-Downs

Models: 2014 Chevrolet Silverado 1500
2014 GMC Sierra 1500

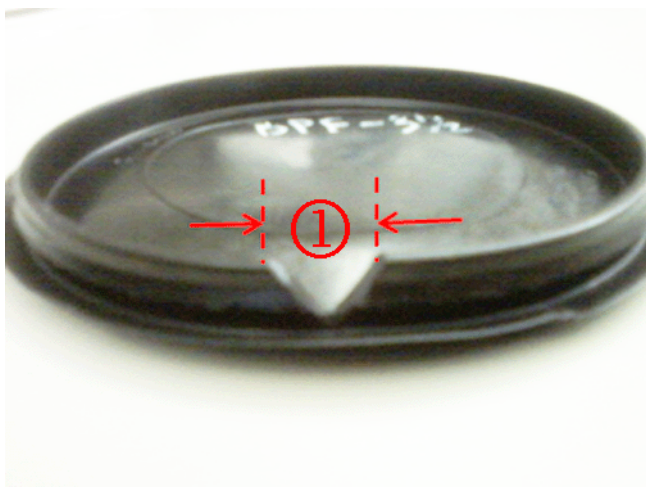
Important: DO NOT make the notch any larger than the recommended dimension below, and DO NOT add multiple notches. Doing either of these will cause the plug to easily pop out after installation.

1. Cut a relief “V” notch into the plug as shown in the graphic above. The widest distance of the “V” (1), should be approximately 12-15mm (0.472–

0.590 in).
