Service Bulletin

Subject: Voice Response Appears Louder Than it Should Be and Lowest Volume is Still too Loud

Models: 2014 Chevrolet Corvette

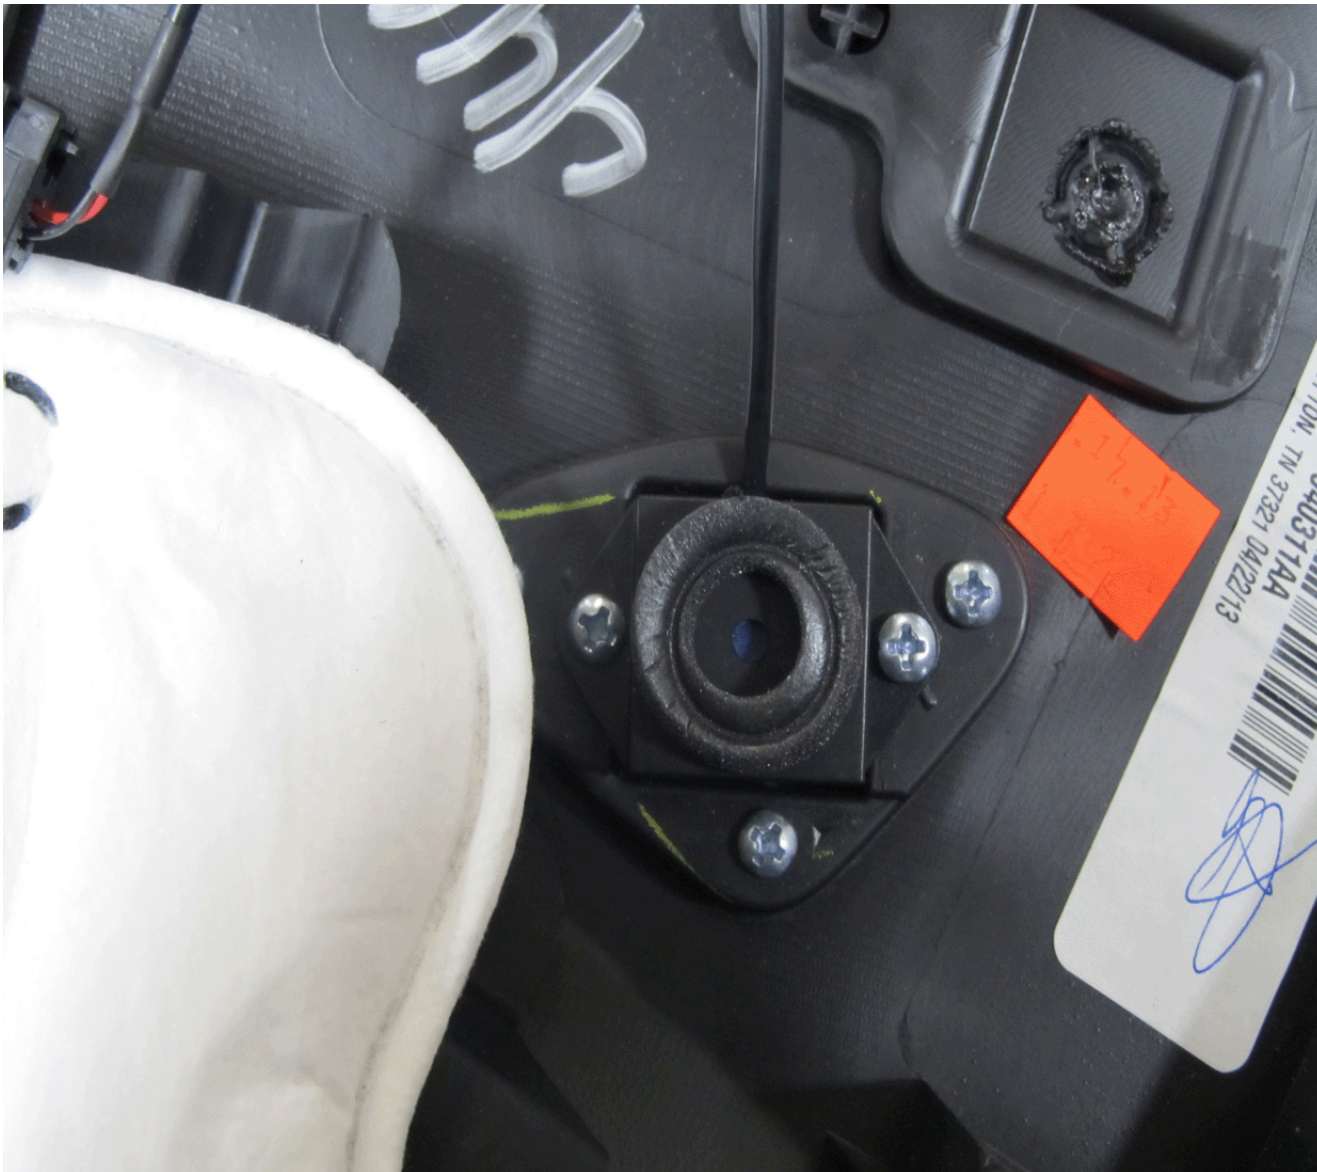
This condition may be caused by the interior noise microphone, located inside each door, facing the incorrect position as shown in the illustration above. In this

position, the microphone may pick up road noise and make a volume adjustment based on the road noise in the door rather than the cabin noise inside the car.
