Service Bulletin

PRELIMINARY INFORMATION

Subject: SERVICE HIGH VOLTAGE CHARGING SYSTEM Message Displayed on Driver Information Center (DIC), Hybrid/EV Charging System Disabled, DTCs Set

Models: 2011-2014 Chevrolet Volt

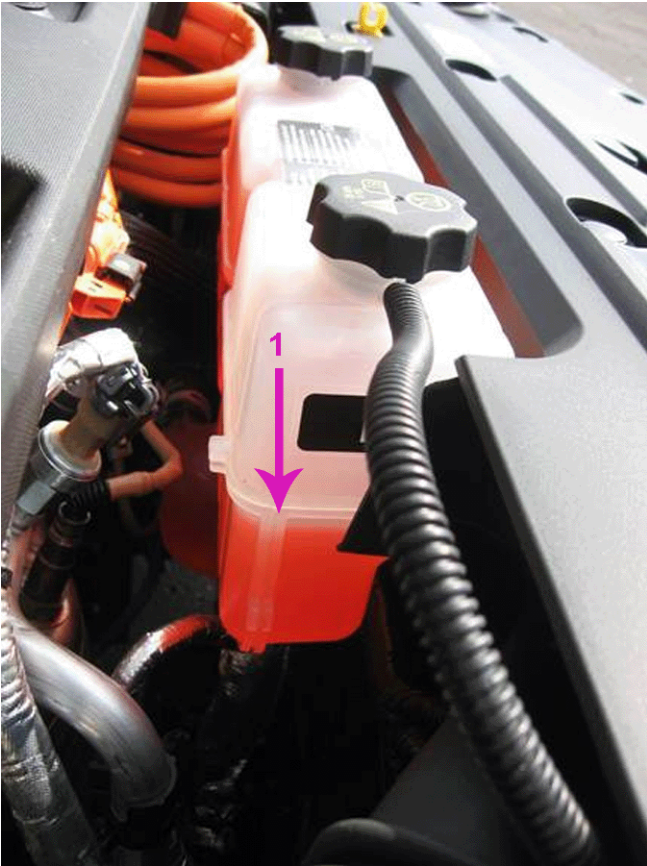
5. Visually inspect the coolant level in the HV battery surge tank and verify that the coolant level is **at** or **near** the seam (1) of the surge tank.

- ⇒ If the HV battery surge tank coolant level is **not at** or **near** the seam (1) of the surge tank, Go to the section titled: **Pressure Test Procedure** in this Diagnostic.

- ⇒ If the HV battery surge tank coolant level is **at** or **near** the seam (1) of the surge tank, Go to Step 6.
6. Remove the front compartment front sight shield. Refer to Front Compartment Front Sight Shield Replacement in SI.

13. Upon completion of the Hybrid/EV battery pack coolant pump bleed procedure, **adjust** the surge tank coolant level to a position just above the seam (1), by performing this procedure, — Drive Motor Battery Cooling System Draining and Filling — Removing Excess Coolant From System in SI.
