Service Bulletin

Subject: Door Rattle Noise from Outside of Vehicle During High Radio Volume or High Bass Levels

Models: 2014 Chevrolet Corvette
Built Prior to VIN Breakpoint E5105000

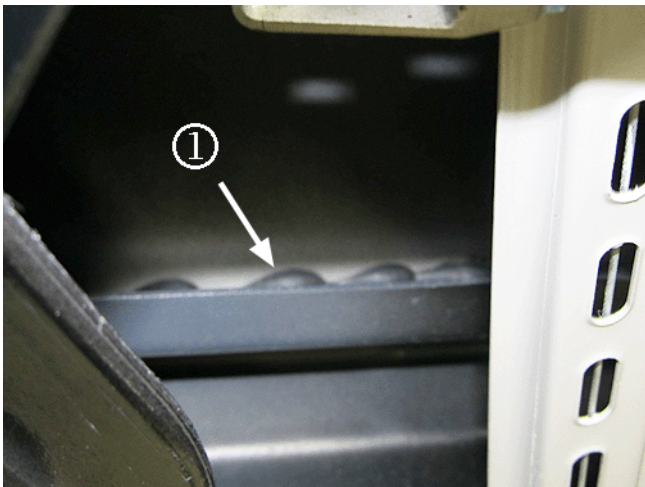
The cause of this condition may be voids in adhesive (1), leaving gaps between the inner door beam and the door skin.

Inspect the front side door beam and door skin gap for voids and add a bead of butyl ribbon sealer in those areas following the steps below:

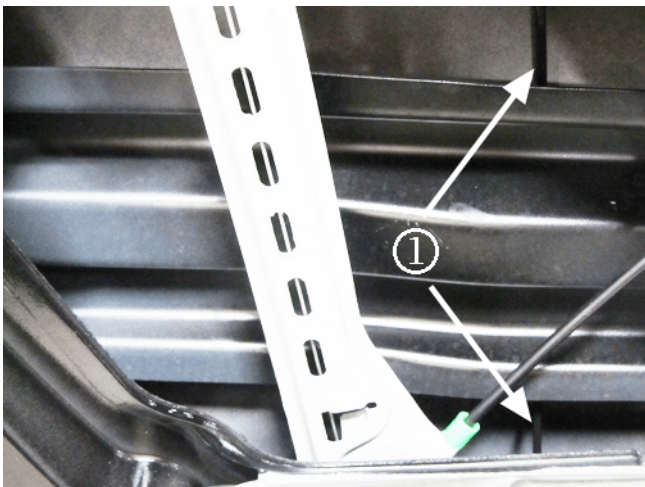
The graphic above shows an example in which a tie strap (1) was passed through a 15-20 cm (6-8 in) length gap where the adhesive was missing towards the center of the door.

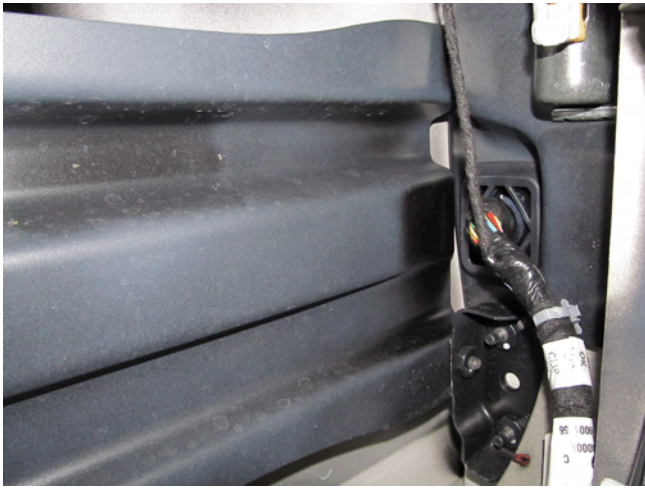
This can also occur in the front and/or rear area of the door beam; with the condition sometimes more evident in the front area (shown above) where the radio speaker is mounted.
