# Service Bulletin

## PRELIMINARY INFORMATION

**Subject:** Transmission Fluid Leak at Auxiliary Pump Seal

**Models:** 2014 Chevrolet Malibu  
Equipped with 6T40 Automatic Transmission (RPO MNH)

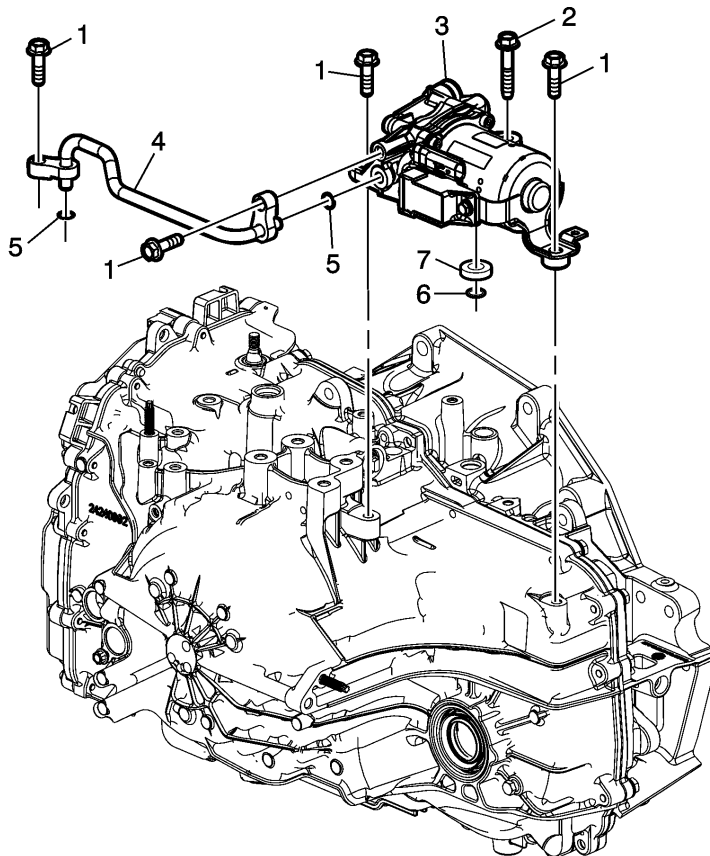
Investigation of the leak may show that the fluid is leaking on top of the transmission at the auxiliary fluid pump seal (6).

If leak diagnosis determines that the leak source is the auxiliary fluid pump seal, it should be replaced.

**Important:** To prevent damage to the replacement seal, be sure to lubricate the seal with transmission fluid before installing the auxiliary pump.

For replacement of the seal, refer to the Auxiliary Fluid Pump Replacement procedure in SI.

**Important:** The auxiliary pump seal should be checked for leaks after installation using the following steps.

1. Start the engine.
2. With the transmission in Park and the park brake applied, raise the engine speed to 4,000 RPM for at least 30 seconds.
3. After 30 seconds, shut off the engine and inspect the transmission for leaks in the area of the auxiliary pump.
