# Service Bulletin

**Subject:** Floor/Carpet Wet at Front Passenger Side Under Dash, or at Any Front/Rear Footwell Area

**Models:** 2011-2013 Chevrolet Caprice PPV

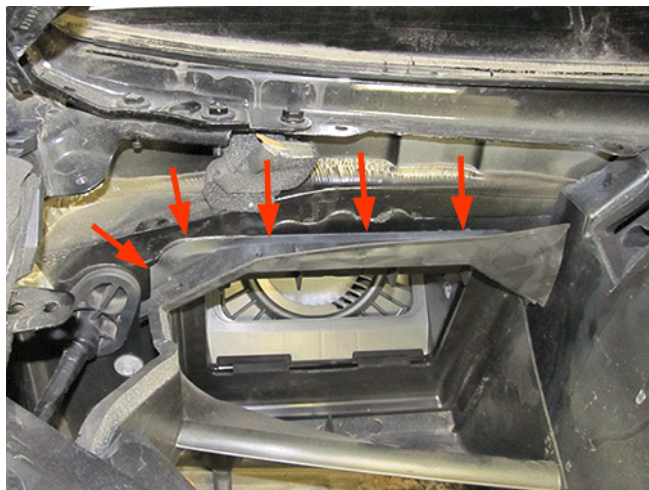
- Water intrusion in the seam (1) between the HVAC case and the cowl.

3. Apply windshield urethane, such as \*Kent Industries Speed Set Windshield Sealant P/N P10545, or equivalent, to the seam to seal the top of the HVAC case to the cowl.

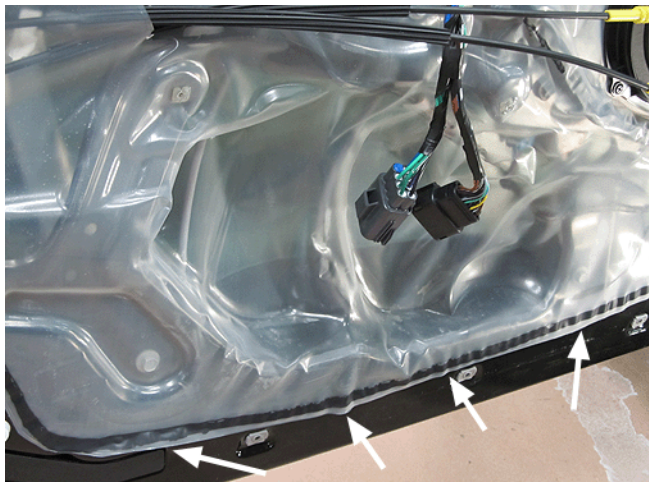
The cause of this condition may be that water, normally being channeled through a side door, may bypass an improperly sealed water deflector and create a leak path into the vehicle. Because of the increased mirror/window switch wiring harness content, this condition most commonly occurs at the driver door, but may occur at any front or rear side door.
