## Service Bulletin No. 392B

MODEL	D Series	TYPE	Field Change Program	SECTION/GROUP	7 – Electrical	DATE	Sept. 18, 2013
SUBJECT	ACTIA MULTIPLEX INTERFACE WITH CUMMINS 2010 ENGINE						
CONDITIONS

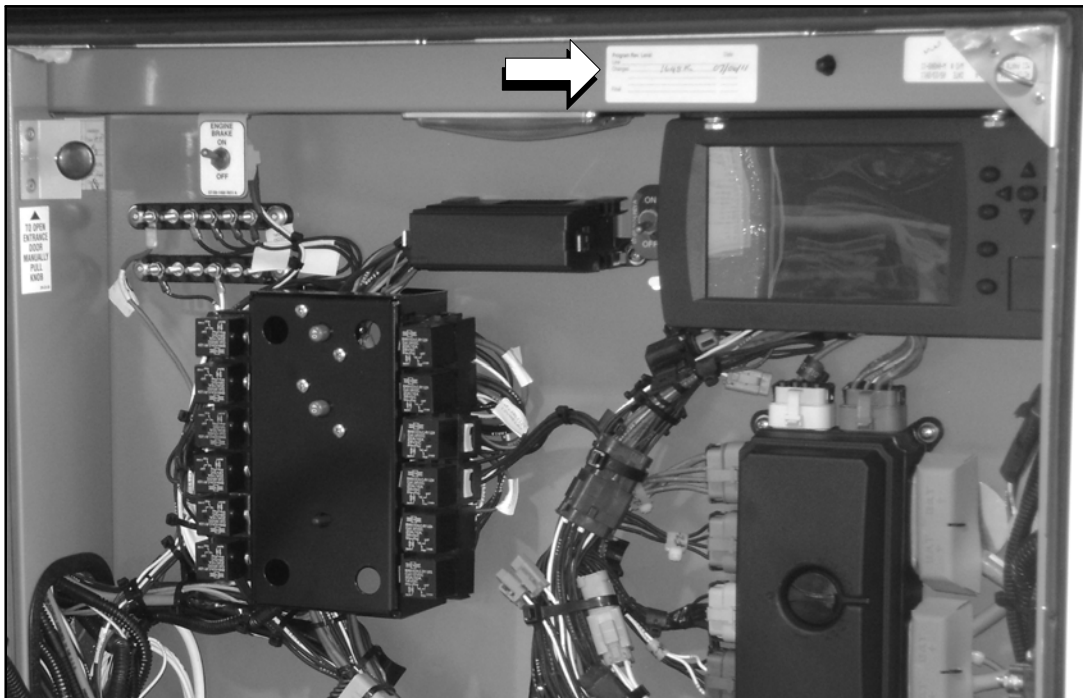
**Figure 1. Program Rev. Level decal located on the front junction box frame.**

1. Position the rotary dial on the lower, LH console switch panel to ENGINE STOP. Ensure the main battery disconnect switch is in the ON position.
2. Connect the laptop to the coach, equipped with Amp reflash software, and download the new control logic.
3. Open the front junction box door. Locate the Program Rev. Level decal in the upper, RH corner ( refer to Figure 1 ).
4. Using a marker or pen, clearly print to update the Program Rev. Level decal by recording the new control logic revision level and the date the download occurred on the applicable line of the decal.
