Technical Service Bulletin

66 Wind noise from exterior rear view mirror base or at lane change assist lamp

66 13 36 2029586/7 October 4, 2013. Supersedes Technical Service Bulletin Group 66 number 13-34 dated September 30, 2013 for reasons listed below.

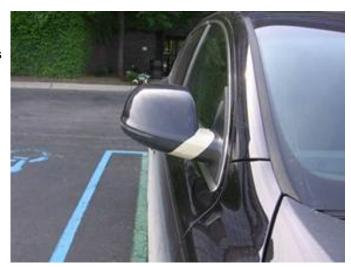
- Apply tape to the seam at the rotation collar between the mirror mount assembly and the painted cover (Figure 1) to determine if the noise is coming from the mirror base.
 - If the mirror base is not the source of the noise, move to step 2.
 - If the mirror base is the source of the noise, replace the mirror base according to the ElsaWeb Repair manual: Body >> Body Exterior >> 66 Exterior Equipment >> Removal and Installation >> Exterior rearview mirror >> Exterior rearview mirror.

Figure 1. Tape applied to rotation collar seam.

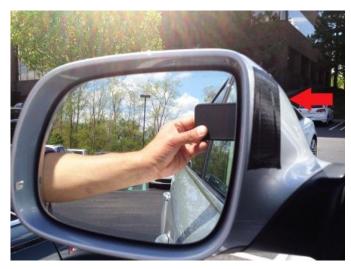
- If the vehicle is equipped with lane change assist, remove the first piece of tape, then apply tape to cover the lane change assist marker lens (Figure 2) to determine if the lane change assist lamp is the source of the noise.
 - If the lane change assist lamp is the source of the noise, replace one or both of the lamps according to the ElsaWeb Repair manual: Electrical System >> Electrical Equipment >> 96 Interior Lights, Switches >> Removal and Installation >> Lane Change Assistance >> Lane Change Assistance Warning Lamp in Exterior mirror.

Figure 2. Tape applied over the lane change assist lens.
