Technical Service Bulletin

68 Rattle noise from driver side door or dash area

68 13 12 2035626/1 October 30, 2013.

Model(s)	Year	VIN Range	Vehicle-Specific Equipment
Q5	2013 - 2014	All	Not applicable

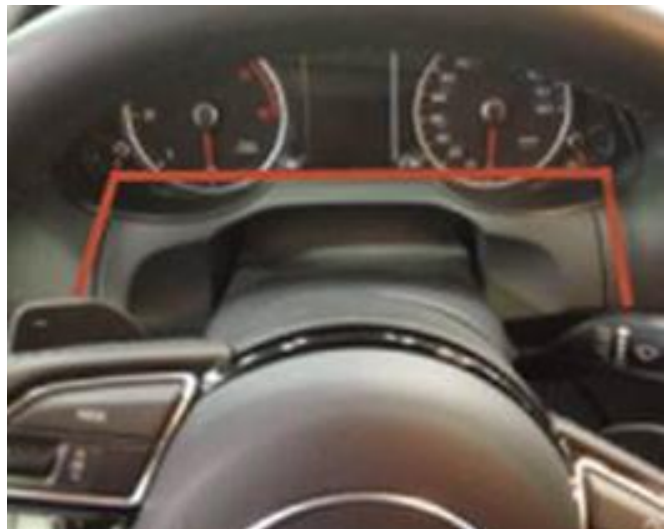
Figure 1. Steering column upper cover to be removed.

1. Compare the noise from the customer vehicle to the noise heard in the audio file attached to this bulletin. If a similar noise is heard, continue with this bulletin.
2. Remove the steering column upper cover (Figure 1) and the dash trim side cover (Figure 2) in order to access the bolts.

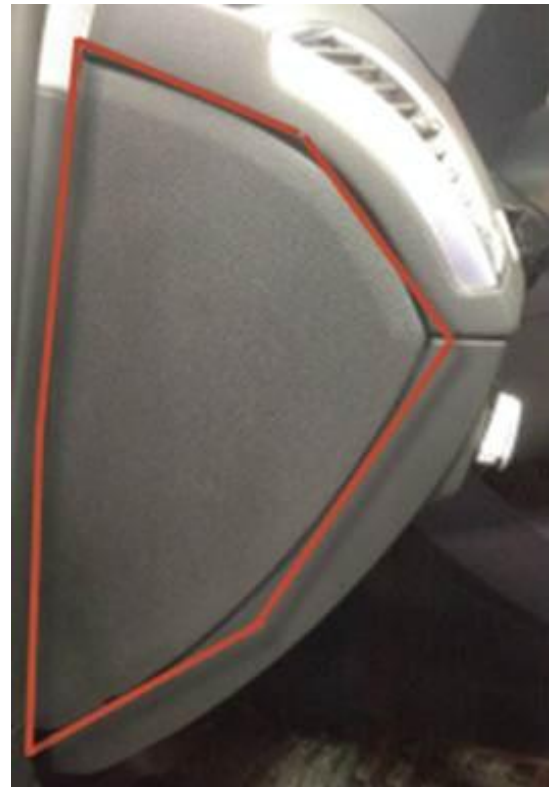
Figure 2. Dash trim side cover to be removed.

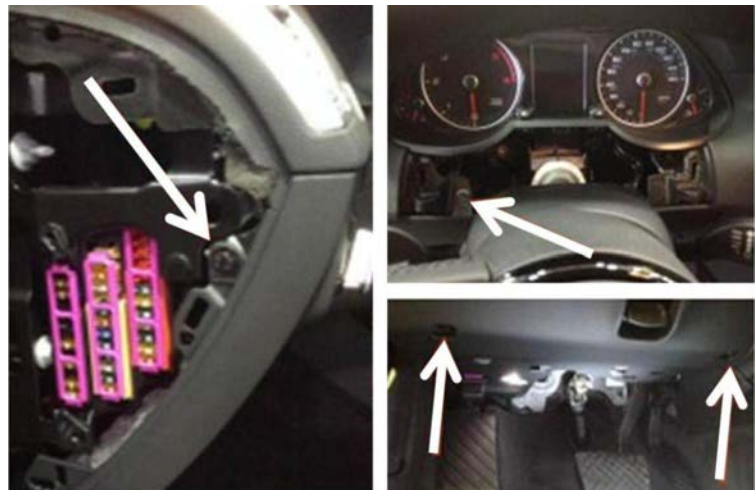
Figure 3. Remove the bolts indicated by the arrows.

3. Remove the four bolts indicated in the images at right (Figure 3).

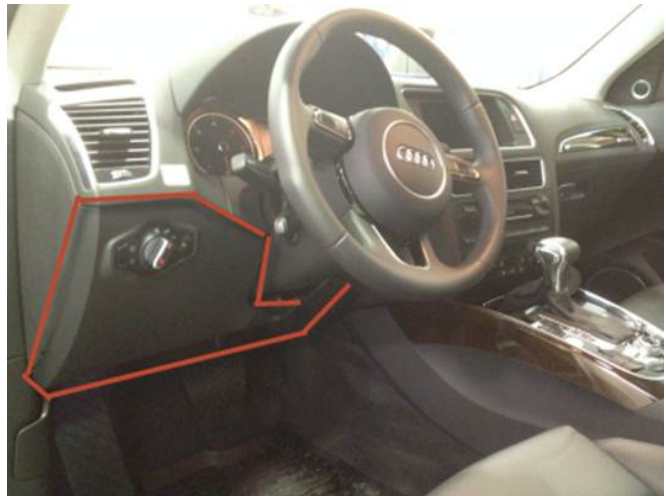
Figure 4. Lower dash cover to be removed.

4. Remove the lower dash cover to gain access to the knee bar support bracket (Figure 4).

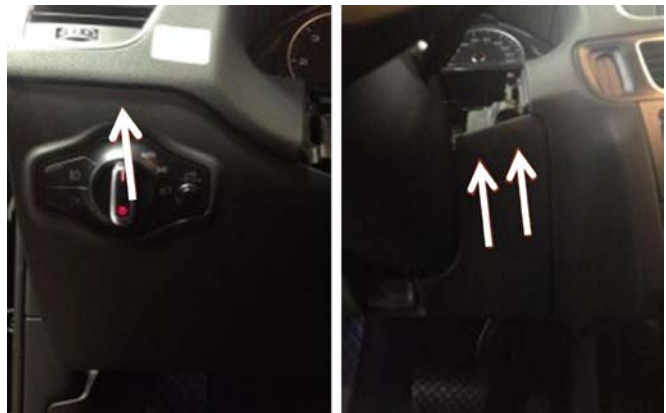
Figure 5. Location of hidden clips indicated by arrows.

Tip: Use caution when removing trim. There are hidden clips securing the upper section of the lower dash trim (Figure 5).

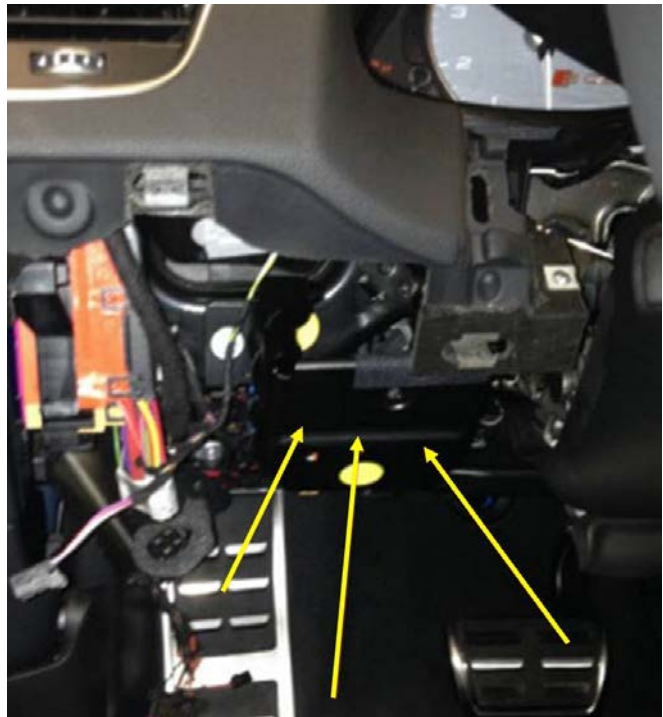
Figure 6. Knee bar support bracket.

An improper bolt torque sequence at the knee bar support bracket can cause unwanted vibration.

5. Inspect the knee bar support bracket (Figure 6) and try to reproduce the rattle noise by tapping the bracket with a rubber mallet:
- If no noise is heard when the bracket is tapped, do not continue with this bulletin. Perform a road test and continue diagnosis.
 - If the noise is heard when the bracket is tapped, continue with this bulletin.

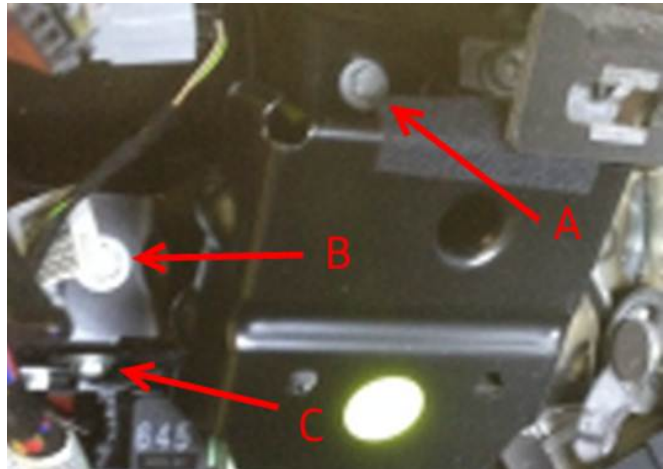
Figure 7. Bolts to check for proper fastening torque.

6. Check bolts A, B, and C (Figure 7) for proper fastening torque of 9Nm +/- 1Nm, then re-check for rattle noise:
- If no noise is heard after the bolts are adjusted, proceed to step 10.
 - If the noise is still present after the bolts are adjusted, continue with step 7.

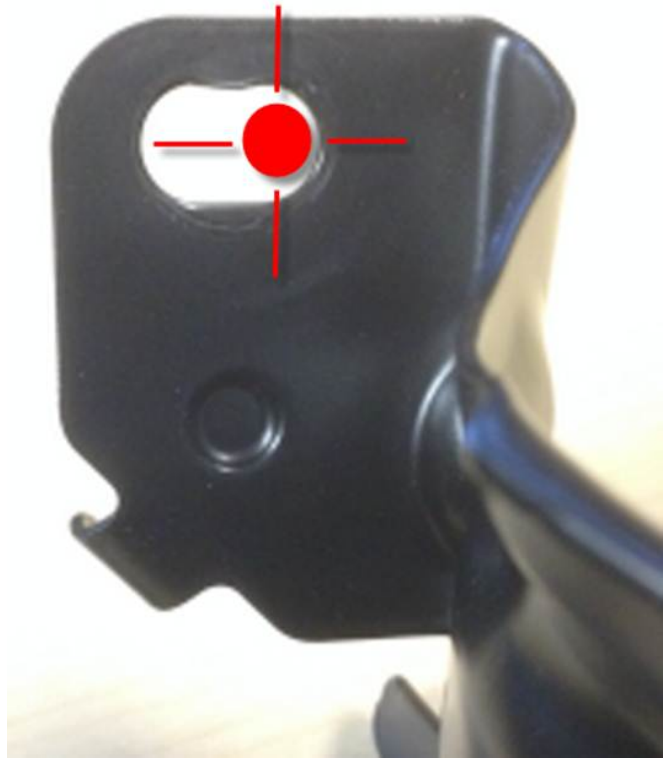
Figure 8. Bolt A should clamp the bracket as shown.

7. Release torque on bolt A, then position the knee bar support bracket so that bolt A will clamp it as shown (Figure 8). Torque to 9Nm +/- 1Nm, then re-check for rattle noise:
 - If no noise is heard after the bracket is adjusted, proceed to step 10.
 - If the noise is still present after the bracket is adjusted, continue with step 8.
