Technical Service Bulletin

72 Rear center seat rattles and does not fold flat

72 13 11 2023324/3 October 21, 2013. Supersedes Technical Service Bulletin Group 72 number 13-08 dated September 10, 2013 for reasons listed below.

Model(s)	Year	VIN Range	Vehicle-Specific Equipment
Q5	2009 - 2010	All	Not Applicable

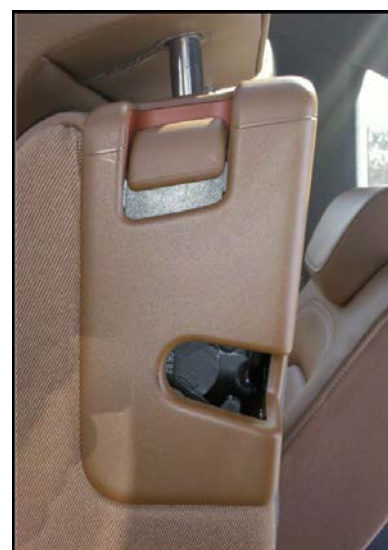
The rod between the rear center backrest latch and the release lever is detached (Figure 1). After the rod detaches and the center backrest is latched to the rear backrest on the driver's side, the center backrest cannot be folded flat independent from the driver's side rear backrest.

The loose connection inside the latching mechanism can create noises from the rear center seat when the vehicle is driven over rough roads.

Figure 1. The rear center backrest latch and release lever.

Follow the instructions below to replace both the release lever and the lock cover.

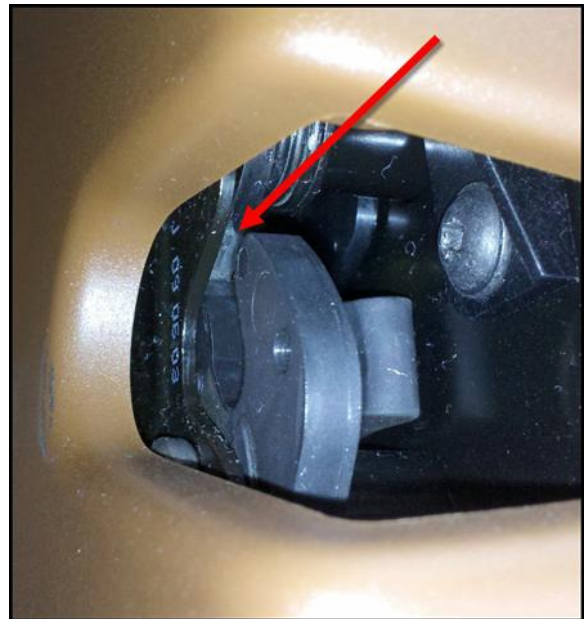
Figure 2. Arrow indicates direction to insert screwdriver. The latch is shown in the locked position.

1. Manually unlatch the center backrest from the driver's side rear backrest. To do this, insert a small, flat, regular screwdriver (with an end width of 6 mm-8 mm) into the latch to release the locking mechanism (Figure 2).

The latch concept is the same as a door latch; pressing inward will release the latch.

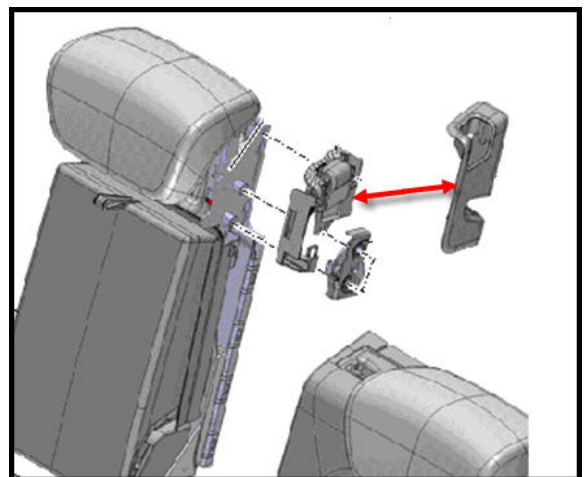
Figure 3. The release lever button and lock cover (arrows).

2. Use the repair instructions in Elsa to remove and replace the release lever button and the lock cover (Figure 3 and Figure 4).

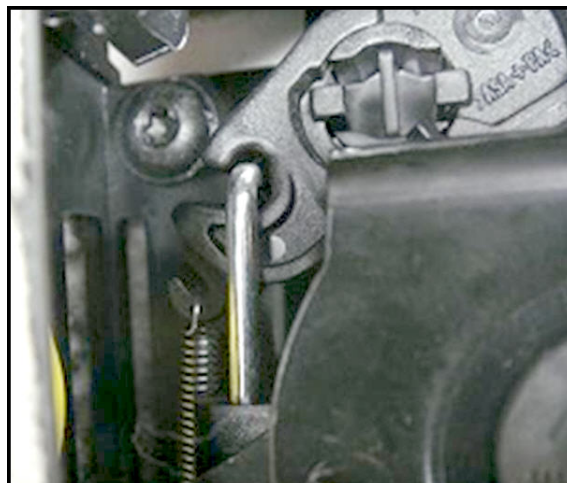
Figure 4. The optimized connection point of the release lever and the connecting rod.

The connection between the release rod and the release lever is optimized. The release lever is optimized.
