# Technical Service Bulletin

## 45 ABS warning light on with additional warning lights on (EPB/TPMS/EPC/MIL) - Wire harness damage

45 13 07 2033412/2 September 25, 2013. Supersedes Technical Service Bulletin Group 97 number 13-35 dated March 27, 2013 for reasons listed below.

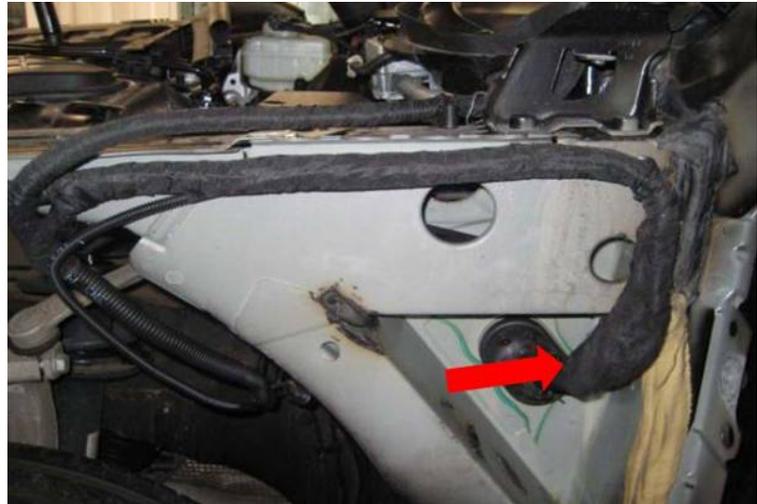
The insulation for the ABS wheel speed sensor is damaged in production. Over time, this can lead to corrosion on the wires and restricted functions with the ABS control module. Only the wires in the left bulkhead grommet (Figure 1) are affected.

**Figure 1.** Left front fender is removed to show the left bulkhead grommet

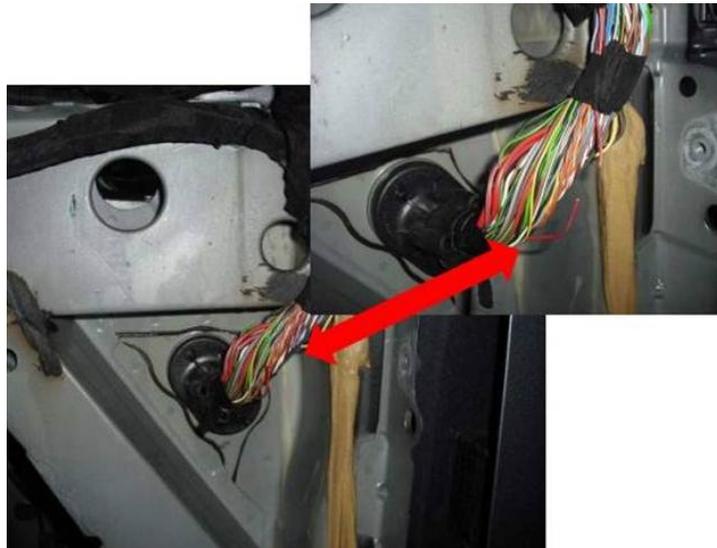
- If the voltage drops (over 0.3 V), the wiring loom around the grommet must be checked (Figure 2)

**Figure 2.** Affected area of the left front wiring loom behind the fender

3. Repair the damaged cable in the wiring loom using the VAS1978B wiring harness repair kit.
4. Remove the sections of the individual cable where the copper wires are black or corroded.
5. Pull back the insulation for the complete wiring loom, for a distance of about 40 cm from the grommet towards the front of the vehicle, and inspect for additional damage or corrosion.

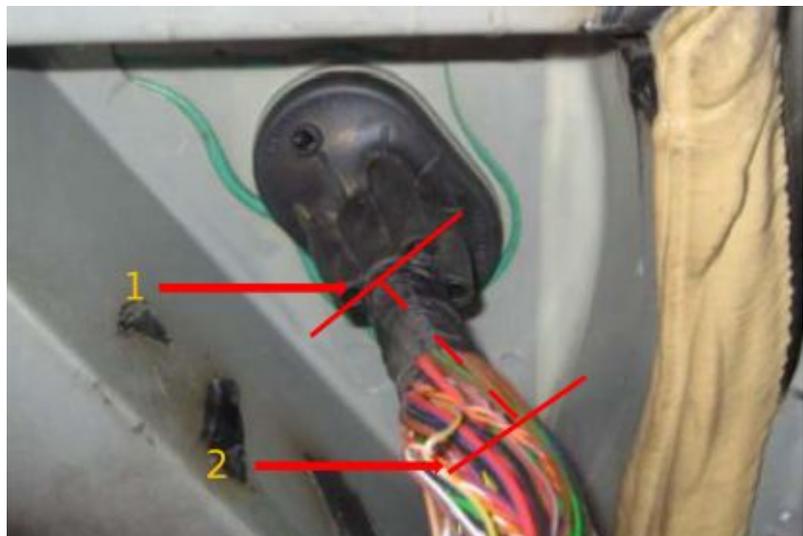
2. If damage is found, please contact the Technical Assistance Center (TAC) and take a photo of the damage:
  - Measure the distance from the **grommet front side** (Figure 3, point 1) to the **point of damage point** (Figure 3, point 2). Include this measured distance in the TACS contact.

**Figure 3.** Measuring point of damage in relation to the end of the grommet

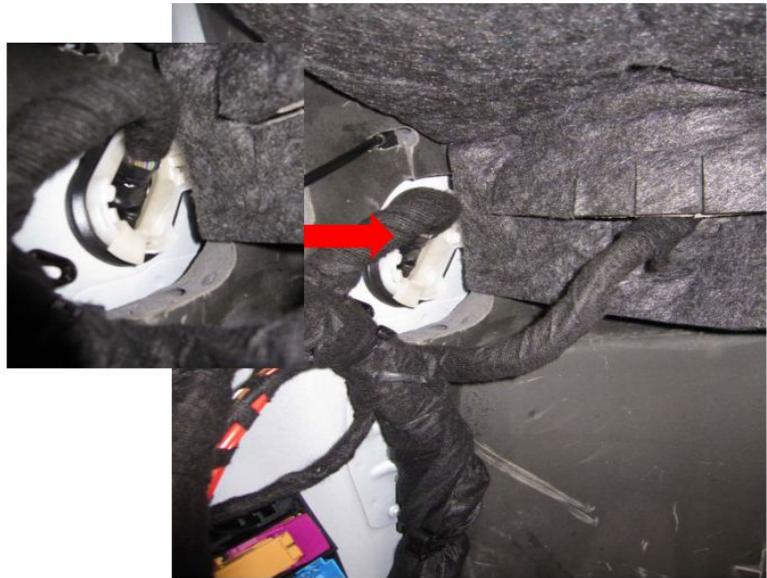
- Take a photo, using camera flash, of the grommet and original harness position from the passenger compartment (Figure 4). Please attach the photo to the TACS contact.

*Figure 4. Grommet position photo, taken from inside the passenger compartment.*
