Technical Service Bulletin

63 Noise from rear of vehicle

63 13 04 2035370/1 September 27, 2013.

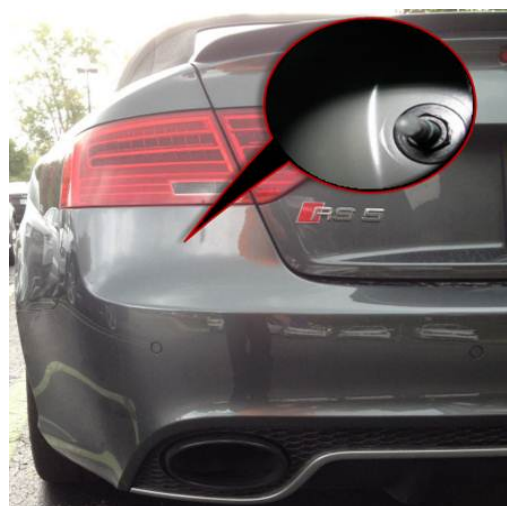
The center mounting nut on the rear bumper cover (Figure 1) might be loose, allowing the rear cover to move when the vehicle is driven over a rough surface.

Figure 1. Center mounting nut on rear bumper cover.

Application of thread lock during production assembly

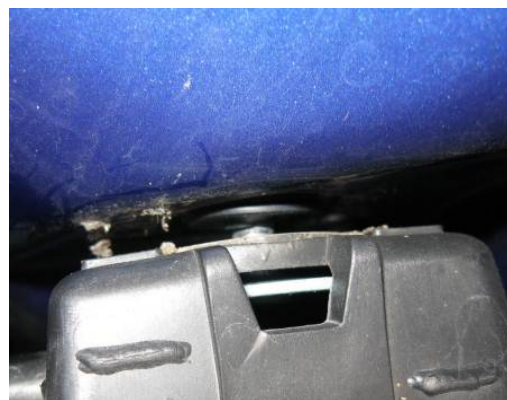
The play from the loose mount (Figure 2) will cause a noise. Additional noise can be heard when the cover and tail lamp rub.

Figure 2. Loose mount.

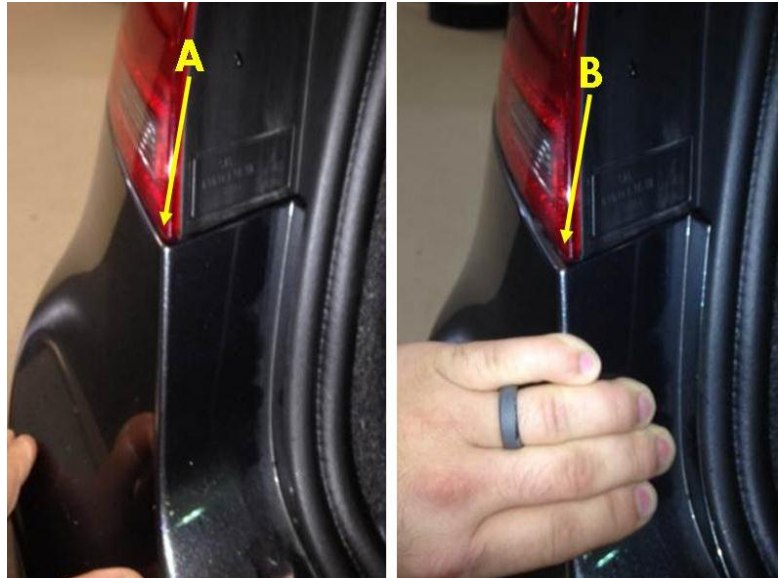
Figure 3. Bumper cover with no free play (A) and bumper cover with free play (B).

1. Check for free play from the rear bumper cover at the left and right rear mount nuts by opening the trunk and applying a light force, by hand, to the bumper cover:
 - If no free play is found (Figure 3, A), do not proceed with this bulletin. Continue to diagnose the issue.
 - If free play is found (Figure 3, B), continue with this bulletin.
