Technical Service Bulletin

72 Audi Q5 rattle from left rear seat back

72 13 05 2030729/3 September 5, 2013. Supersedes Technical Service Bulletin Group 72 number 12-04 dated November 30, 2012 for reasons listed below.

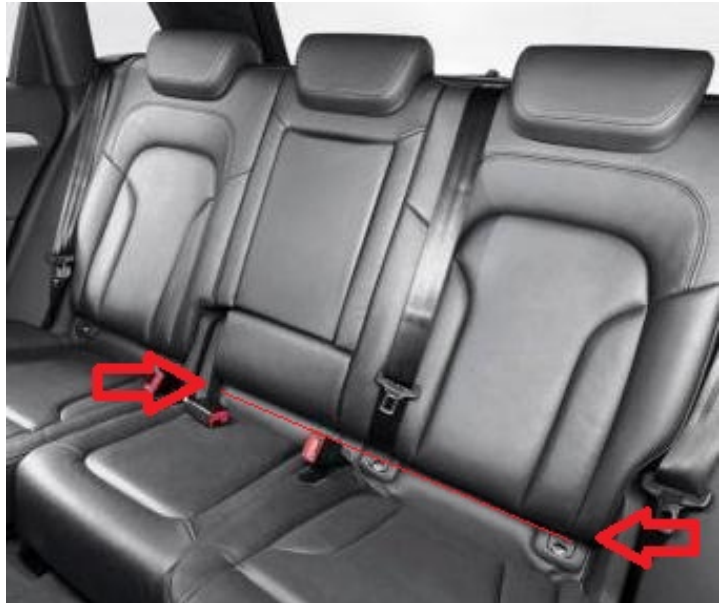
- The rattle sound may be caused from the pivot point of the torsion bar (Figure 1) within the 2/3 rear seat backrest pivot assembly.

Figure 1. Left rear seat noise area marked with red arrows.

1. Start diagnosis by performing a test drive. Sit in the right rear seat of the vehicle while a partner drives.
2. Ensure that there are no objects or passengers in the left rear seat, as the rattle is best diagnosed under these conditions.
3. If the 2/3 rear seatback is confirmed as the source of the rattle, the 2/3 rear seatback frame must be replaced, as the 2/3 rear seat backrest frame is not serviceable (Figure 3).

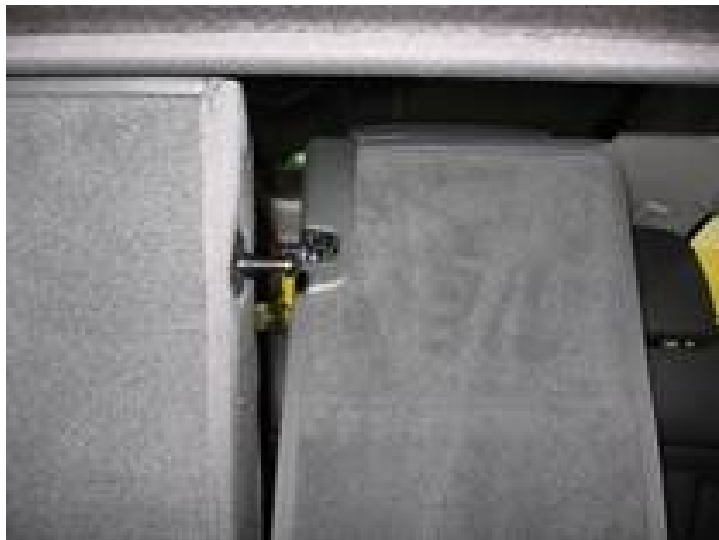
- The squeak noise may be coming from the rear seat armrest area, specifically from the contact surface between the armrest lock and the striker pin (Figure 2).

Figure 2. Armrest lock striker pin.

1. Confirm that the source of the squeak is the armrest lock.
2. Lightly sand the contact surface of the striker pin to create a “knurled” effect (Figure 4).

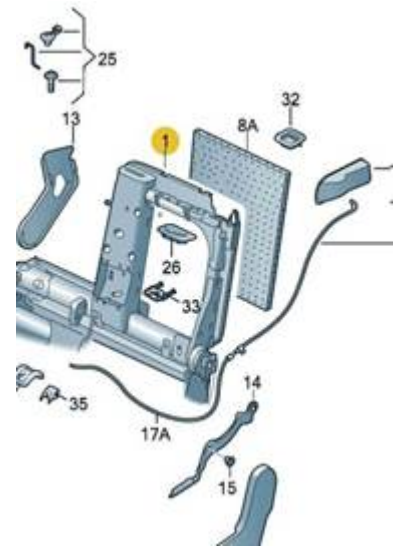
Figure 3. 2/3 seatback frame

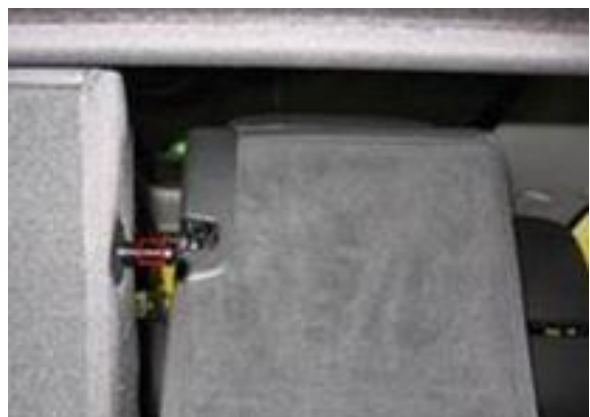
Figure 4. Area of striker pin to be lightly sanded.
