Technical Service Bulletin

72 Seat memory does not work

72 13 09 2035357/1 September 25, 2013.

Model(s)	Year	VIN Range	Vehicle-Specific Equipment
A4	2012 - 2014	All	Not Applicable
A5, A6, A7,A8, Q5, Q7	2011 - 2014	All	Not Applicable

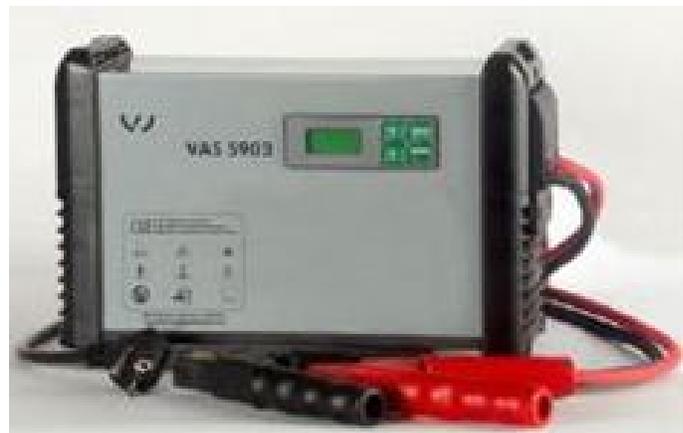
Figure 1. Approved battery maintainer.

1. Install approved vehicle battery maintainer on vehicle (Figure 1).

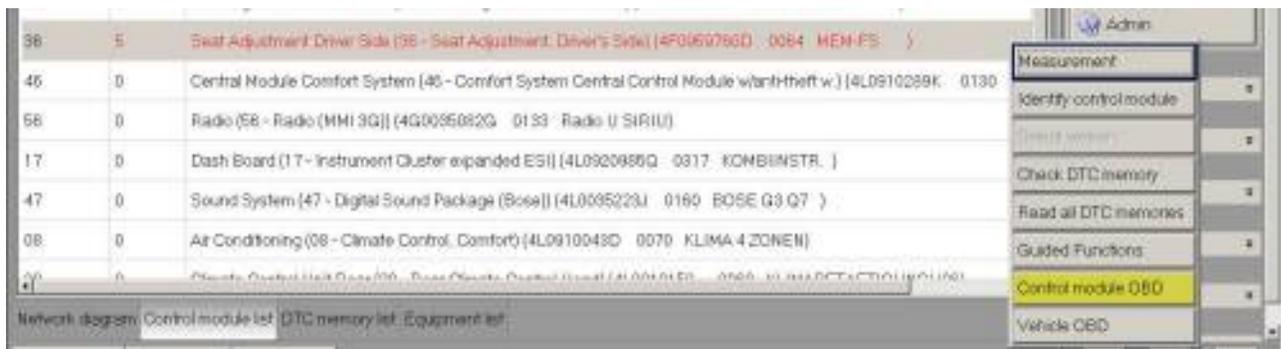
Figure 2. Select “Control module ODB”.

Before performing the update, record the coding of the module by right-clicking on the control module in ODIS, then selecting “Control module ODB” (Figure 2).

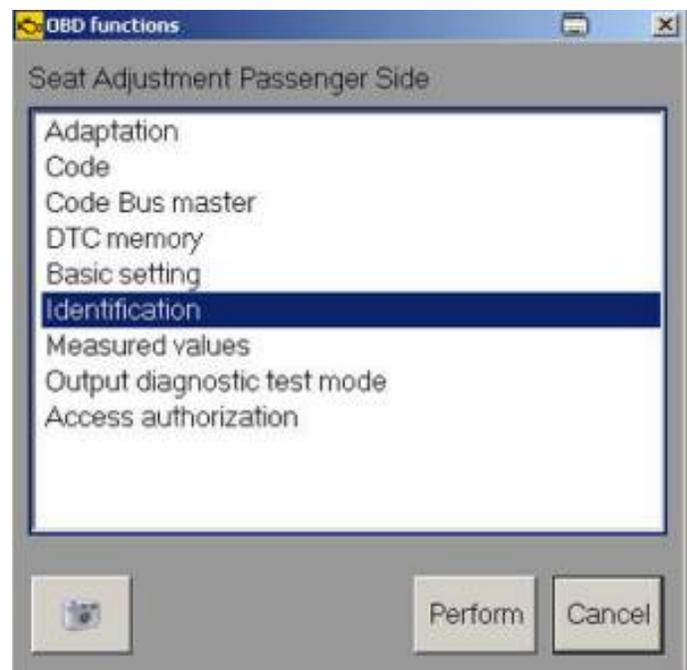
Figure 3. Identification in OBD Functions.

- Perform Identification (Figure 3).

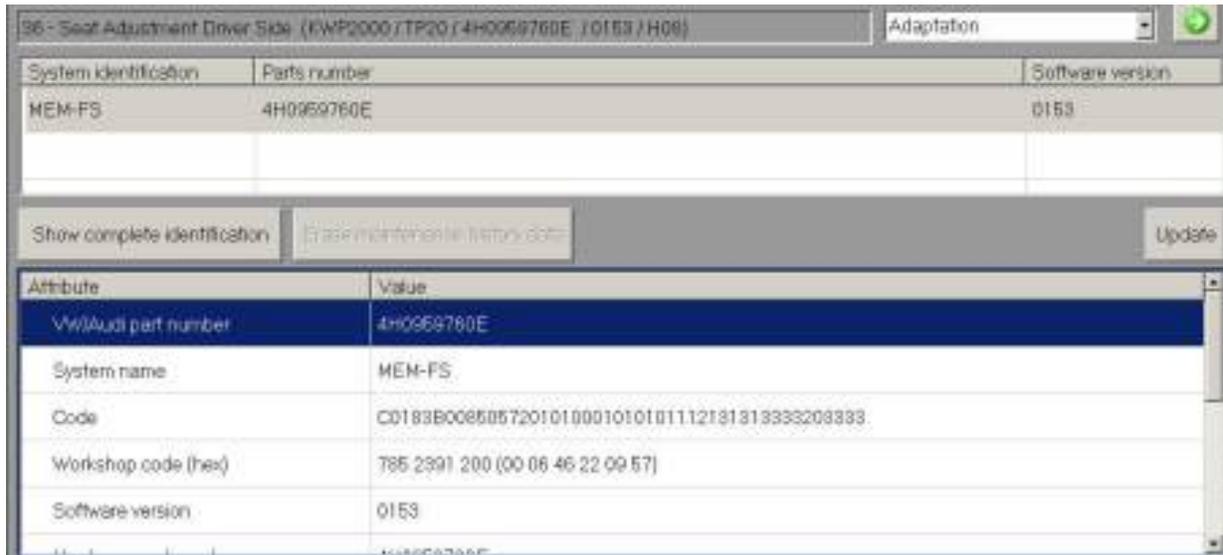
Figure 4. Module coding.

4. Make note of the module coding (Figure 4). The coding should be double-checked after the control module update.

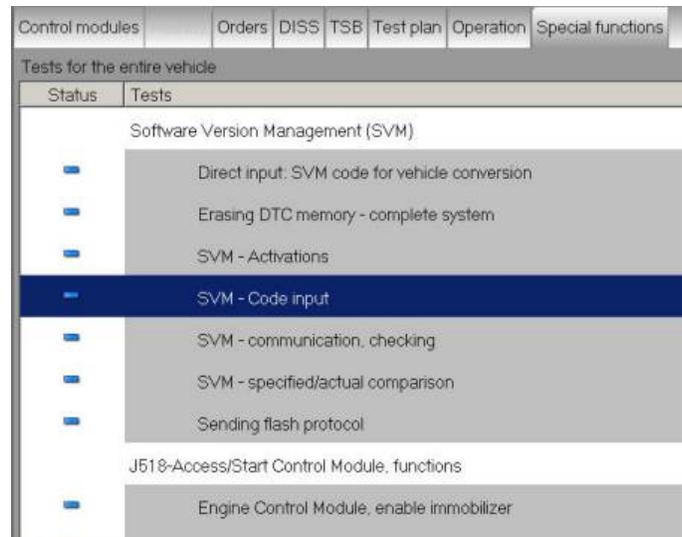
Figure 5. Selecting “SVM - Code input”.

5. To perform SVM in GFF, select the “Special functions” tab, then “SVM - Code input” (Figure 5).

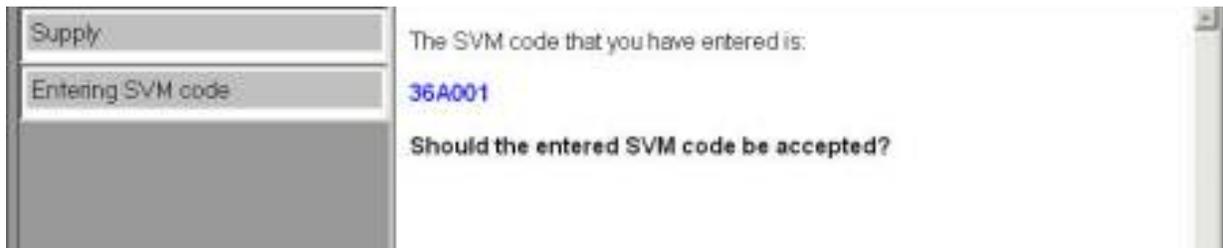
Figure 6. Entering SVM code.

6. Enter SVM code 36A001 (Figure 6). Refer to the SVM table at the bottom of this section for software information.

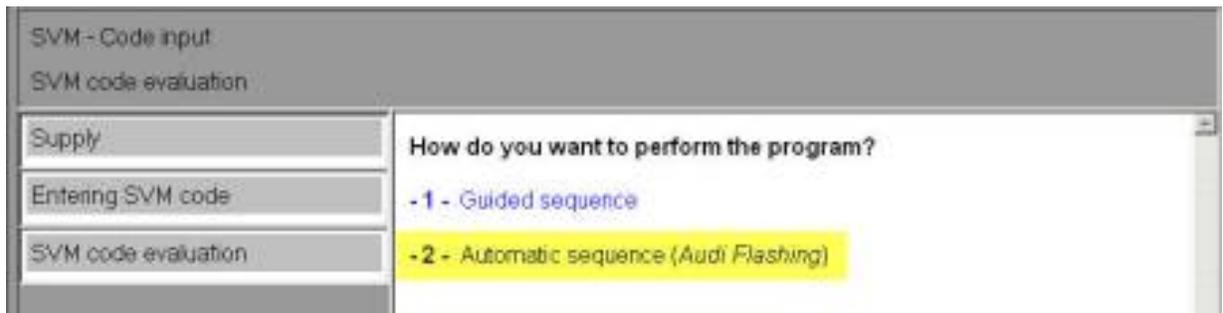
Figure 7. Selecting “Automatic sequence (Audi Flashing)”

7. When prompted, select “Automatic sequence (Audi Flashing)” (Figure 7).

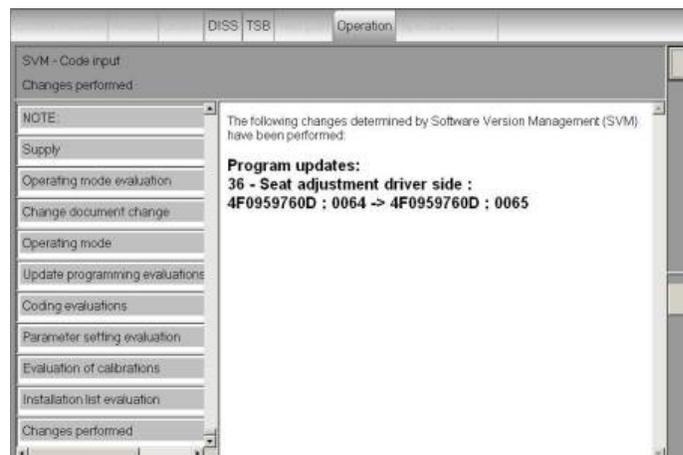
Figure 8. Completing the update.

8. Follow the instructions on the tester to complete the control module update (Figure 8).

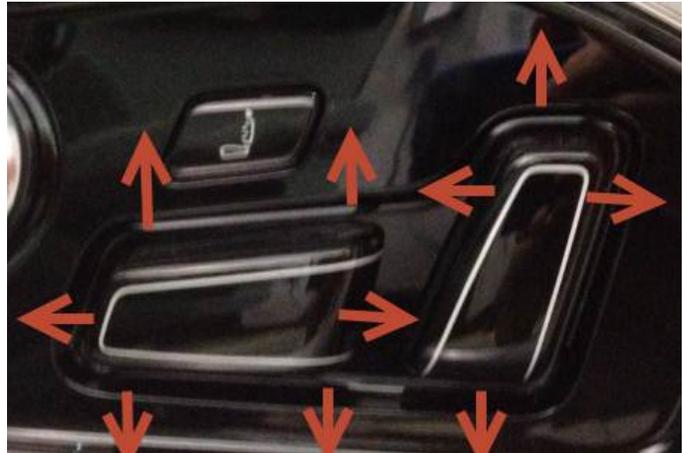
Figure 9. Directions in which the basic settings should be tested.

9. After updating the control module, verify that the coding is correct.
10. Perform basic settings of the front seats. Each seat must run the full length of travel, forward, backward, up, and down for each motor (Figure 9). The number of adjustments will vary depending on vehicle options.

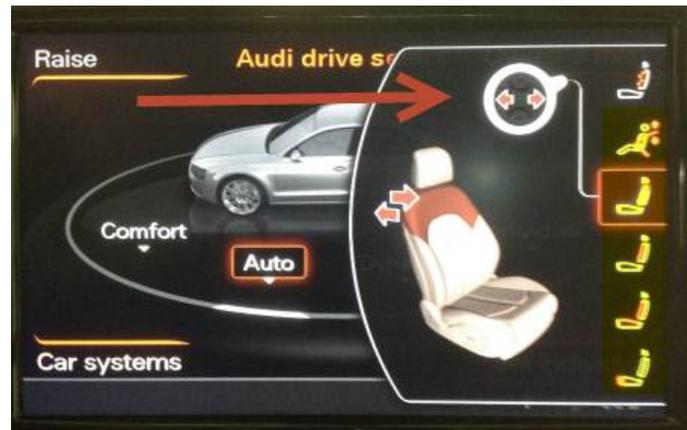
Figure 10. Additional basic settings in MMI.

11. If necessary, perform the additional seat and seatbelt basic settings shown in the MMI (varies by vehicle) (Figure 10).

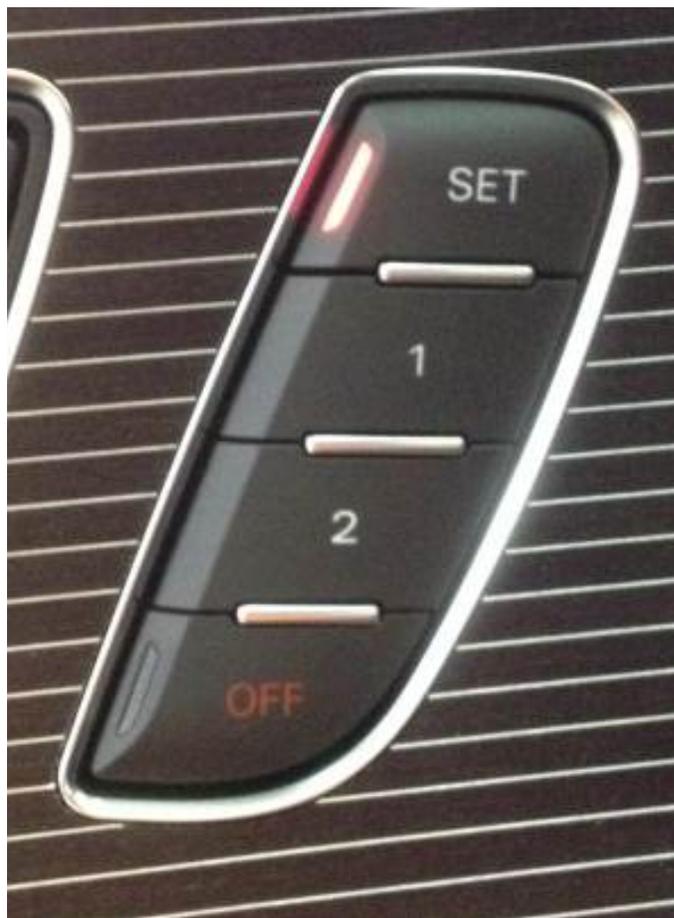
Figure 11. The “SET” button lit up, indicating that the seat is fully adapted and properly coded.

When the seat is fully adapted and properly coded, the “SET” button will light up when pressed (Figure 11).

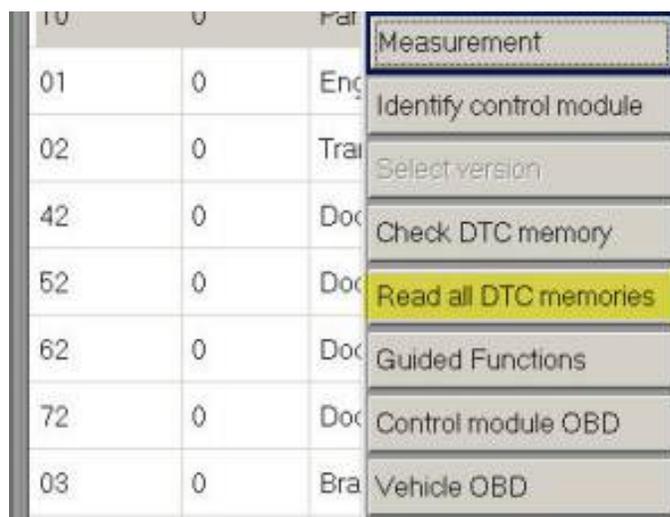
Figure 12. Rechecking the DTC memory.

12. Recheck the DTC memory (Figure 12). If all work has been performed properly, the fault will not return.

If the fault does return, run the affected adjustment to its end stops and recheck the fault.

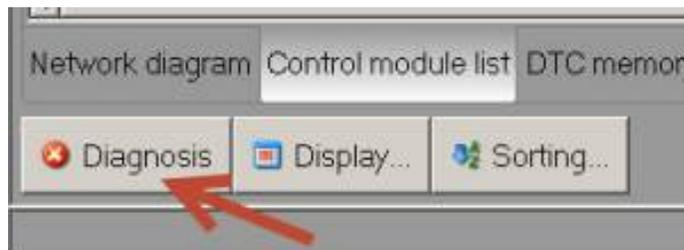
Figure 13. End diagnosis.

13. After all work is complete, end Diagnosis (Figure 13).
