# Technical Service Bulletin

## 74 S-line front seat head restraint feed-through hole exposed in leather backrest cover

74 13 10 2018257/4 September 13, 2013. Supersedes Technical Service Bulletin Group 74 number 09-01 dated September 21, 2009 for reasons listed below.

Model(s)	Year	VIN Range	Vehicle-Specific Equipment
A6	2006 - 2008	All	S-line Sport Seats
A6	2009	000001 - 019420	S-line Sport Seats

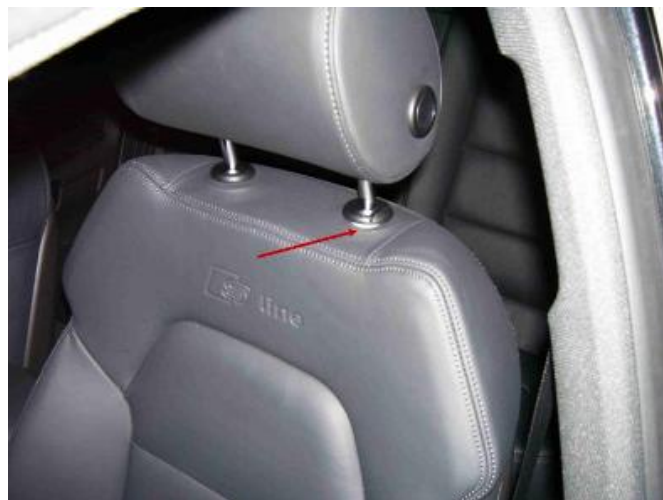
The head restraint feed-through hole is visible on the seat backrest cover.

Depending on how the customer enters the vehicle, the leather backrest cover may be pulled forward, exposing the feed-through hole for the head restraint. This condition only affects vehicles with S-line sport seats.

**Figure 1.** The head restraint feed-through hole, exposed.

Replace the front seat backrest cover.
