# Technical Service Bulletin

## 74 Seat heating performance too low

74 13 11 2028257/7 September 13, 2013. Supersedes Technical Service Bulletin Group 74 number 12-08 dated April 24, 2012 for reasons listed below.

Model(s)	Year	VIN Range	Vehicle-Specific Equipment
Q5	2012	000000 -090179	Heated front seats

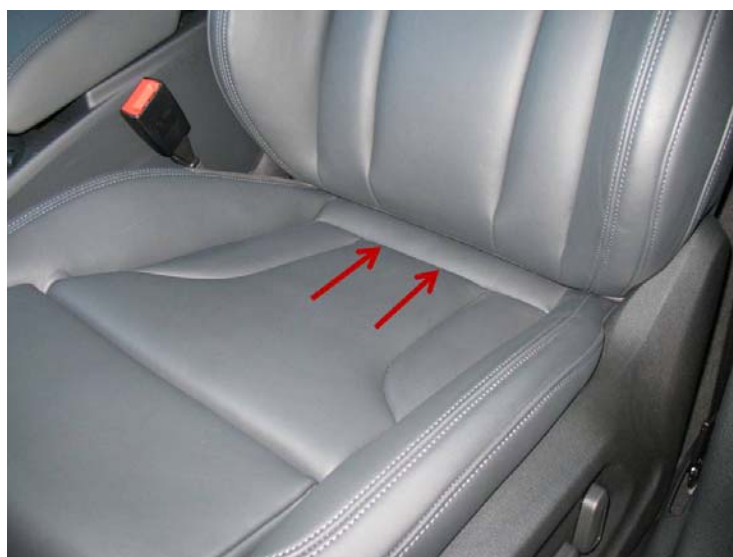
The customer may complain that the seat heating temperature is too low or that it takes too long to heat up.

From model year 2012, an additional row of fastening features were added to improve the fit of the leather seat covers on the basic and sports seats (Figure 1).

As a consequence of this change, the temperature sensor within the seat was moved to a location that is more sensitive to heat. As a result, the control limit is reached too early and the heat is reduced before the seating surface reaches the correct temperature.

**Figure 1.** Arrows show area where additional fastening clips were added.

Install new software in the electronic central electrics unit (BCM1) control module, J519 (address word 09), to modify the control limit for the seat heater.
