Technical Service Bulletin

80 Coolant loss from coolant valve, engine warning light on, "Limp Home" mode active

80 13 05 2033806/4 September 11, 2013. Supersedes Technical Service Bulletin Group 80 number 13-04 dated August 9, 2013 for reasons listed below.

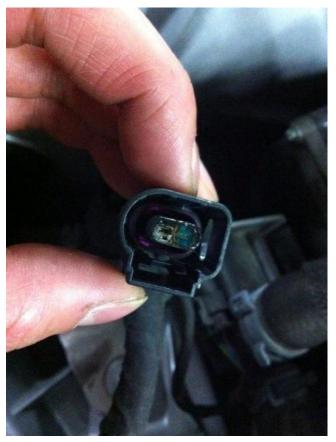
The connectors, wiring harness, and/or connected control units may have been damaged from exposure to coolant (Figure 2).

Figure 2. Corrosion formation on the connector pins.

Tip: Check the connectors, wiring harness, and connected control units for coolant damage. Perform repairs as necessary.
