Technical Service Bulletin

87 Moisture in driver or front passenger footwell

87 13 45 2024644/8 September 10, 2013. Supersedes Technical Service Bulletin Group 87 number 13-41 dated May 30, 2013 for reasons listed below.

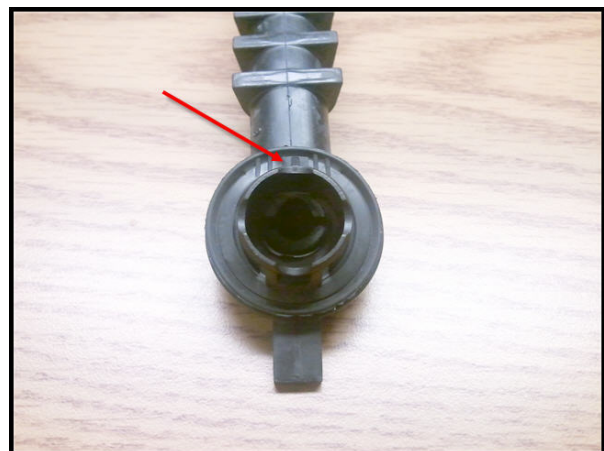
Due to a faulty and/or incorrectly installed condensation drain hose, condensation from the evaporator could enter the front foot well areas through a gap between the body and the sealing surface of the drain hose.

Figure 1. Incorrectly assembled drain hose, with locating tab pointing up.

- Should the snap ring have been incorrectly installed to the body of the vehicle, do not repair the condensation drain hose assembly. Replace the hose using the repair procedure in *ElsaWeb >> Heating, Ventilation and Air Conditioning >> 87 Air Conditioning >> Removal and Installation >> Condensation Water Drain Hose*. Improper installation at the factory may have damaged the snap feature (opposite the locating tab), thus creating a poor seal to the body.

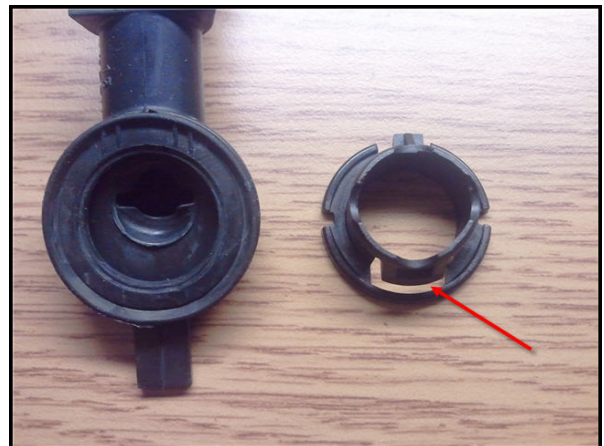
When the snap ring is installed upside down, condensation is allowed to leak out through a hole at its bottom (Figure 2). The water can then migrate into either of the front footwell carpeted areas.

Figure 2. Hole in snap ring.

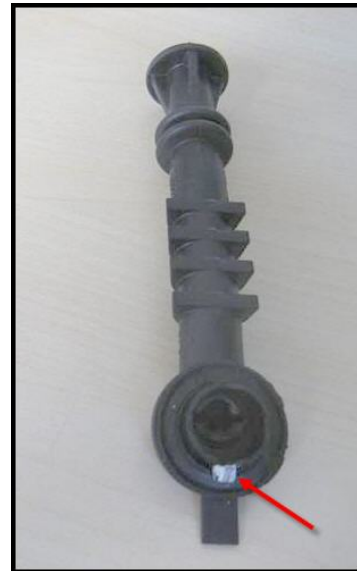
Service parts have been checked, but it is still possible to receive unchecked parts. Corrected parts will be marked in white on the locating tab. This tab must be pointing down (Figure 3).

Figure 3. White mark on locating tab.

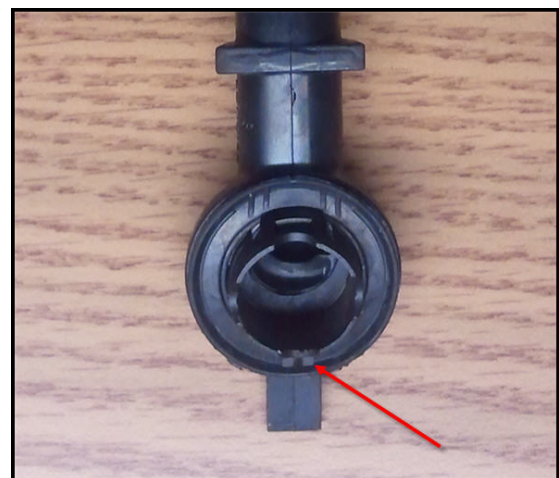
Figure 4. Snap ring installed in the correct position.

- If the locating tab on the new part is in the wrong position (pointing up), use a small set of needle nose pliers to gently pull the snap ring out of the rubber hose and align it in the correct position (pointing down). Dipping the end of the hose in soapy water may make the process easier.
- Reinstall the snap ring in the correct position (Figure 4).
