Technical Service Bulletin

90 Instrument cluster, driver information system (DIS) display is blank with white screen

90 13 40 2029781/2 September 9, 2013. Supersedes Technical Service Bulletin Group 90 number 12-30 dated June 26, 2012 for reasons listed below.

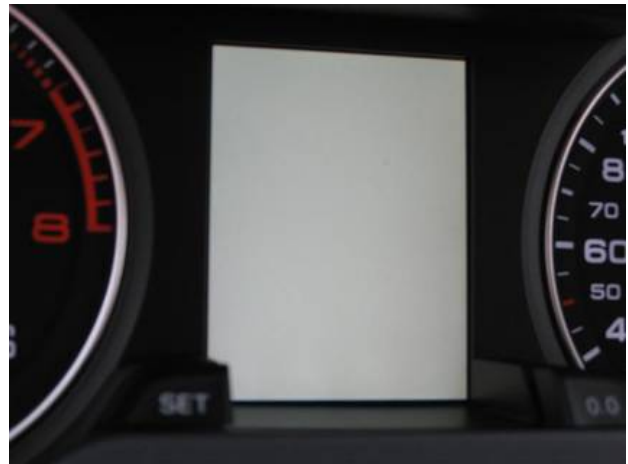
- The driver information system (DIS) display screen is completely blank or appears to be all white (Figure 1).
- The condition is intermittent and the DIS can function normally when the key is cycled off and back on.
- This condition only affects vehicles with the highline instrument cluster (PR No. 9Q7 or 9Q8).

Figure 1. Blank white DIS Screen in the instrument cluster.

The issue is attributed to incorrect software for clusters with the Hitachi display screen.

1. Replace the cluster.
2. If the issue is repeatable, attach a photo of the condition to the damaged part or repair order.
