Technical Service Bulletin

91 MMI 3G Sound system "popping" and various other technical issues (K0133 Update)

91 13 06 2034923/2 September 12, 2013. Supersedes Technical Service Bulletin Group 91 number 13-99 dated August 5, 2013 for reasons listed below.

Model(s)	Year	VIN Range	Vehicle-Specific Equipment
A4	2011-2012	All	MMI 3G
A5/A5 Cab	2011-2012		
A6	2011		
Q5	2011-2012		
Q7	2011

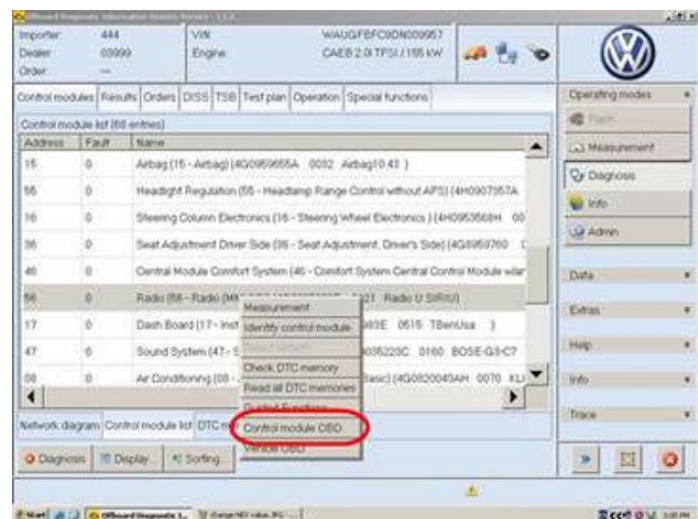
Figure 1. Radio self-diagnosis.

1. Verify the HD radio is enabled in the MMI by navigating to *Radio >> Settings*.
 - If the HD radio options are present in the MMI menu, proceed directly to Step 6.
 - If the HD radio options are not present in the MMI menu, continue with Step 2.
2. Using ODIS, right-click on 56 – *Radio* in the control module list, and select *Control Module OBD* (Figure 1).

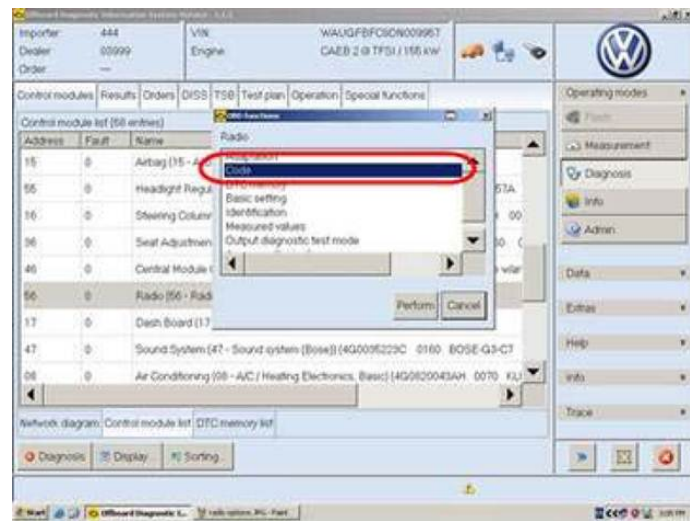
Figure 2. Code radio option.

3. Select *Code* (Figure 2).

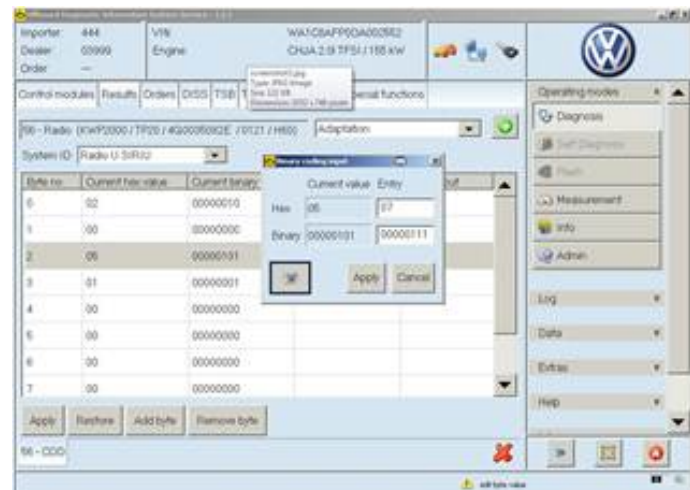
Figure 3. Changed radio coding.

4. Verify the coding in byte 2 is HEX 07.

- If it is not HEX 07, change the coding to HEX07. Apply changes (Figure 3).

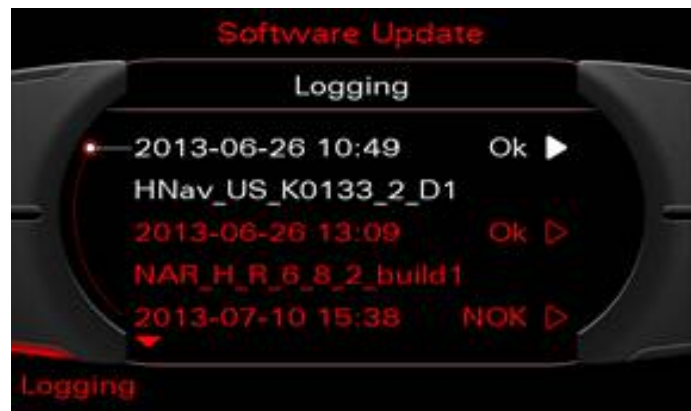
After a successful update, the screen will show the date on which the update was performed and the software that was installed (HNav_US_K0133_X_XX — The X characters will be one of several different numbers or letters). 'Ok' will be listed on the right. If K0133 does not have any rows with 'Ok', the update must be retried until it is successful.

Figure 4. Software update log showing a successful software installation.

7. Verify that the software update has been completed successfully by accessing the logging page (Figure 4). To access this screen, proceed to step 8 in TSB 2028141 and press the lower left softkey.

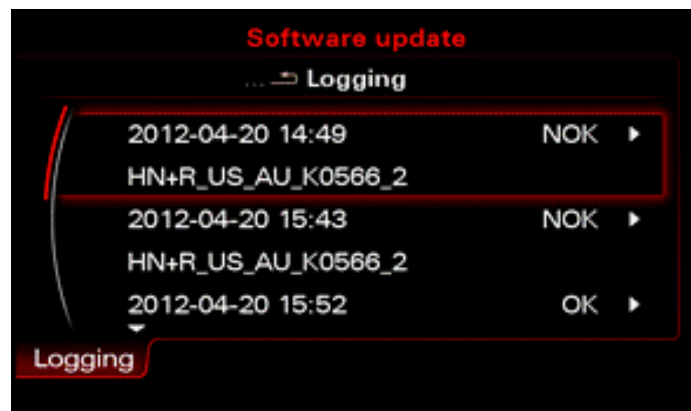
Figure 5. Software update log showing 2 failed attempts before a successful installation (MMI 3G+ screenshot used as reference).

Tip: If the update must be performed two or more times because the modules are not updating correctly, a screenshot of the software update log is required (Figure 5). This should be kept on-hand for warranty auditing purposes. To take a screenshot, insert an SD Card into slot 1 and press and hold the left and right arrow keys at the same time. All 4 softkeys will flash when the screenshot is taken. A screenshot should be taken of each page in the logging display.
