Technical Service Bulletin

91 MMI 3G+ Sound system "popping" and various other technical Issues (K0715 Update)

91 13 07 2030465/6 September 12, 2013. Supersedes Technical Service Bulletin Group 91 number 13-98 dated August 5, 2013 for reasons listed below.

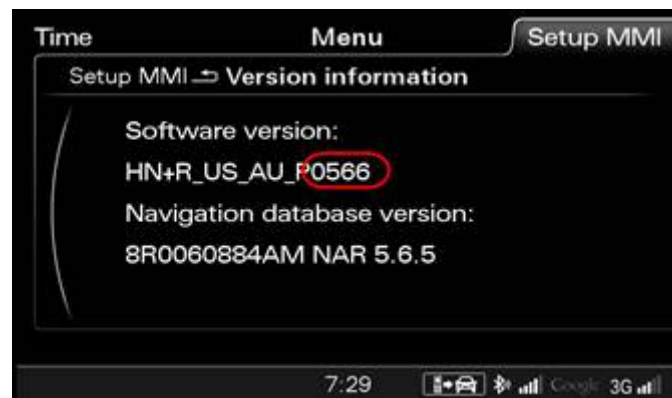
Figure 1. MMI software version (566).

Tip: The MMI software version can be found under *Menu >> Setup MMI >> Version Information* (Figure 1).

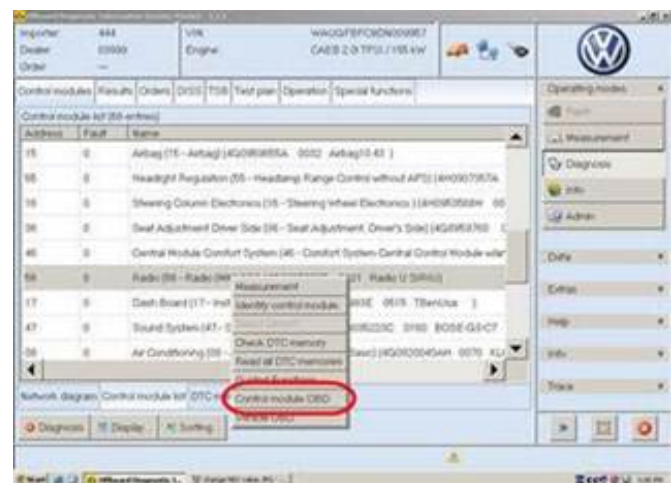
Figure 2. Radio self-diagnosis.

1. Verify the HD radio is enabled in the MMI by navigating to *Radio >> Settings*.
 - If the HD radio options are present in the MMI menu, proceed directly to Step 6.
 - If the HD radio options are not present in the MMI menu, continue with Step 2.
2. Using ODIS, right-click on *56 – Radio* in the Control module list, and select *Control Module OBD* (Figure 2).

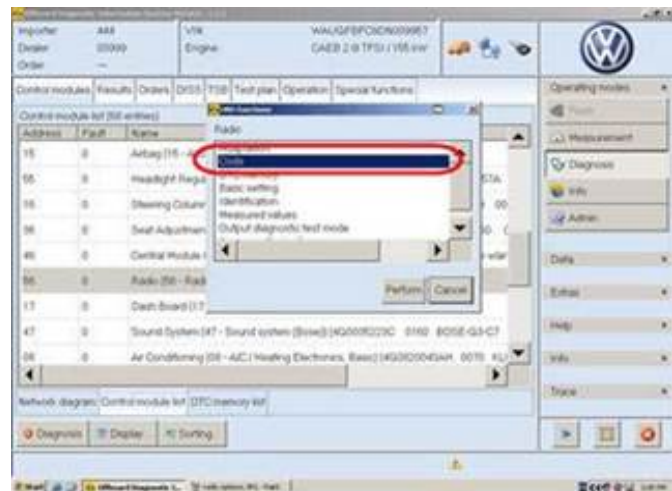
Figure 3. Code radio option.

3. Select *Code* (Figure 3).

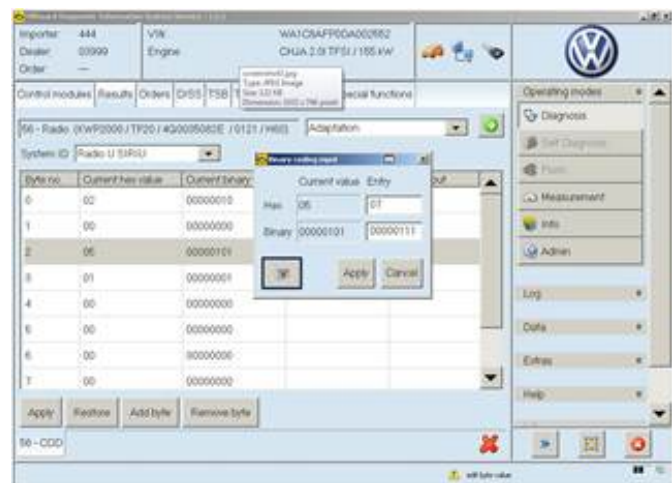
Figure 4. Changed radio coding.

4. Verify the coding in byte 2 is HEX 07.

- If it is not HEX 07, change the coding to HEX 07. Apply changes (Figure 4).

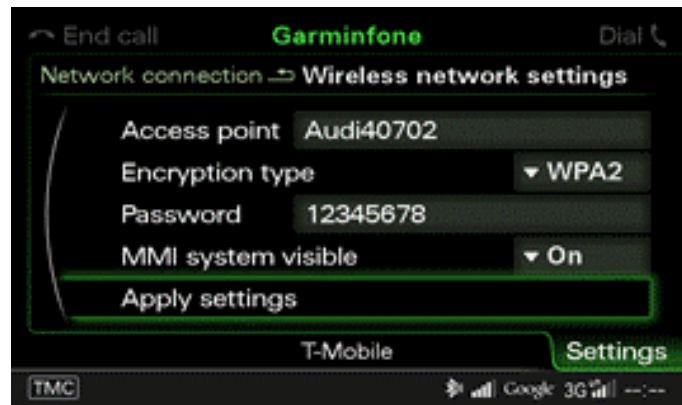
Figure 5. Wireless network settings.

6. As part of the update, wireless settings and paired devices will be deleted. All devices will need to be re-paired after the update, and all wireless settings restored to the customer's settings. To access the Wireless network settings on the MMI (Figure 5), press *TEL >> Settings >> Wireless network connection >> Wireless network settings*. Record all settings so they can be re-entered at the end of the update.

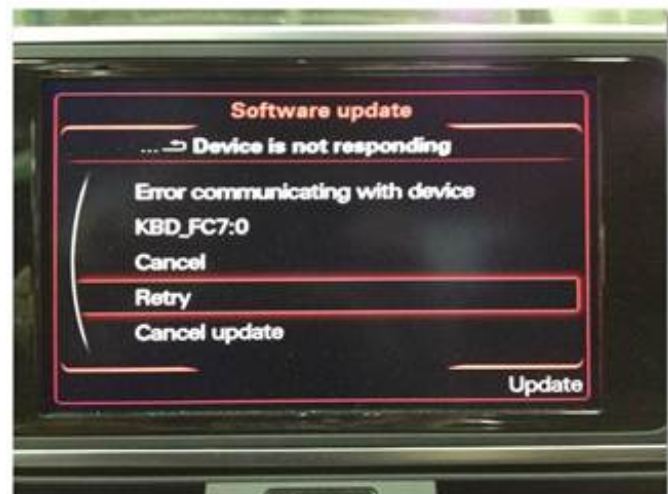
Figure 6. A device requiring a 'Cancel' selection.

Some earlier model year 2012 vehicles, or vehicles equipped with Bose® sound systems may experience certain modules that will not update properly during Step 16 of TSB 2028141. If this should occur, either choose 'Cancel' (Figure 6), or 'Skip device' (Figure 7), depending on the type of error. Do *not* choose 'Cancel update', as this may cause the software update to fail entirely. After the update is finished and the summary page is shown, select 'Retry' at the bottom of the list if it is available to attempt to update the modules again. If 'Retry' is greyed out, then the software update was successful. Select 'Continue' to proceed. In some cases 'Retry' may have to be repeated two or three times to get all modules to update successfully.

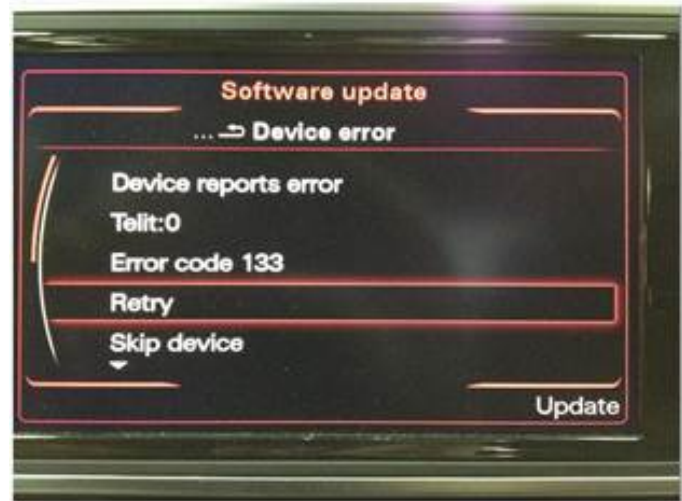
Figure 7. A device requiring a 'Skip device' selection.

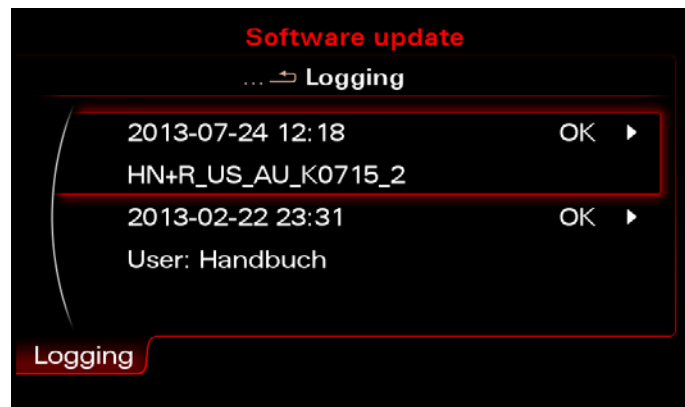
Figure 8. Software update log showing a successful software installation.

- Verify that the software update has been completed successfully by accessing the logging page (Figure 8). To access this screen, proceed to step 8 in TSB 2028141 and press the lower left softkey. A successful update will show the date the update was performed and the software that was installed (HN+R_US_AU_K0715_X), with 'OK' listed on the right. The 'X' may be one of several different numbers. If K0715_X does not have any rows with 'OK', the update must be retried until it is successful.

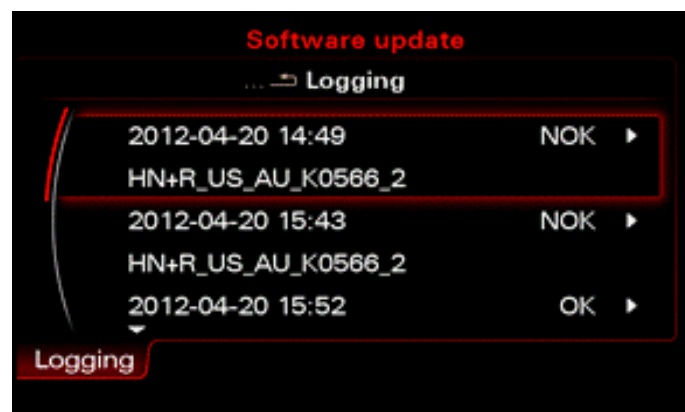
Figure 9. Software update log showing 2 failed attempts before a successful installation.

Tip: If the update must be performed two or more times due to modules not updating correctly, a screenshot of the software update log is required (Figure 9). This should be kept on-hand for warranty auditing purposes. To take a screenshot, insert an SD Card into slot 1. For A6/A7/A8/Q7, press and hold the left and right arrow keys at the same time. For A4/A5/Q5, press and hold the bottom two softkeys at the same time. All 4 softkeys will flash when the screenshot is taken. A screenshot should be taken of each page in the logging display.
