Technical Service Bulletin

96 False warning by lane change assistant (Audi Side Assist)

96 13 75 2033782/2 September 23, 2013. Supersedes Technical Service Bulletin Group 96 number 13-62 dated May 28, 2013 for reasons listed below.

Model(s)	Year	VIN Range	Vehicle-Specific Equipment
allroad	2013	All	Not Applicable

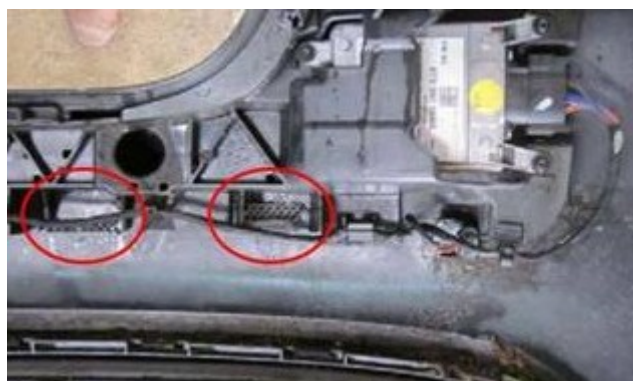
3. Perform a visual inspection of the plastic mounting brackets for the J769 and J770 control units. It is possible the plastic weld has come loose or is broken apart from the rear bumper cover (Figure 5).

Figure 5. Bumper bracket weld locations with broken welds.

4. Replace the rear bumper cover assembly if the bracket is loose (Figure 6).

5. Replace the rear bumper cover assembly if the bracket is broken (Figure 7).

6. Recalibrate the Audi Side Assist system, regardless of whether or not the bumper cover is replaced.

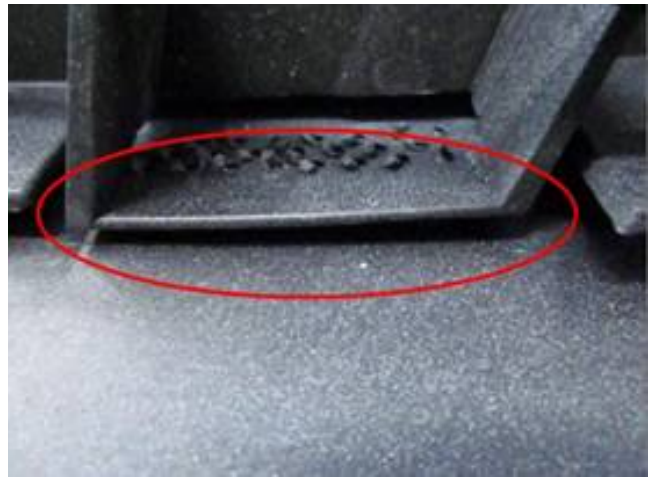
Figure 6. Loose bracket.

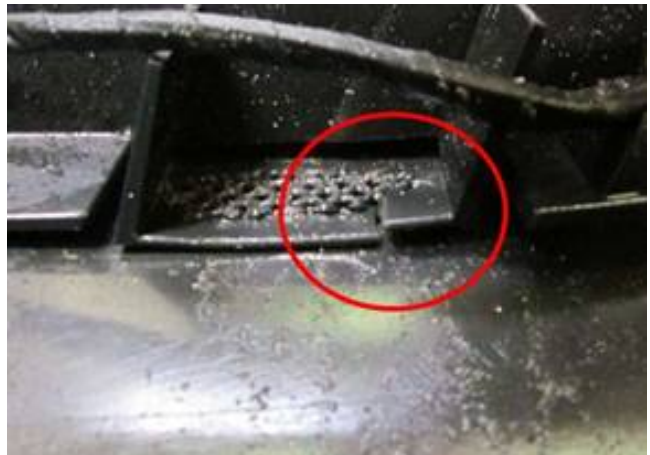
Figure 7. Broken bracket.
