Technical Service Bulletin

96 Lane Change Assistant "Sensors Blocked" warning in DIS (DTC C1114F3 and C1115F5)

96 13 77 2035047/2 September 23, 2013. Supersedes Technical Service Bulletin Group 96 number 13-72 dated August 26, 2013 for reasons listed below.

Model(s)	Year	VIN Range	Vehicle-Specific Equipment
A4, A5, A5 Cab, allroad, Q5	2013-2014	All	Audi Side Assist

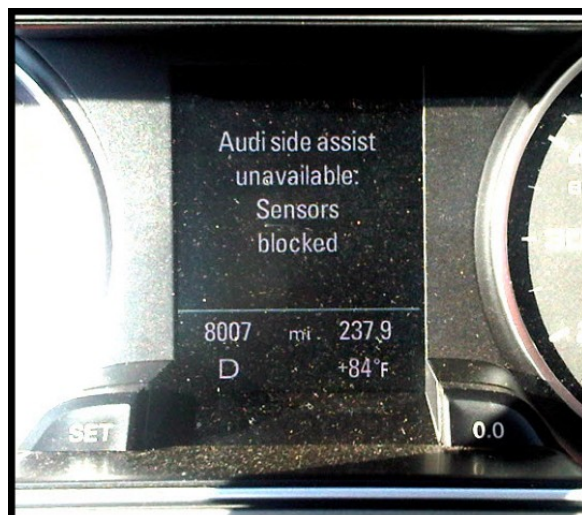
- Audi Lane Change Assistant deactivates or is sporadically inoperative when the vehicle is driven in slow-moving stop-and-go traffic, especially on roads with multiple lanes.
- The message "Audi side assist unavailable: Sensors blocked" appears in the driver information system (Figure 1).

Figure 1. Audi Side Assist warning in DIS

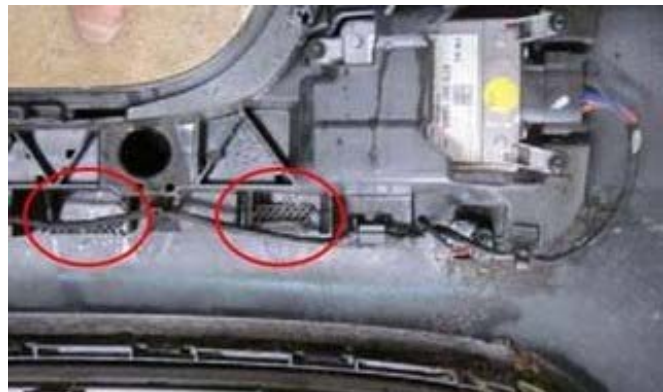
- Audi Lane Change Assistant can be activated without issue.
- No obstructions can be found.
- One or both of the following DTCs is stored in the Lane Change Assistance control module, J769 (address word 3C):
 - **DTC C1114F3** (Lane change assistance control module Restricted view Sporadic)
 - **DTC C1115F5** (Lane change assistance control module 2 Restricted view Sporadic)
- The control module mounting brackets are securely fastened to the lower rear bumper, and no damage is found to the rear bumper area, on the inside or outside (Figure 2).
(If any damage is found, it is not covered under warranty.)

Figure 2. Mounting bracket for one of the ECUs.

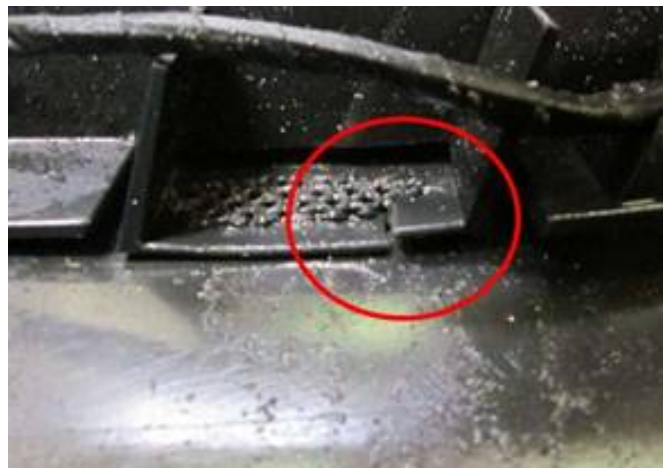
- The control module mounting brackets are not broken or loose (Figure 3 and Figure 4).

Figure 3. Broken mounting bracket

Tip: If a loose bracket is found, repair as necessary using the Elsa Repair Manual. Submit a separate warranty claim, as this TSB does not cover this repair.

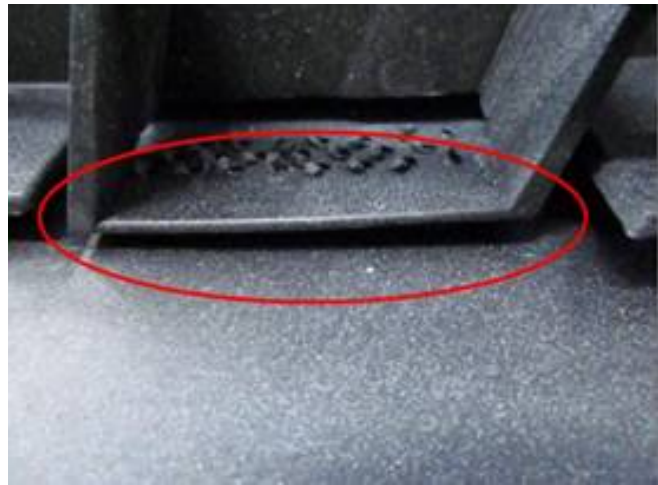
Figure 4. Loose mounting bracket.
