# Technical Service Bulletin

## 66 Wind noise from exterior rear view mirror

66 13 39 2035673/3 December 9, 2013. Supersedes Technical Service Bulletin Group 66 number 13-38 dated November 15, 2013 for reasons listed below.

Model(s)	Year	VIN Range	Vehicle-Specific Equipment
Q5	2009 - 2013	000001 - 999999	Not Applicable
Q5	2014	000001 - 052276	
Q7	2007 - 2013	000001 - 999999	
Q7	2014	000001 - 009004

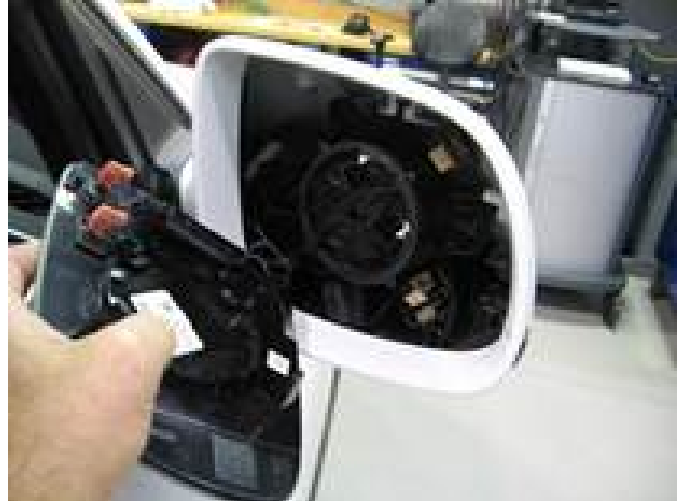
*Figure 1. Exterior rear view mirror glass removed.*

1. Begin by removing the exterior rear view mirror glass (Figure 1). Disconnect the electrical connectors carefully and set the glass aside.

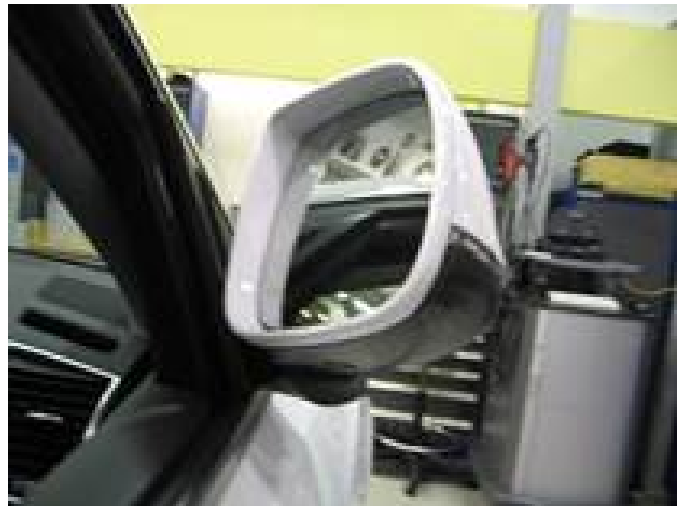
*Figure 2. Exterior rear view mirror manually folded.*

2. Remove the exterior rear view mirror cover. Manually folding the mirror body up will aid in the removal process (Figure 2).

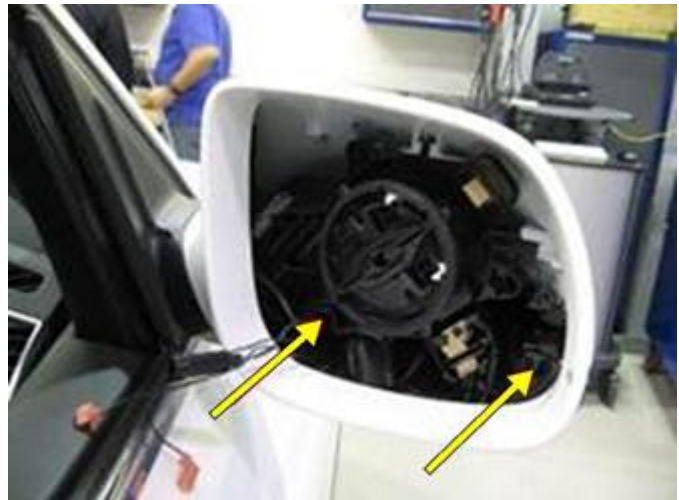
*Figure 3. Location of the retaining clips.*

- Carefully pull the lower rim of the cover away from the mirror base. Release the two retaining clips for the cover inside the mirror base (Figure 3).

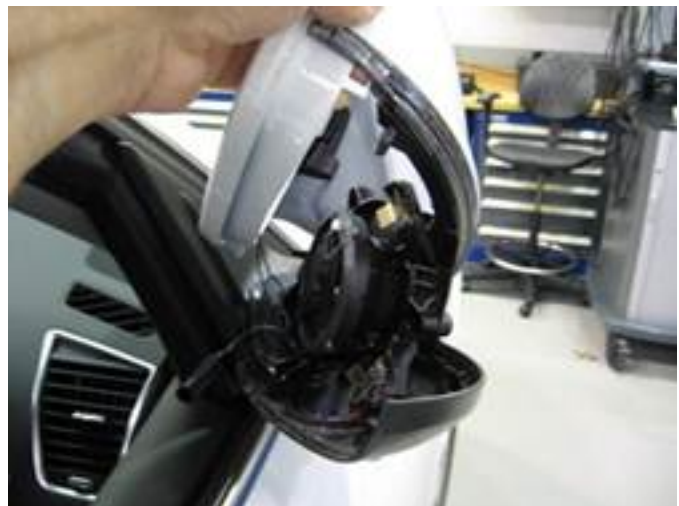
*Figure 4. Removing the mirror cover.*

- Unsnap the cover and set it aside (Figure 4).

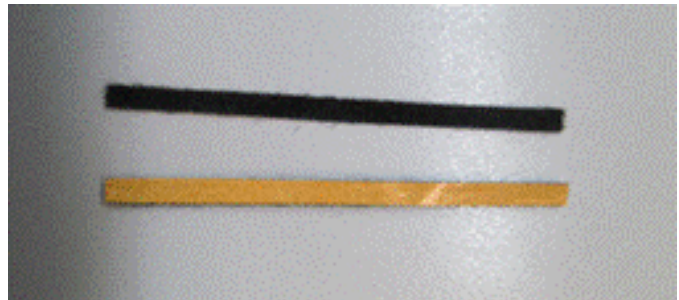
*Figure 5. Strips cut from felt tape.*

- Cut two 60mm x 3mm strips of felt tape (part number: **533863288A**) (Figure 5).

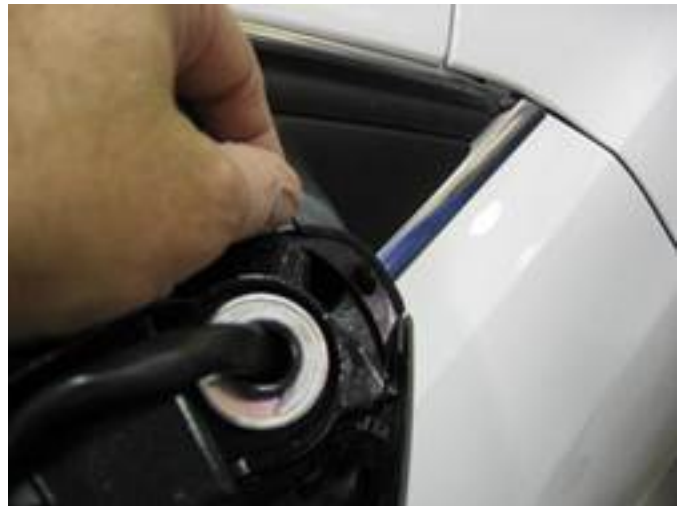
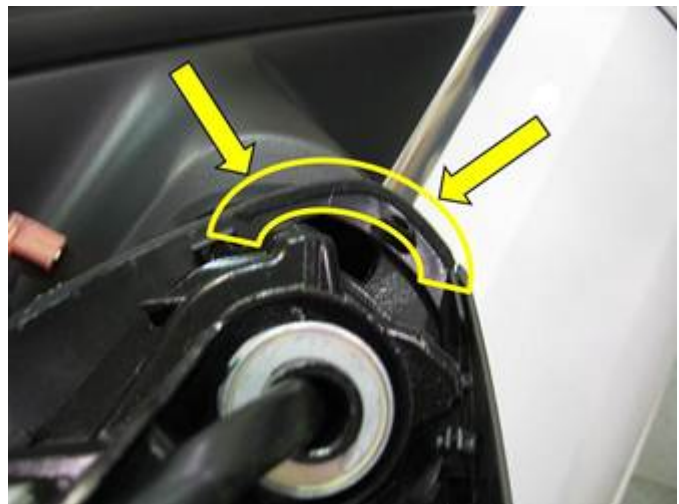
The two main sources of wind noise from the exterior rear view mirrors are: the seam surrounding the turn signal lamp and the seam at the mirror base. The modifications explained in the *Service* section of this bulletin will effectively mitigate the wind noise symptom for the customer.

*Figure 6. Application of felt tape.*

*Figure 7. Felt tape applied.*

6. Apply the felt tape strips to the exposed area of the mirror base, as shown at right (Figure 6 and Figure 7).

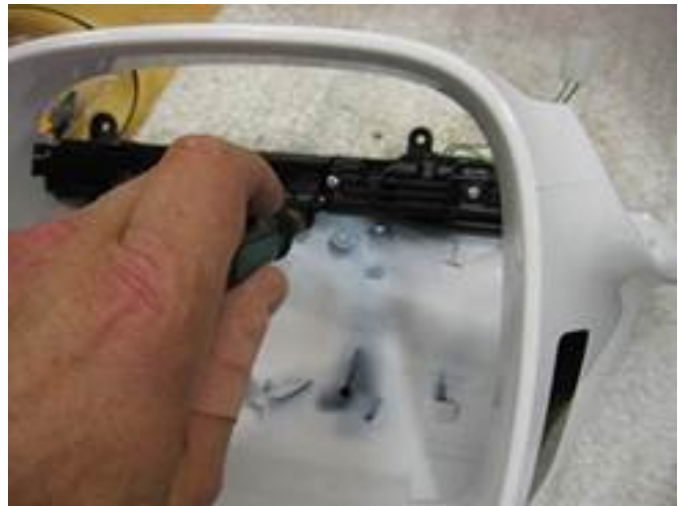
*Figure 8. Removing the turn signal lamp.*

7. Remove the turn signal lamp from the mirror cover (Figure 8).

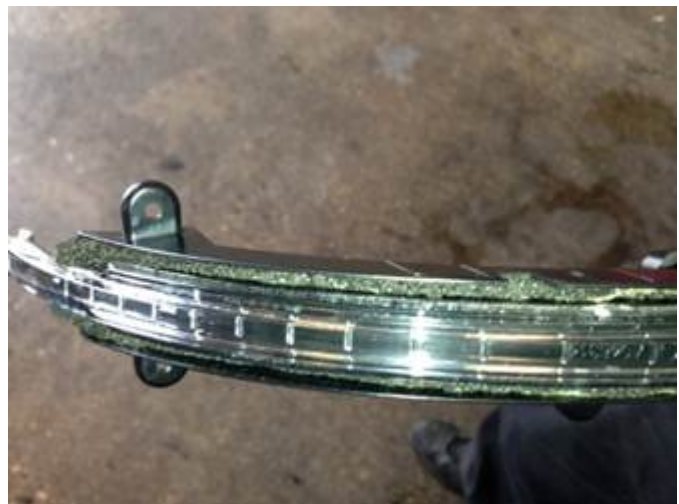
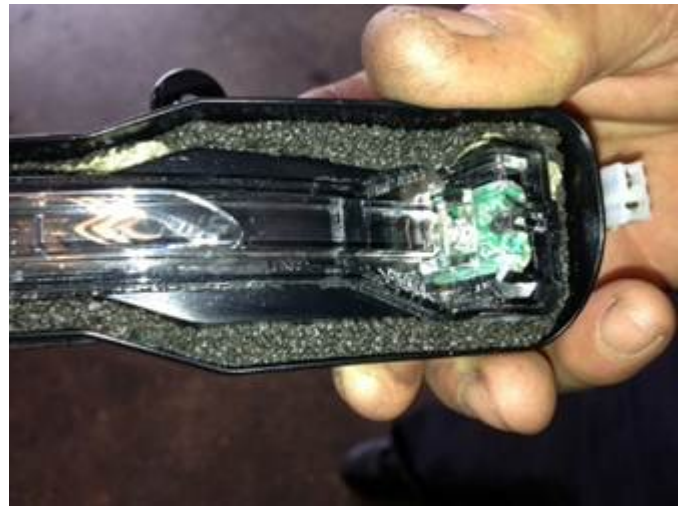
*Figure 9. Turn signal lamp with sealing foam tape installed.*

**Figure 10.** Turn signal lamp with sealing foam tape installed.

8. Apply strips of foam material (part number **8F0857869**) into the entire channel that surrounds the turn signal lamp, as shown at right (Figure 9 and Figure 10).

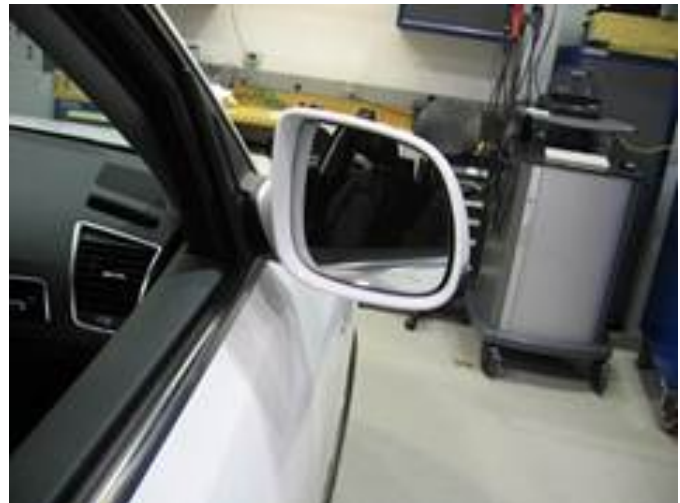
**Figure 11.** Mirror reassembled.

9. Reinstall the turn signal lamp into the mirror cover. Reinstall the mirror cover onto the mirror base (Figure 11).

**Tip:** Exercise care in the reassembly process. Incorrect or incomplete reassembly will cause recurrence or additional wind noise from the mirror assembly.
