Technical Service Bulletin

96 False warning by lane change assistant (Audi Side Assist)

96 13 81 2033782/3 December 6, 2013. Supersedes Technical Service Bulletin Group 96 number 13-75 dated September 23, 2013 for reasons listed below.

Model(s)	Year	VIN Range	Vehicle-Specific Equipment
A4 allroad	2013	000001-999999	Audi Side Assist (PR Code 7Y1)
A4 allroad	2014	000001-057893	Audi Side Assist (PR Code 7Y1)

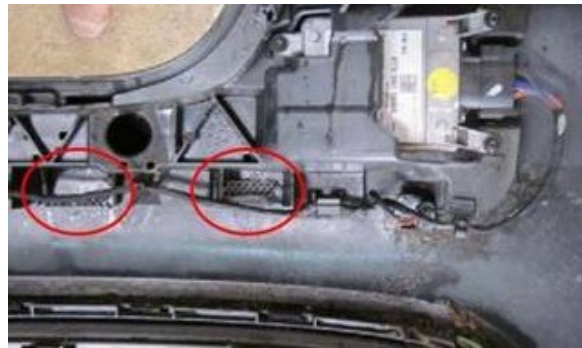
- Incorrect hardware from the supplier.
- The mounting bracket for the control units becomes loose over time.

3. Perform a visual inspection of the plastic mounting brackets for the J769 and J770 control units. It is possible the plastic weld has come loose or is broken apart from the rear bumper cover (Figure 5).

Figure 5. Bumper bracket weld locations with broken welds.

4. Replace the rear bumper cover assembly if the bracket is loose (Figure 6).

5. Replace the rear bumper cover assembly if the bracket is broken (Figure 7).

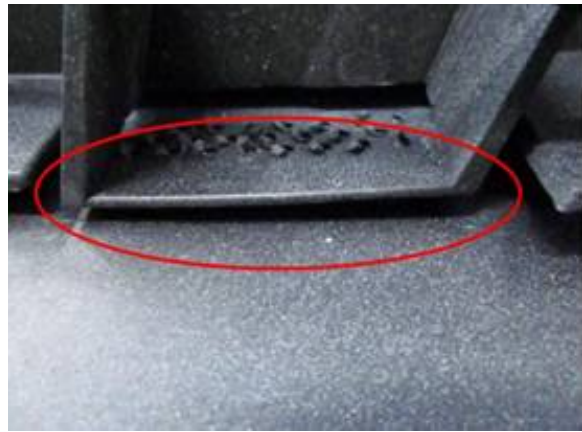
Figure 6. Loose bracket.

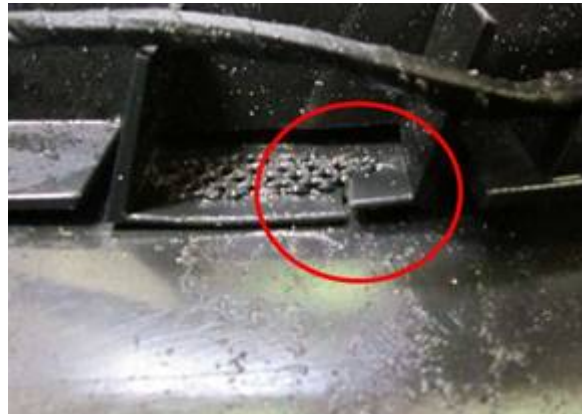
Figure 7. Broken bracket.
