# Technical Service Bulletin

## 28G6 UPDATE – Ignition Coils (NVLW)

Model(s)	Year	VIN Range	Vehicle-Specific Equipment
A4	2010-2013	See Campaign/Action screen in ElsaWeb	2.0L Engine
A5/A5 Cab	2010-2013		2.0L Engine
A6	2013		2.0L Engine
Q5	2011-2013		2.0L Engine

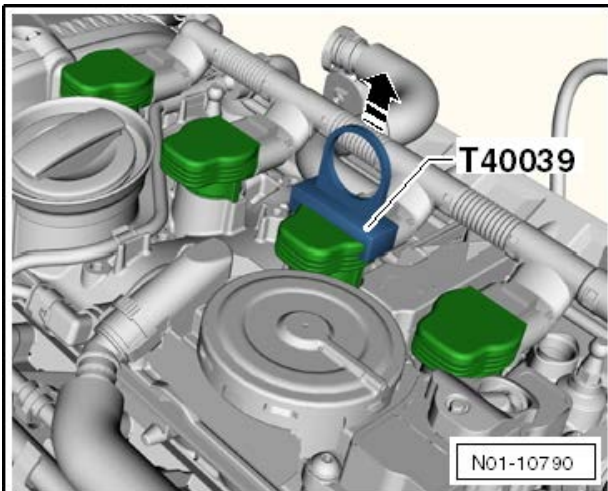
- ⇐ Using coil removal tool T40039, pull each ignition coil approximately 30mm upward.

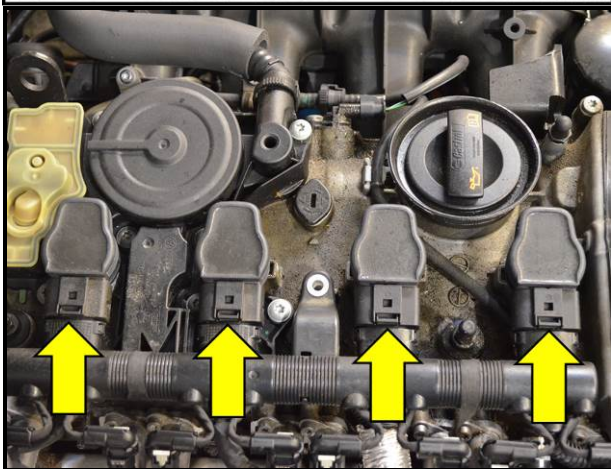
- ⇐ Carefully disengage the locking tab on each ignition coil connector <arrows>.

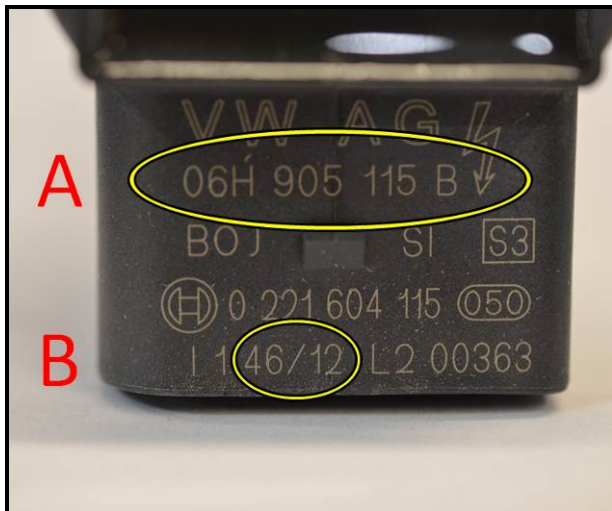
- Inspect the part number and build date of all 4 ignition coils.

⇐ If any one of the ignition coils is NOT part number 06H 905 115B or any of the build dates are 29/11 or earlier <circle B>

⇐ If any one of the ignition coils is NOT part number 07K 905 715F <circle A>

**Replace all 4 ignition coils if:**

- If all 4 ignition coils are P/N 06H 905 115B **AND** the build date is 30/11 or later or if all 4 ignition coils are P/N 07K 905 715F it is not necessary to replace the ignition coils.  
**Reassemble the vehicle.**

**If ignition coil replacement is necessary, Continue to Section C.**
