# Technical Service Bulletin

## 66 Wind noise from exterior rear view mirror

66 13 38 2035673/2 November 15, 2013. Supersedes Technical Service Bulletin Group 66 number 13-37 dated November 4, 2013 for reasons listed below.

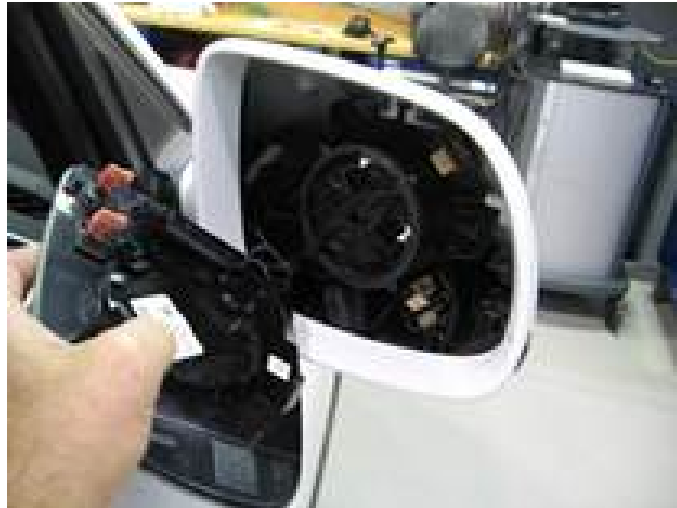
*Figure 1. Exterior rear view mirror glass removed.*

1. Begin by removing the exterior rear view mirror glass (Figure 1). Disconnect the electrical connectors carefully and set the glass aside.

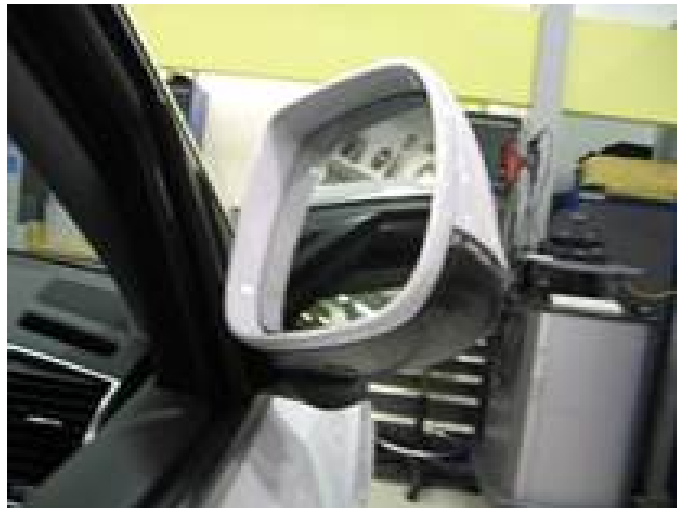
*Figure 2. Exterior rear view mirror manually folded.*

2. Remove the exterior rear view mirror cover. Manually folding the mirror body up will aid in the removal process (Figure 2).

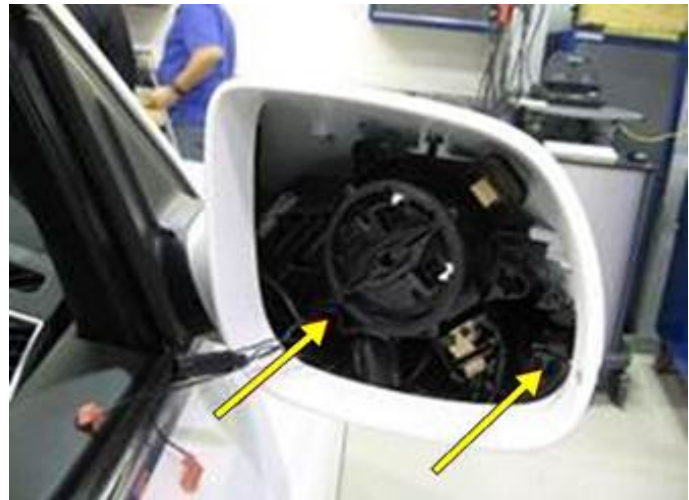
*Figure 3. Location of the retaining clips.*

3. Carefully pull the lower rim of the cover away from the mirror base. Release the two retaining clips for the cover inside the mirror base (Figure 3).

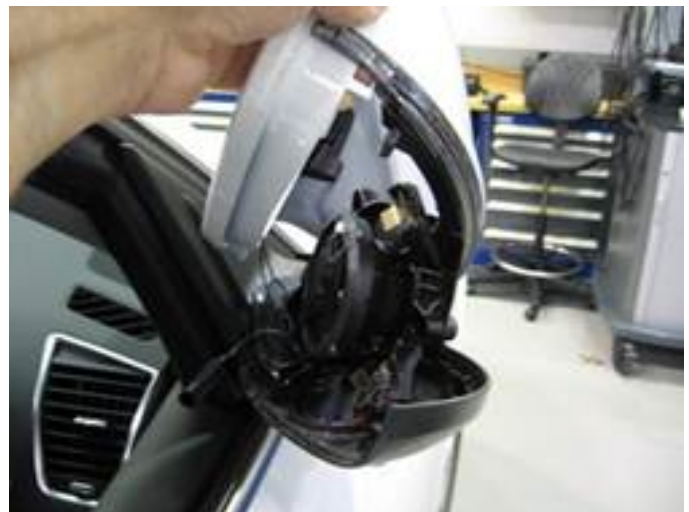
*Figure 4. Removing the mirror cover.*

4. Unsnap the cover and set it aside (Figure 4).

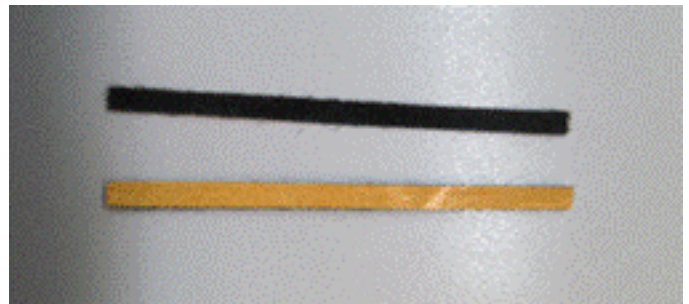
*Figure 5. Strips cut from felt tape.*

5. Cut two 60mm x 3mm strips of felt tape (part number: **533863288A**) (Figure 5).

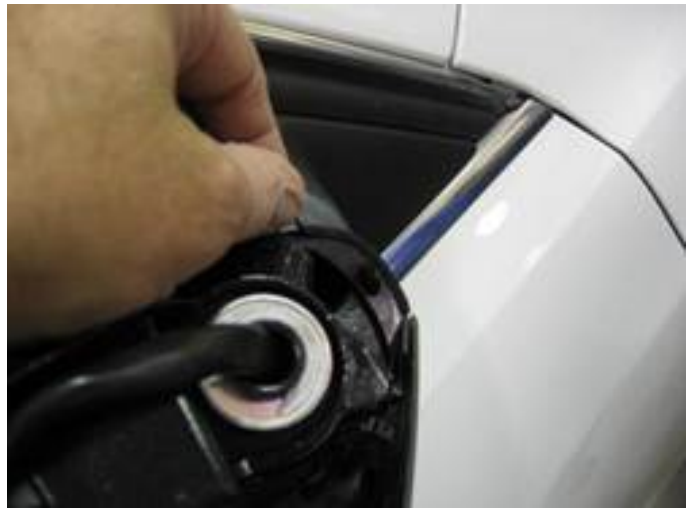
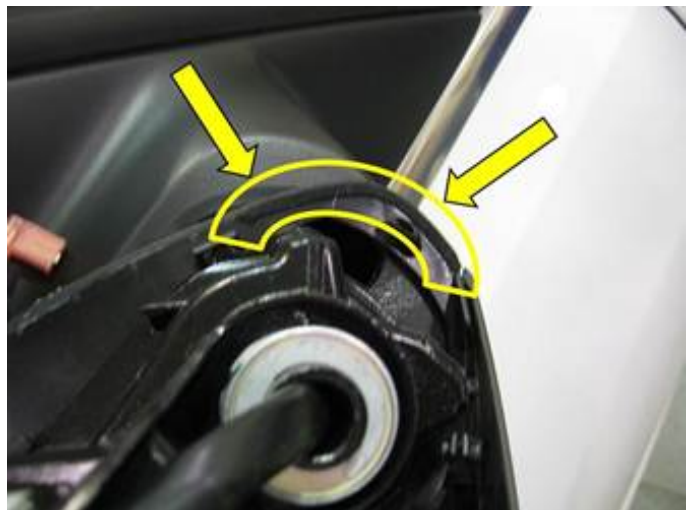
The two main sources of wind noise from the exterior rear view mirrors are: the seam surrounding the turn signal lamp and the seam at the mirror base. The modifications explained in the *Service* section of this bulletin will effectively mitigate the wind noise symptom for the customer.

*Figure 6. Application of felt tape.*

*Figure 7. Felt tape applied.*

6. Apply the felt tape strips to the exposed area of the mirror base, as shown at right (Figure 6 and Figure 7).

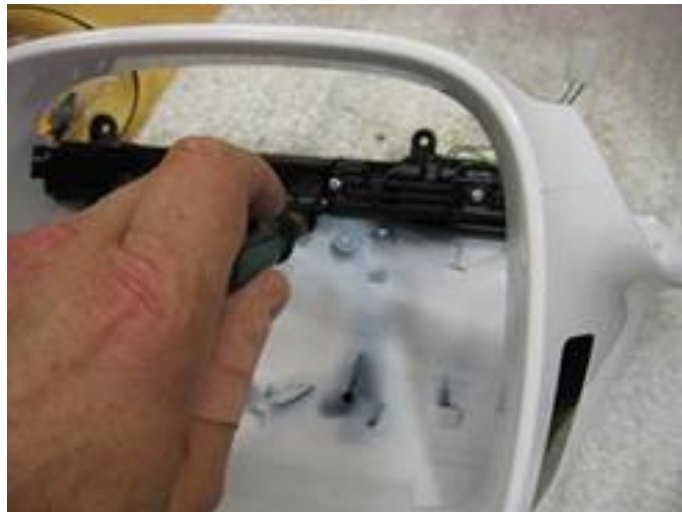
*Figure 8. Removing the turn signal lamp.*

7. Remove the turn signal lamp from the mirror cover (Figure 8).

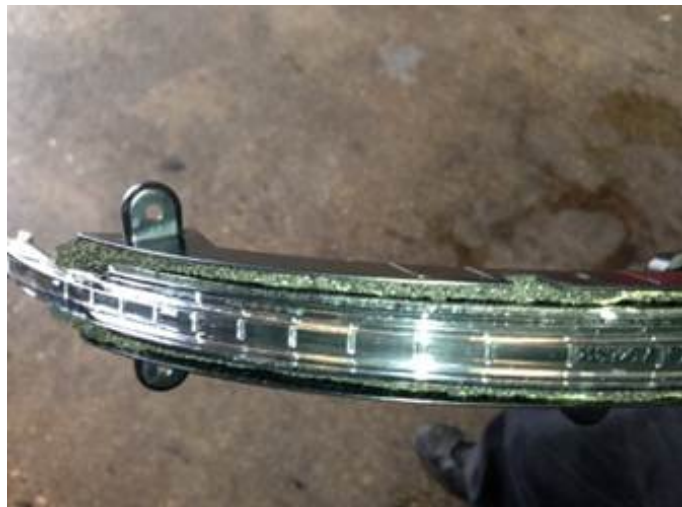
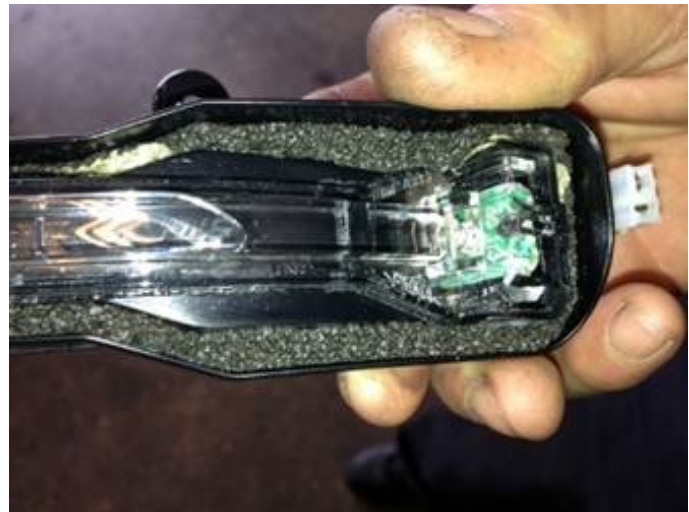
*Figure 9. Turn signal lamp with sealing foam tape installed.*

**Figure 10.** Turn signal lamp with sealing foam tape installed.

8. Apply strips of foam material (part number **8F0857869**) into the entire channel that surrounds the turn signal lamp, as shown at right (Figure 9 and Figure 10).

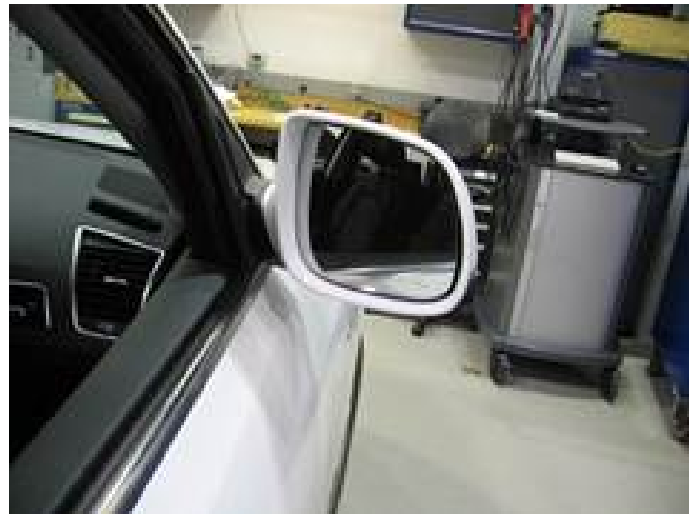
**Figure 11.** Mirror reassembled.

9. Reinstall the turn signal lamp into the mirror cover. Reinstall the mirror cover onto the mirror base (Figure 11).

**Tip:** Exercise care in the reassembly process. Incorrect or incomplete reassembly will cause recurrence or additional wind noise from the mirror assembly.
