Technical Service Bulletin

70 A pillar trim is loose

70 13 34 2035687/1 November 4, 2013.

| Model(s) | Year | VIN Range | Vehicle-Specific Equipment |
|---|---|---|---|
| Q7 | 2007 - 2014 | All | Not Applicable |

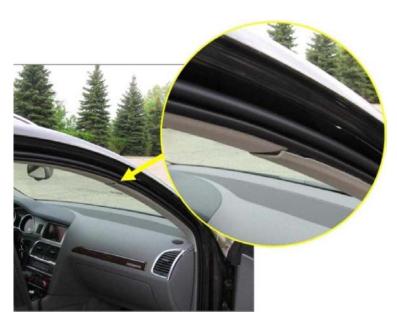
The A pillar trim on the right or left side of the vehicle is loose or does not fit properly.

The shape of the trim deforms over time.

Figure 1. Loose A pillar trim.

2. Replace the affected trim on one or both sides of the vehicle as necessary.

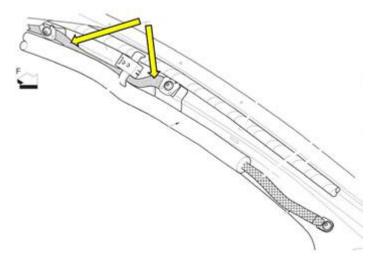
Figure 2. Location of the assembly support strap along the A pillar trim bracket.

Tip: A single mounting screw is used to mount the A pillar trim. It runs through an adapter under the trim. The adapter also guides the wiring harness and sunroof drain hose. Alongside the adapter is the assembly support strap for the curtain airbag (Figure 2). When installing the new trim, make certain that this assembly support strap is not trapped or pinched between the adapter and the A pillar structure.
