## Technical Service Bulletin

#### 74 Seat pneumatics system activates without driver input

74 13 15 2035757/1 November 15, 2013.

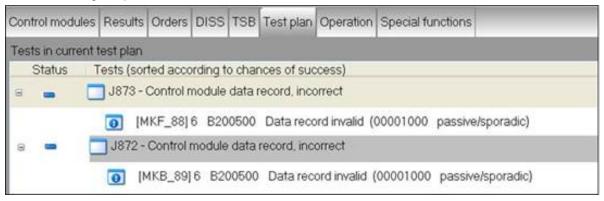
Figure 2. Example of DTC set for the control module after SVM code is performed.

2. After the SVM code is performed, one DTC will be set for each control module (Figure 2). Clear the DTCs before finalizing the procedure.
