# Technical Service Bulletin

## 91 Bluetooth call quality issues for caller on other end of call

91 13 11 2027718/5 October 31, 2013. Supersedes Technical Service Bulletin Group 91 number 13-86 dated June 11, 2013 for reasons listed below.

Model(s)	Year	VIN Range	Vehicle-Specific Equipment
TT, A5 Cab, A6, A7, A8	2011 - 2014	All	Bluetooth hands-free telephone system

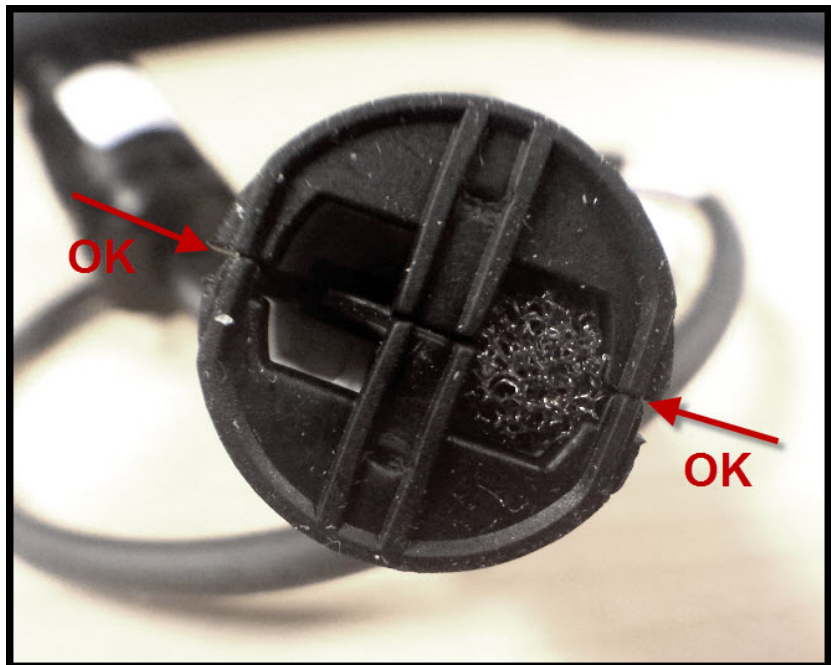
1. Inspect the seal of the microphone for damage:
  - There are two splits in the rubber seal. This is normal as long as the two halves of the seal are touching each other (Figure 5).

*Figure 5. Undamaged seal*

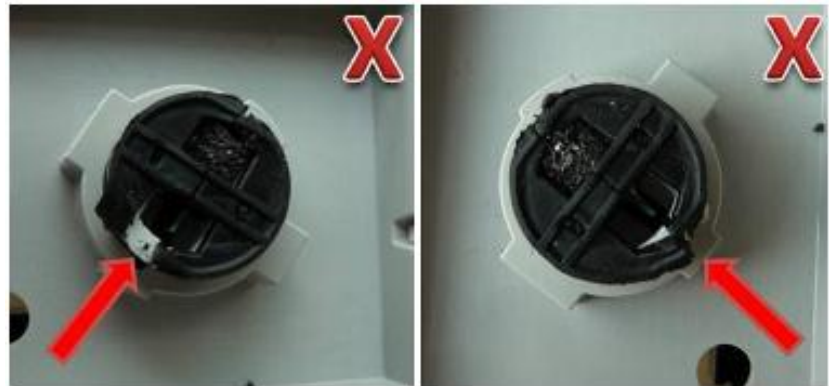
The microphone seal is damaged during installation into the roof module.

- If the two halves of the seal are loose and move freely, the seal is damaged (Figure 6).

Figure 6. Examples of damaged seals

- If the vehicle is a 2013+ A6/A7 built after VIN DN005481, contact TAC prior to proceeding with repairs for special instructions. When calling, please provide repair order number, as well as part numbers for microphones and interior light assembly.
- If the vehicle does not fall into the above range, replace the microphone set by installing the replacement microphone while the decorative trim is removed from the base plate. Take care when doing so to prevent damaging the new microphone's seal by slowly installing it perpendicular to the base plate (Figure 7). Do not install the microphone at an angle, as this may pinch the seal (Figures 8 and 9)

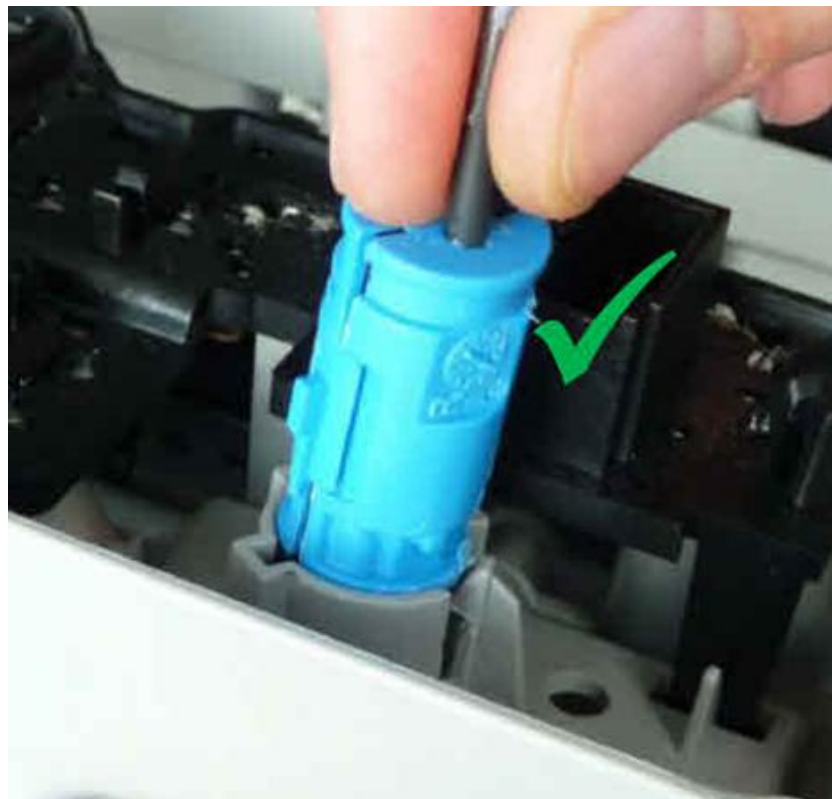
Figure 7. Proper installation.

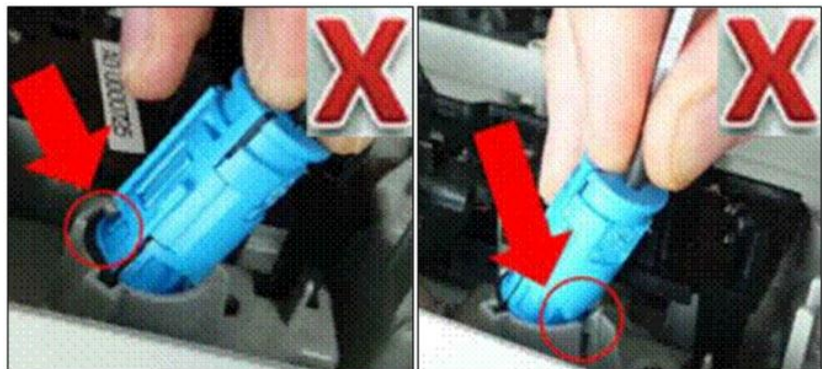
**Figure 8.** Incorrect installation at an angle, showing a pinched seal on the left.

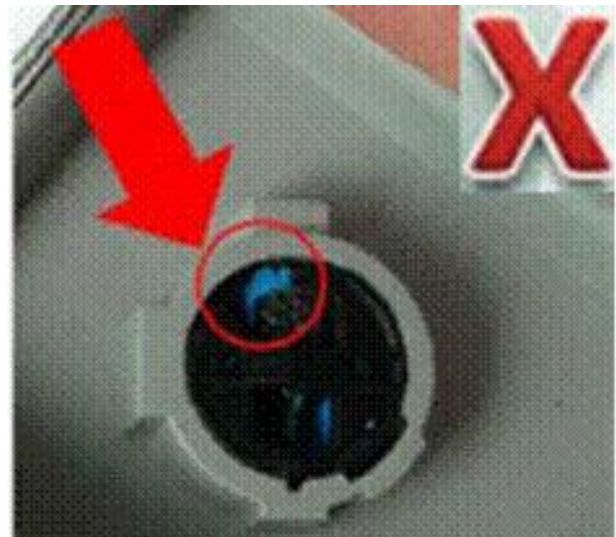
**Figure 9.** Damage caused by a pinched seal.

- Carefully inspect the new microphone seal after it has been snapped into place.
3. If the vehicle is a TT or A5 Cabriolet:

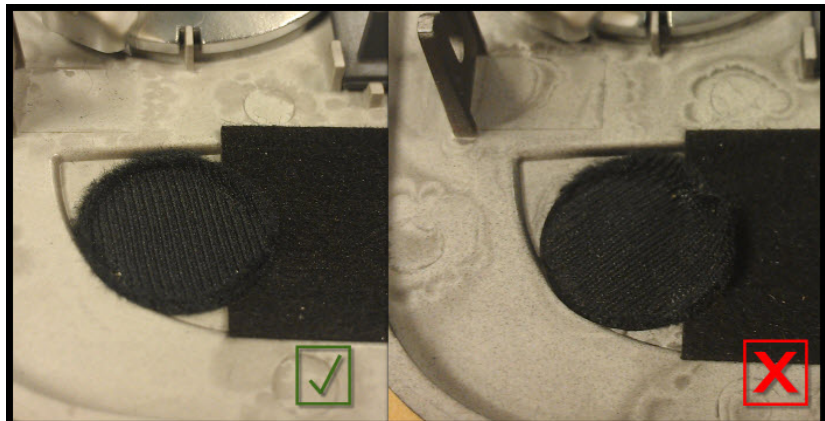
- Visually inspect the round felt material on the underside of the decorative trim (Figure 10). The felt material pushes against the microphone's rubber seal and forms a barrier. The decorative trim should be replaced (see ETKA) if the material is bunched up or not centered perfectly, as it can potentially affect the call quality.

**Figure 10.** Felt on backside of decorative trim.
