Technical Service Bulletin

91 Sound system has background static with hill-hold active

91 13 12 2035013/1 October 31, 2013.

Model(s)	Year	VIN Range	Vehicle-Specific Equipment
A3	2010 - 2013	All	Not Applicable

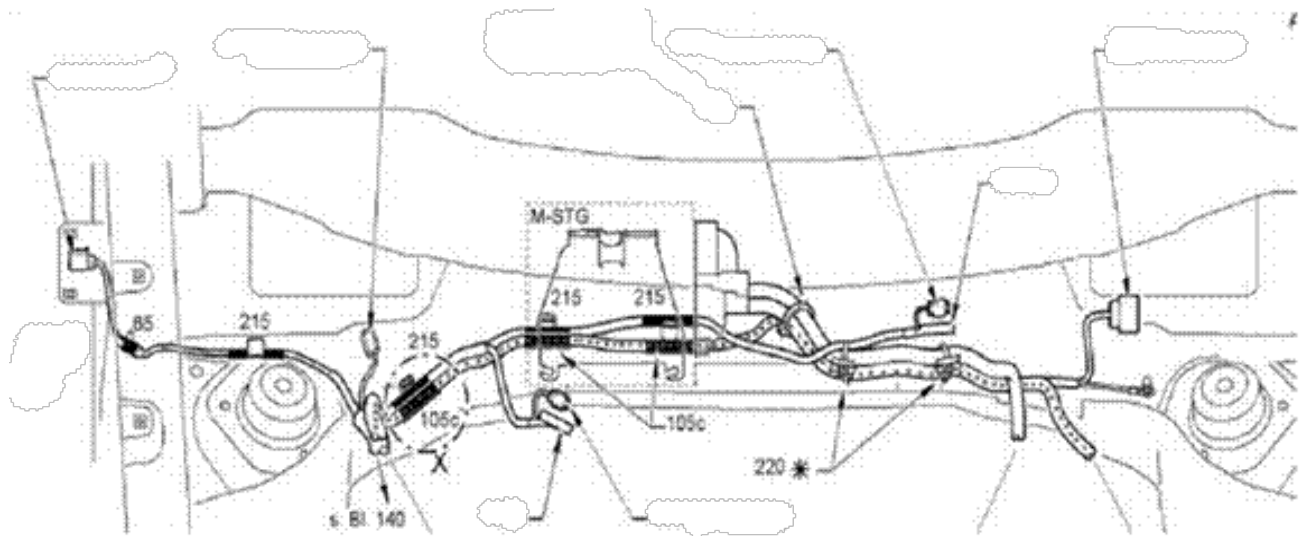
Figure 1. Overlay cable routing through plenum (dotted line shows recommended routing).

1. Remove battery, battery tray, Central Electrics, and cowl panel trim to perform overlay.
2. Using a 10AWG cable, overlay from pin 32 of the ESP to pin 27 in block T40 of the Central Electrics through plenum (Figure 1). Use corrugated pipe (part number: **N10732401**) to protect overlay.

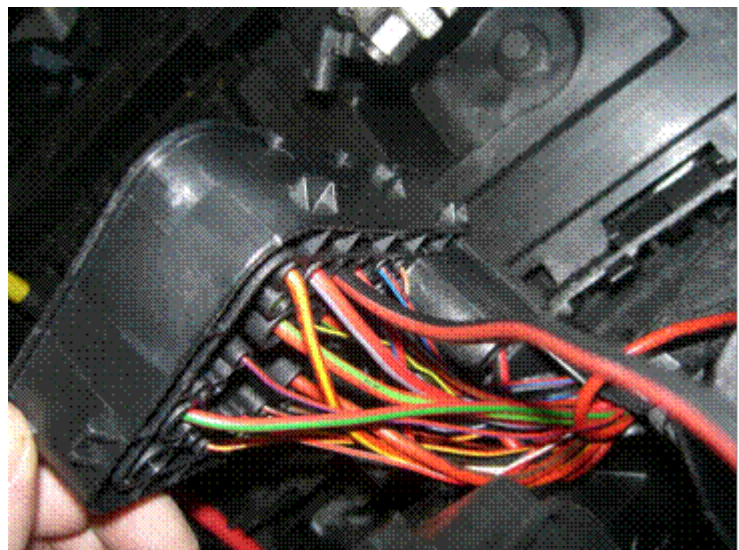
Figure 2. Overlay cable (red/black) inserted into T40 pin 27.

3. Attach terminal and insert new 10AWG cable into pin 27 in block T40 of Central Electrics (Figure 2).

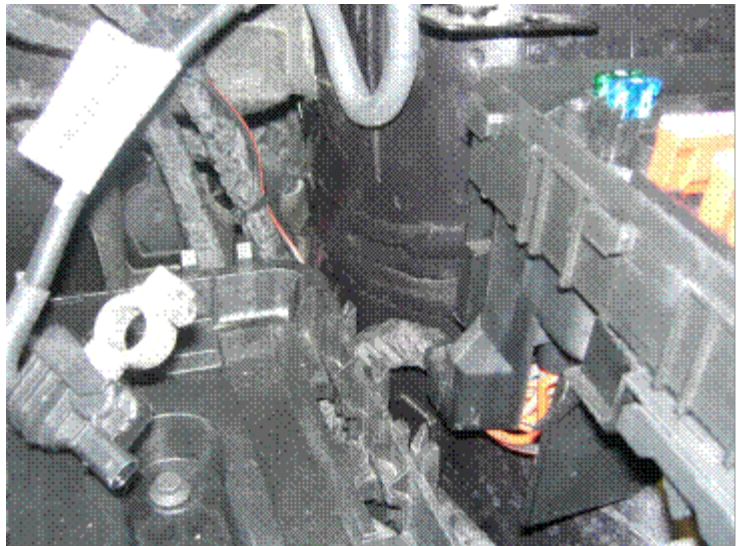
Figure 3. Routing up from Central Electrics.

4. Route cable up under Central Electrics and towards plenum (Figure 3).

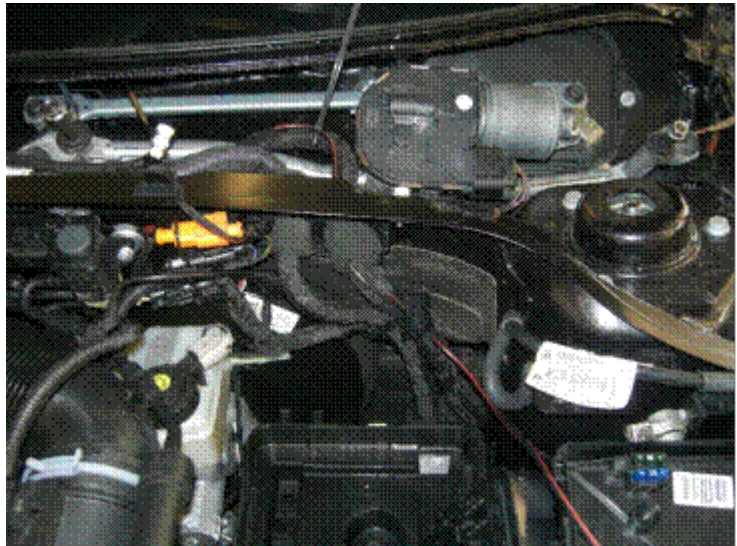
Figure 4. Routing up through plenum chamber.

5. Route cable through plenum wall and into plenum chamber (Figure 4).

Be sure to protect cable through plenum wall to avoid chafing and a possible short.

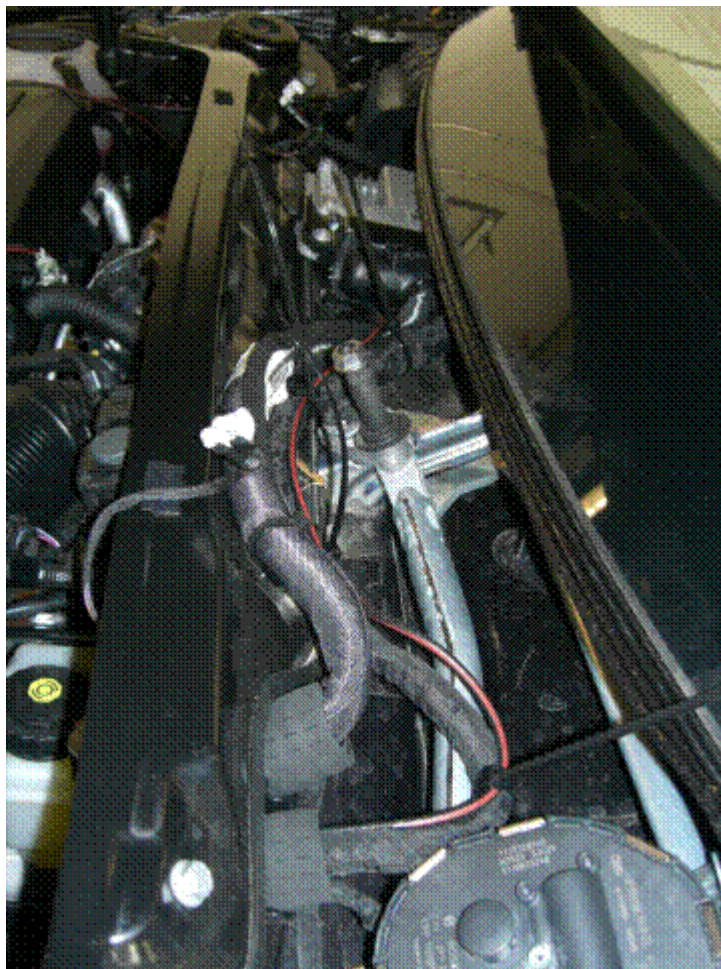
Figure 5. Routing through plenum chamber.

6. Route cable through plenum chamber as shown (Figure 5 and Figure 6).

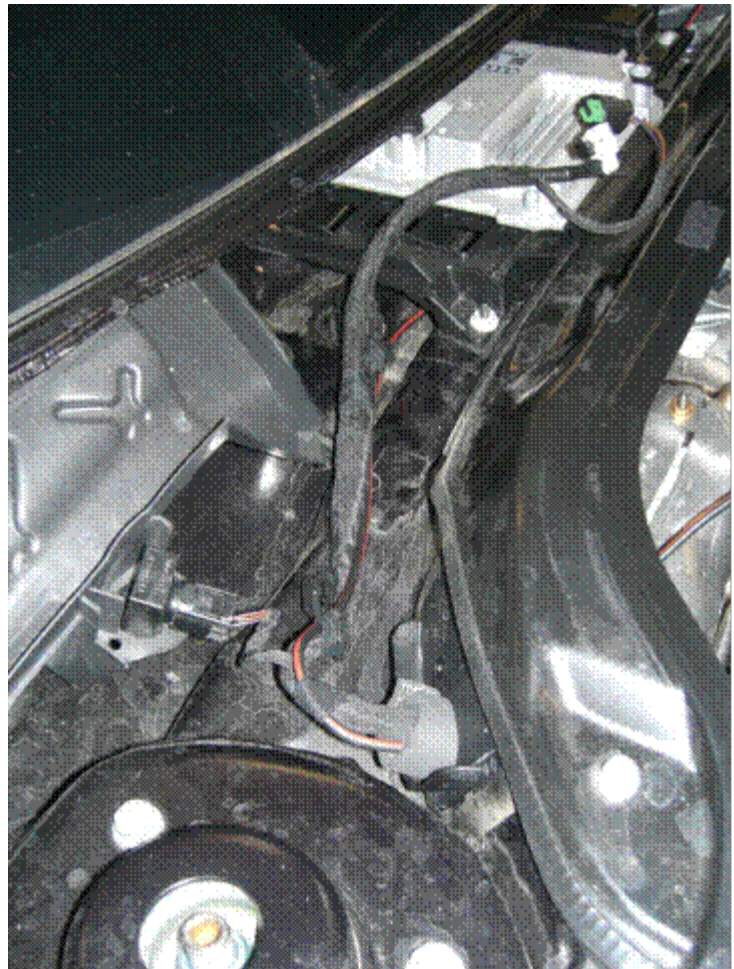
Figure 6. Routing through plenum chamber (continued).

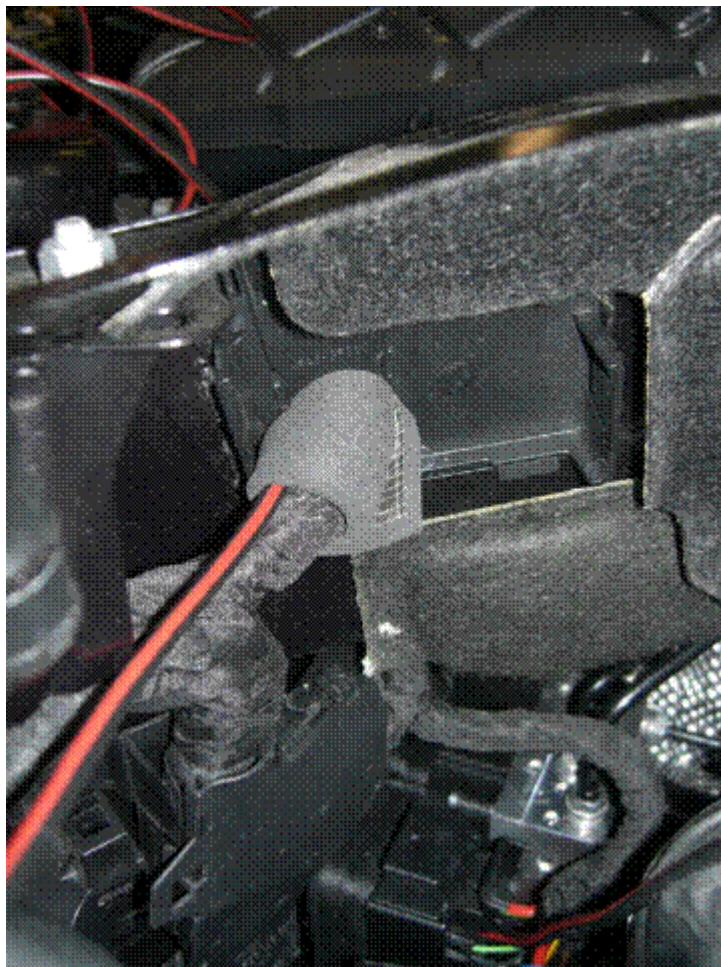
Figure 7. Routing out of plenum chamber to ESP.

7. Return cable to engine compartment through plenum wall (Figure 7). Route to pin 32 of the ESP, affix terminal and secure.
