Technical Service Bulletin

97 Various electrical components inoperative

97 13 38 2016275/5 October 16, 2013. Supersedes Technical Service Bulletin Group 97 number 10-14 dated September 16, 2010 for reasons listed below.

Model(s)	Year	VIN Range	Vehicle-Specific Equipment
Q7	2007 - 2014	All	Not applicable

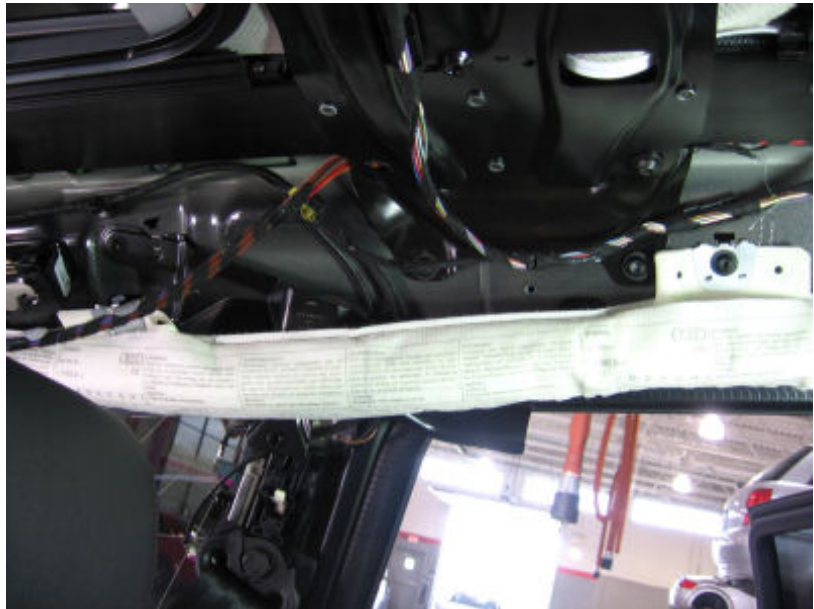
During vehicle assembly, the wire harness that is routed along the left side of the sunroof frame may be pinched at one of the sunroof frame to body assembly points (Figure 1 - Figure 4).

Figure 1. Sunroof frame and mounting bracket above left rear door.

Repair damaged wires using the VAS Repair Kit 1978 (Figure 5).

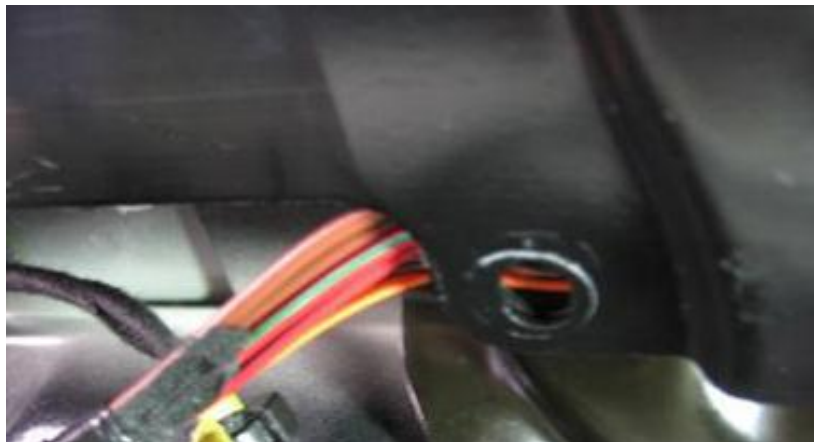
Figure 2. Closer view of wires that fell out of the sunroof frame groove and would become pinched between the sunroof frame and mounting bracket. Mounting bolt removed for demonstration purposes.

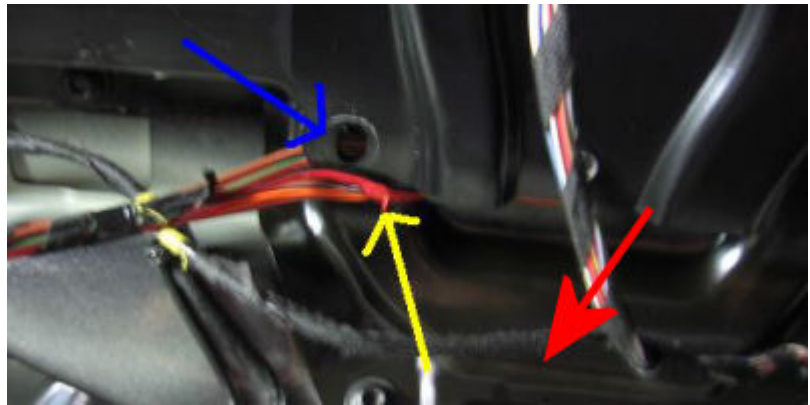
Figure 3. Bracket that fastens the sunroof frame to the body (red arrow), sunroof frame (blue arrow), and pinched wire (yellow arrow).

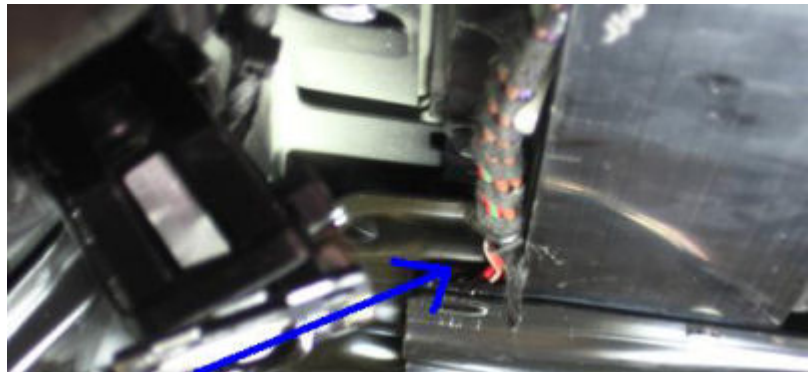
Figure 4. Wire, pinched between the sunroof frame and the bracket that holds the frame to the body on the left side of the vehicle above the C-pillar. Photo taken from the rear hatch opening.
